## Arboricultural impact appraisal and method statement

Land adjacent to Braeside House, 49 Bishopstoke Road, Bishopstoke, Eastleigh,  
Southampton, Hampshire SO50 6BF

12<sup>th</sup> August 2022

22113-AA-LF

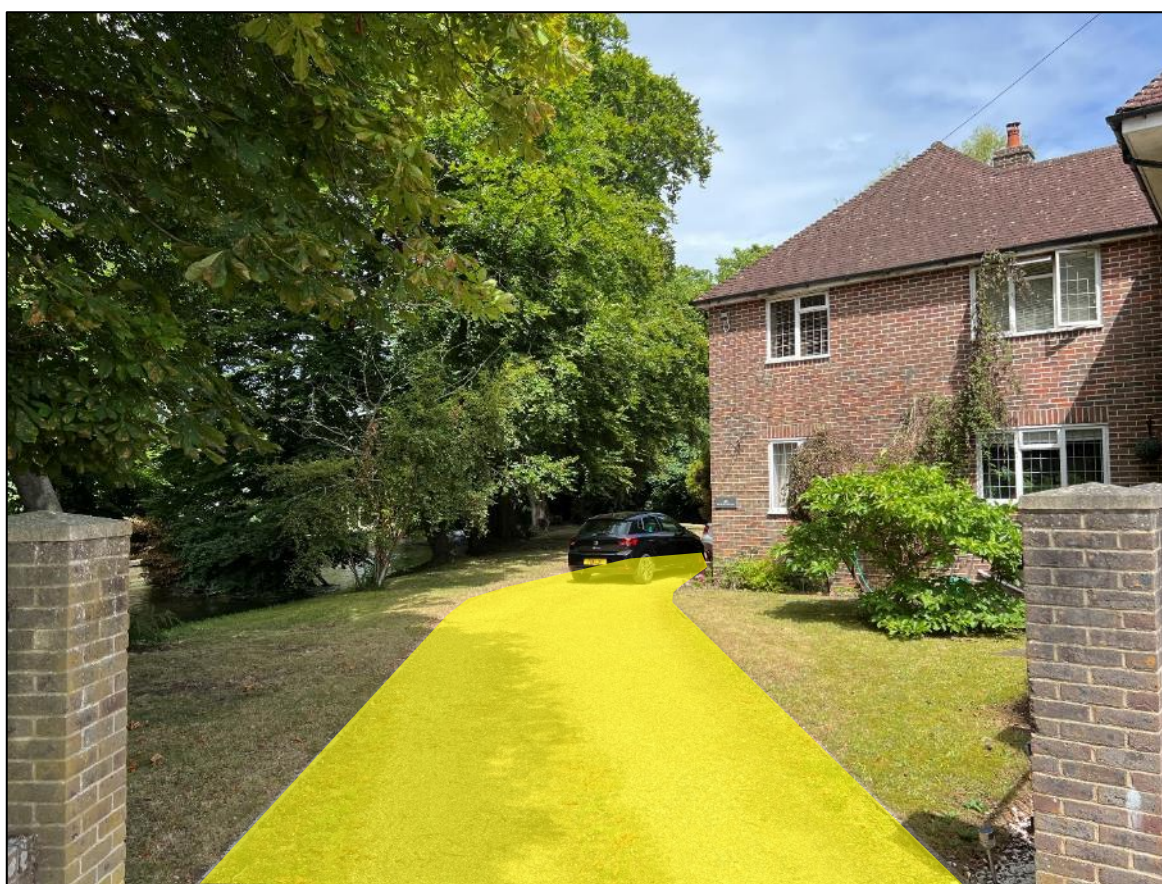
At the front of the site, the existing gravelled driveway will need to be upgraded, which falls within the RPAs of these trees (see Photo 1). Whilst it is currently suitable for the occasional small vehicle access, it will unlikely be robust to withstand both the development activity and the increased usage

**Photo 1:** Showing the existing gravelled driveway highlighted by the yellow annotation, looking northwest, that will need to be upgraded prior to the development activity. The yellow annotation corresponds to the precautionary area on the tree protection plan, and the protective fencing will run either side of the driveway to protect the exposed ground from the development activities.

once the works are complete and the proposed dwelling is occupied. We have carefully reviewed the levels in these areas, and it would be feasible to install a custom designed no-dig specification surfacing without causing any significant disturbance to the RPAs. From our previous experience at installing such surfacing ([www.barrelltreecare.co.uk/case-studies/SurfacingNearTrees.pdf](http://www.barrelltreecare.co.uk/case-studies/SurfacingNearTrees.pdf)), we are confident that this can be implemented without any long term detrimental impact on tree health, with the detail to be agreed as part of a planning condition. This surfacing solution is within the advice set out in BS 5837 (8.6) and would be appropriate in this situation.

In summary, if the guidance set out in SGN 7 *Excavating in RPAs* and SGN 9 *Installing/upgrading surfacing in RPAs* is observed, we believe that the proposed works can be implemented without any long-term detrimental impact on tree health, and therefore local character. All new surfacing must be installed before any development works to prevent damage to the RPAs from the various activities.

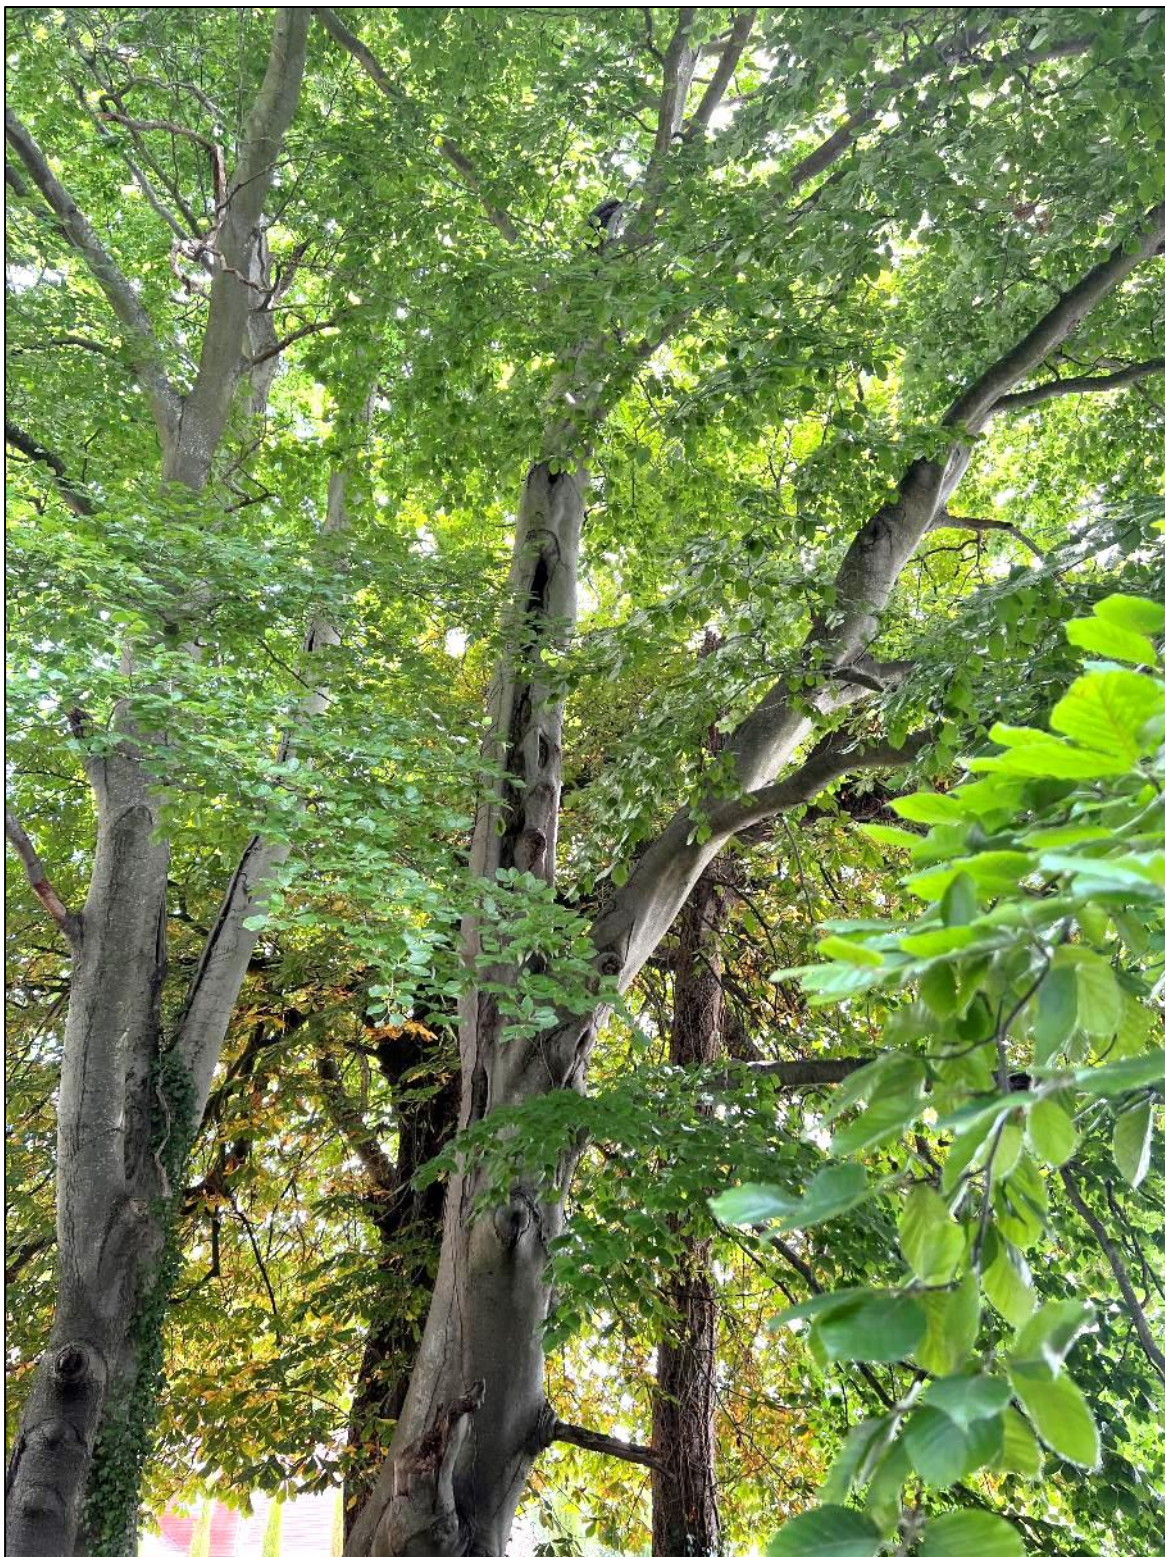
| Tree No | Species | Height (m) | Diameter (cm)<br>@ 1.5 m | Maturity | Low<br>Branches | Category | Notes | Tree Works | RPA<br>Radius<br>(m) |
|---|---|---|---|---|---|---|---|---|---|
| T3 | Beech | 18 | 90* | Mature | | C | River directly west, localised stem decay at<br>base, storm damage, significant stem decay<br>and hollowing of upper stem west, heavily<br>imbalanced and asymmetric canopy | Crown reduce the height by<br>about 4 m, the southerly<br>canopy extent by about 2–3 m,<br>and the westerly canopy<br>extent by about 3–4 m. The<br>resulting height of the tree<br>should be about 14 m, and the<br>canopy extents about 3 m<br>north, 1 m east, 3 m south,<br>and 3 m west. | 10.8 |

**Photo A3.1:** Showing the significant stem decay in T3 looking east, with cavity openings orientated west. Whilst the tree is subject to TPO, its structural condition is so poor that it will need management works soon if it is to be retained in the short term, and so it has been categorised as low value category C and should not be considered a constraint on the development.

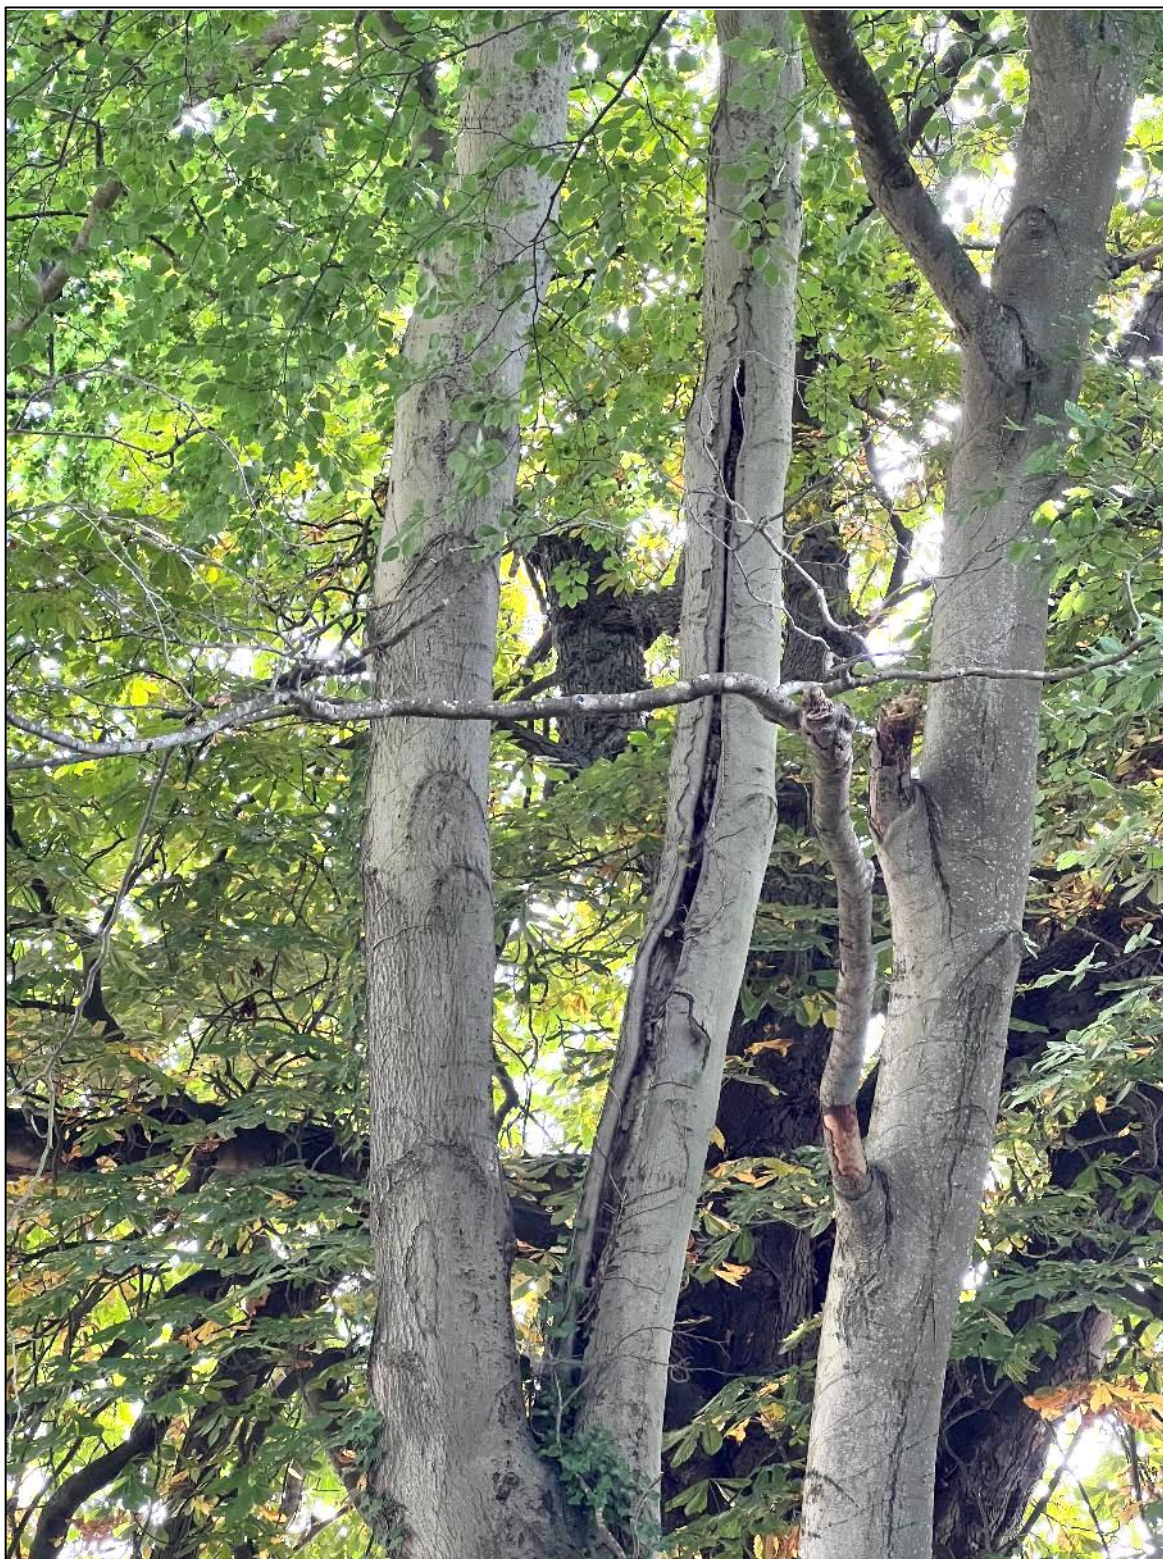
| Tree No | Species | Height (m) | Diameter (cm)<br>@ 1.5 m | Maturity | Low<br>Branches | Category | Notes | Tree Works | RPA<br>Radius<br>(m) |
|---|---|---|---|---|---|---|---|---|---|
| T4 | Beech | 18 | 60* | Mature | | C | River directly west, stem cavity at 0.5 m<br>south with decaying fungal fruiting bodies<br>within (possibly <i>Kretzschmaria deusta</i> ), co-<br>dominant stems at 5 m with significant decay<br>in both stems above | Crown reduce the height by<br>about 4 m, the northerly<br>canopy extent by about 1–2 m,<br>and the westerly canopy<br>extent by about 3–4 m. The<br>resulting height of the tree<br>should be about 14 m, and the<br>canopy extents about 3 m<br>north, 4 m east, 3 m south,<br>and 4 m west. | 7.2 |

**Photo A3.2:** Showing the significant stem decay and hollowing in T4 looking east, with cavity openings orientated west. Whilst the tree is subject to TPO, its structural condition is so poor that it will need management works soon if it is to be retained in the short term, and so it has been categorised as low value category C, and should not be considered a constraint on the development.
