# 4 HEATHFIELD ROAD, CHANDLERS FORD

## Tree Survey Report

AS\_1001\_300  
Tree Survey Report  
-  
April 2023

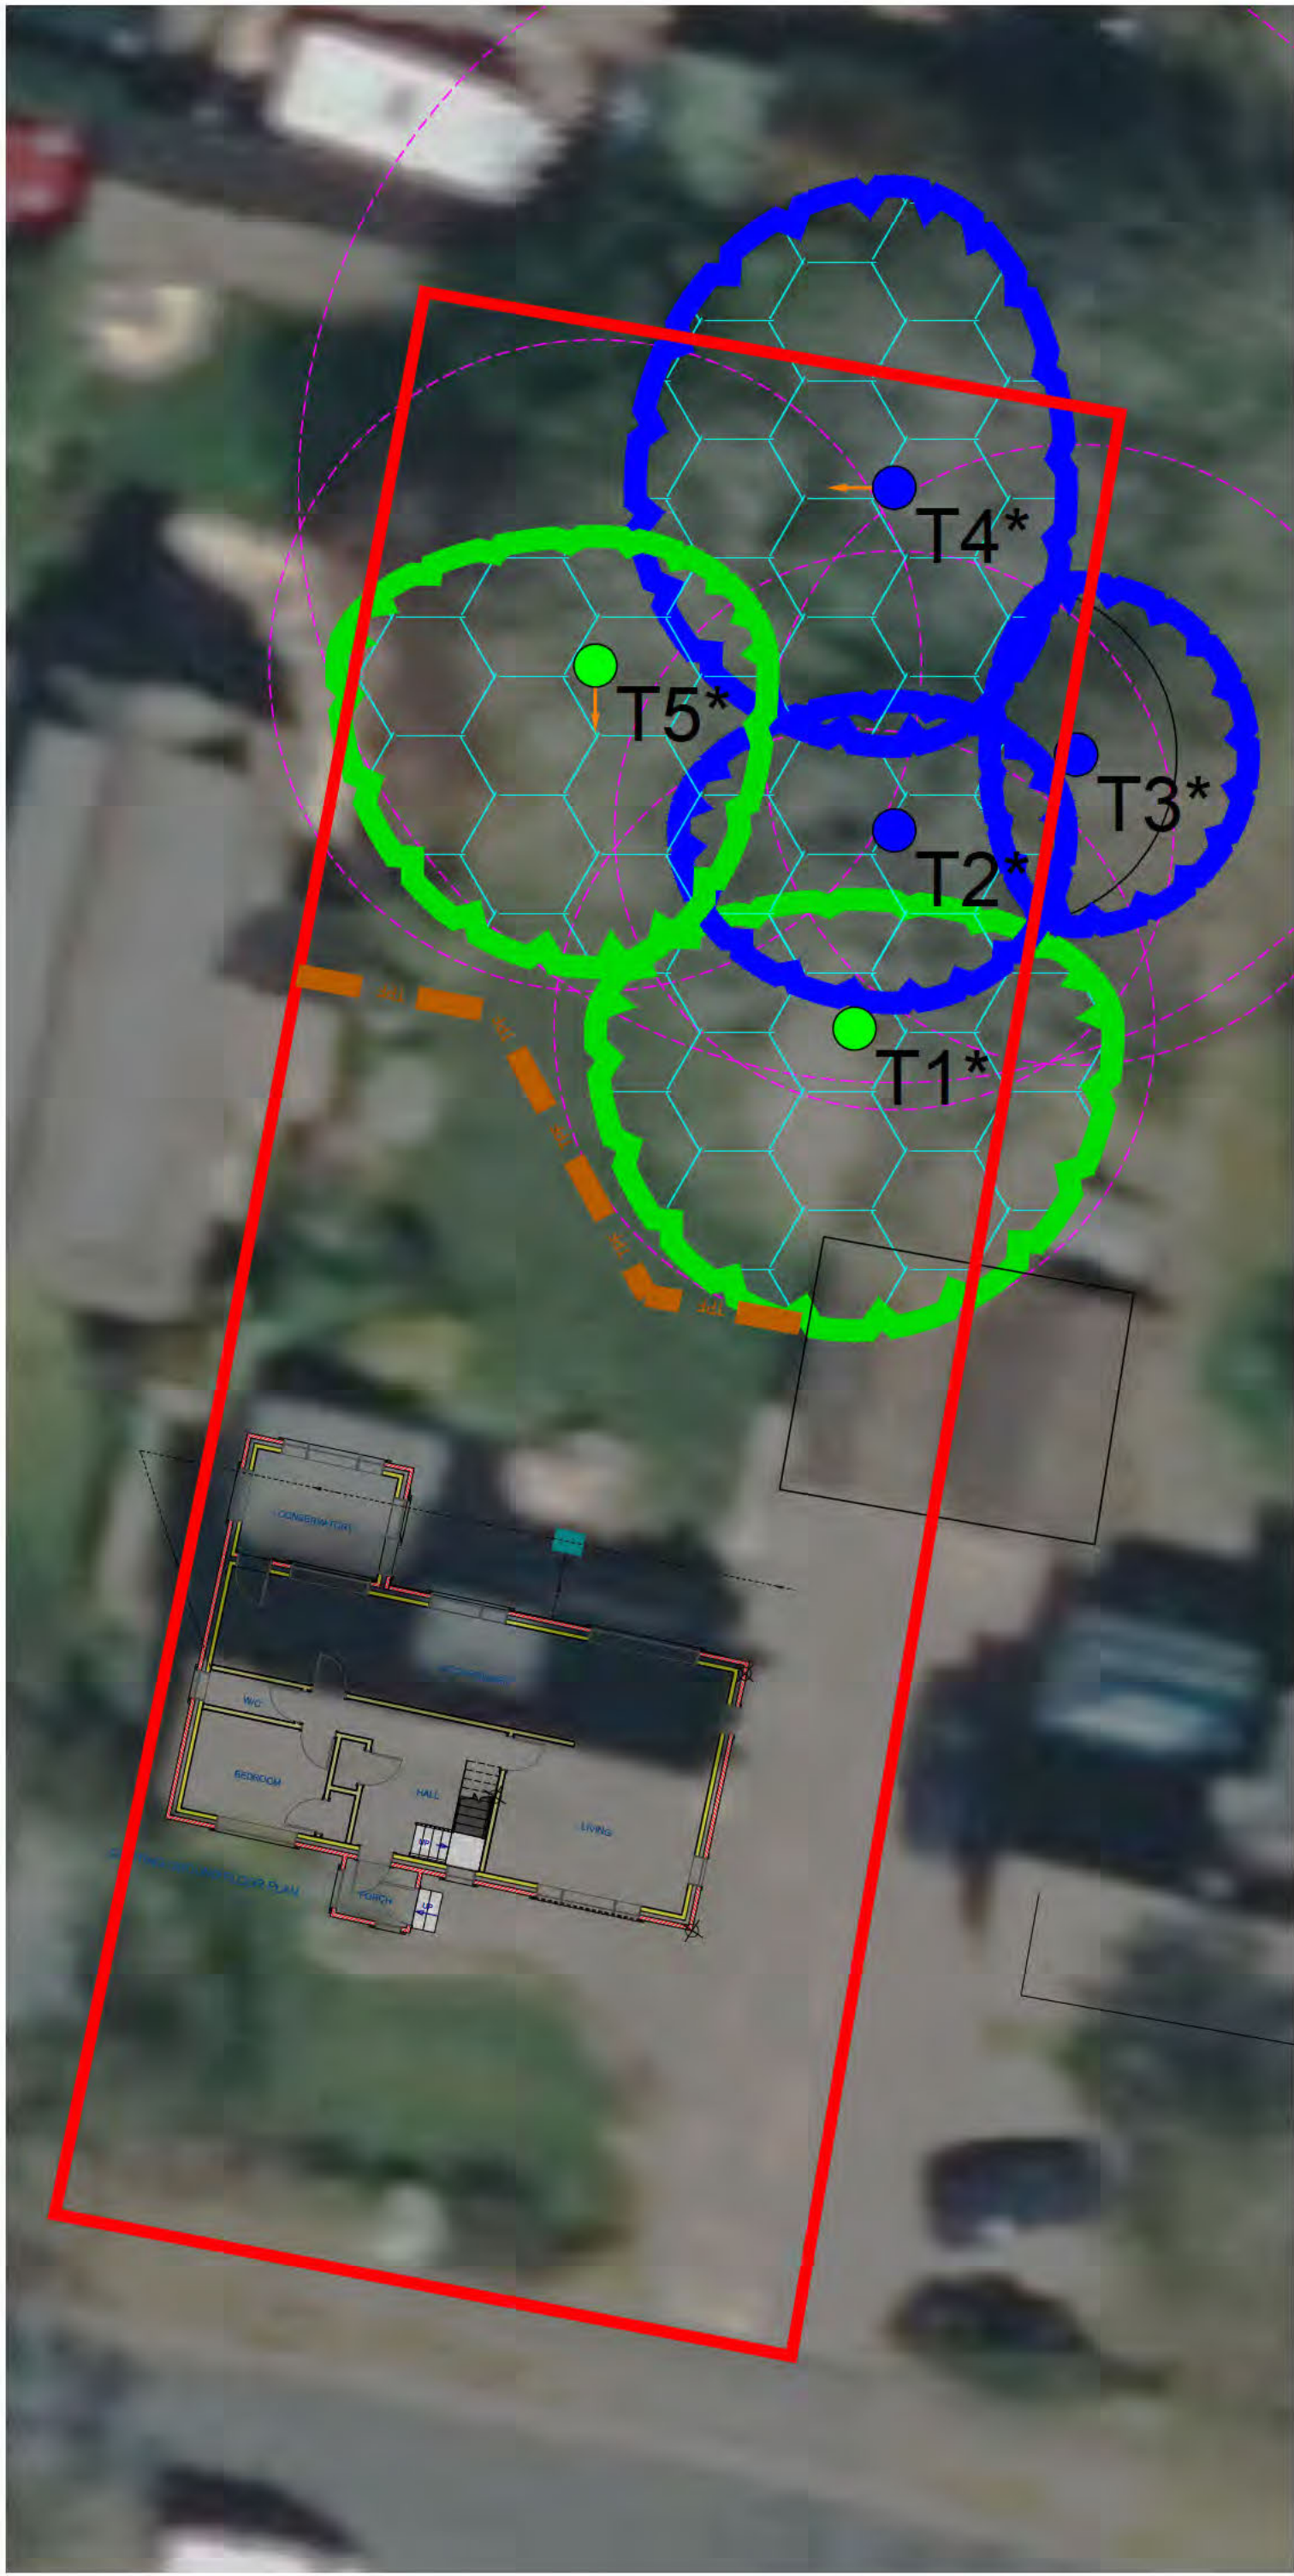
### Tree Constraints Plan AS\_1001\_100

- 4.3 All trees were regarded as mature in age and in fair to good structural and physiological condition.
- 4.4 T1, Oak was a large mature Oak tree situated closest to the dwelling. Its canopy almost overhung the external garage separated from the dwelling. The tree appeared to be declining with what appeared to be a sparse canopy lacking in dense bud and small twig growth in the upper parts of the canopy.

- 4.5 T2, had formed an etiolated canopy due to group pressure. A cavity was identified at the stem base on south side and showed signs of good reaction growth either side of the cavity. Overall, the tree was in satisfactory condition.

- 4.6 T3, was located off-site. No access was available to inspect the stem base in detail however, when viewed from afar no obvious major defects were identified.

- 4.7 T4, was a large specimen tree growing from a small, raised bed approx. 300mm above ground level. The stem appeared to be in satisfactory condition with no obvious major defects being noted other than large deadwood in the canopy up to 200mm in diameter.

- 4.8 T5, had a canopy bias south-westward but appeared in good condition overall.
- 4.9 Further details of each individual tree can be found in the Tree Survey Schedule included within this report.

- Proposed tree protection fencing to restrict any construction access within RPAs.
