# **Arboricultural Impact Assessment and Method Statement**

**Proposed development of two cricket pitches and associated  
footpath at:**

**Lapstone Playing Fields,  
Pavillion Close,  
Fair Oak,  
Eastleigh  
SO50 7PS**

**Report Reference:** HBD2202IAMSR3

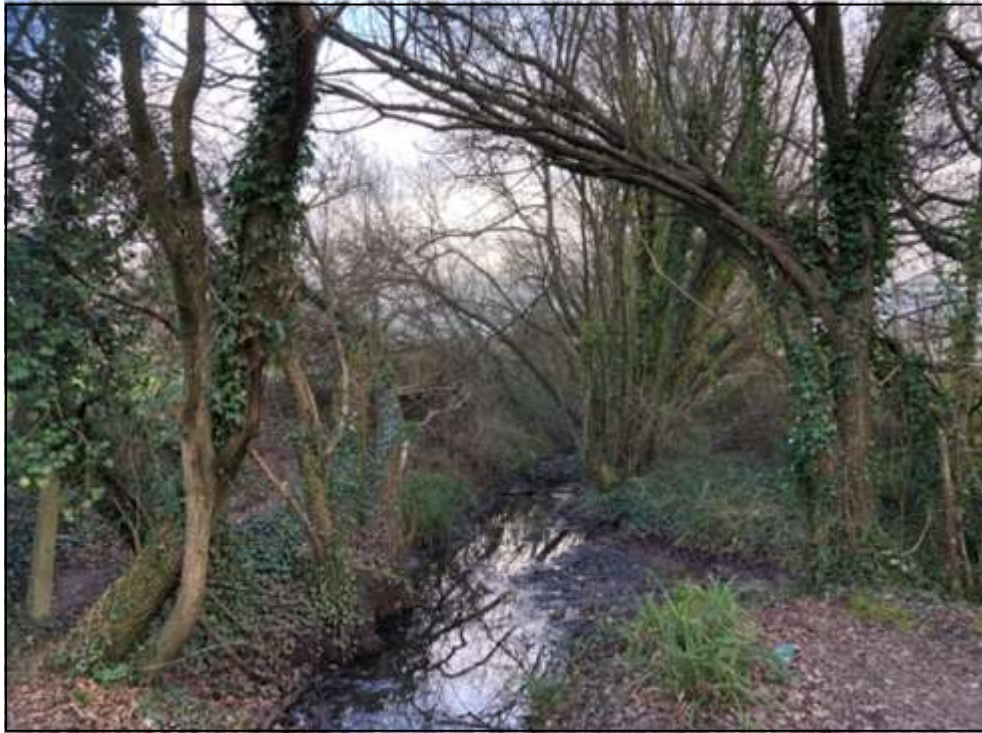
**Plate 1.** The western end of the culvert with goat willow (oak demarcating the boundary will be retained)

In my professional opinion, the removal of the existing culvert and associated goat willow will be more than compensated for by the associated planting scheme which will enhance the arboricultural interest of the playing fields. The scheme will also provide a richer and more diverse range of species for the benefit of biodiversity and will be more aesthetically pleasing for local residents. Planting a combination of native and other trees will future proof the project in terms of resistance to pests and disease and changing climatic conditions.

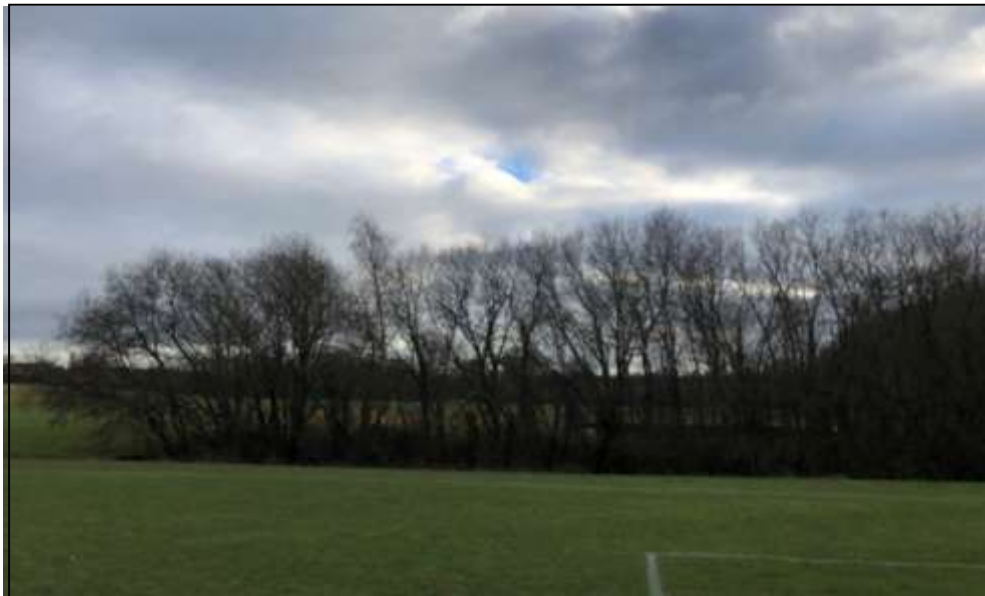
**2.3.1** The culverted channel in the northern reaches of the site issues into a boggy gully which descends by approximately 2-3 metres and is approximately 50 metres in length. The banks of this gully have become colonised with goat

**Plate 2.** Goat willow growing in the culvert (northern view)

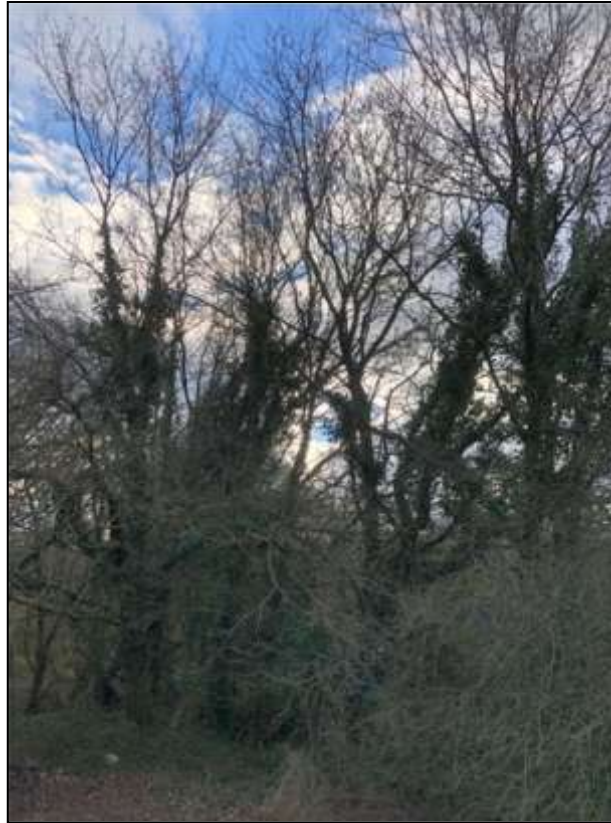
| Tree number | Species | Height (m) | Trunk Diameter (cm) | Crown spread (m) N, E,S,W | Crown height above ground (m) | Life stage | General observations | BS 5837 cat | Root protection area (m) |
|---|---|---|---|---|---|---|---|---|---|
| G2 | Oak x 5<br><i>Quercus robur</i> | 13 | 35 | 5.5, 5.5, 5, 5 | 5 | Semi mature | Growing along boundary line and sharing canopy with G1 | B | 4.2 |

**Plate 3.** G2 comprising oak on the western boundary

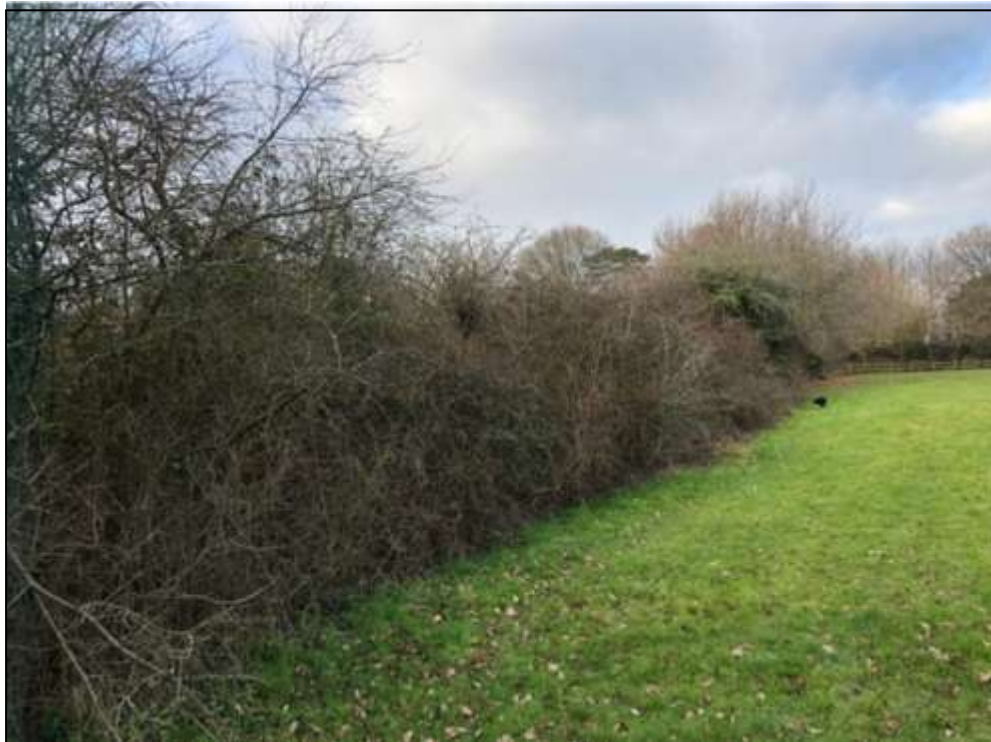
| Tree number | Species | Height (m) | Trunk Diameter (cm) | Crown spread (m) N, E,S,W | Crown height above ground (m) | Life stage | General observations | BS 5837 cat | Root protection area (m) |
|---|---|---|---|---|---|---|---|---|---|
| G3 | Black thorn, <i>Prunus spinosa</i> , blackberry<br><i>Rubus fruticosus</i> . and hawthorn<br><i>Crataegus monogyna</i> | 4 | 7 | 2,2,2,2, | 0 | Mature | Hedgerow species - over grown and congested | C | 0.9 |

**Plate 4.** G3 comprising hawthorn and sloe on the north-western boundary

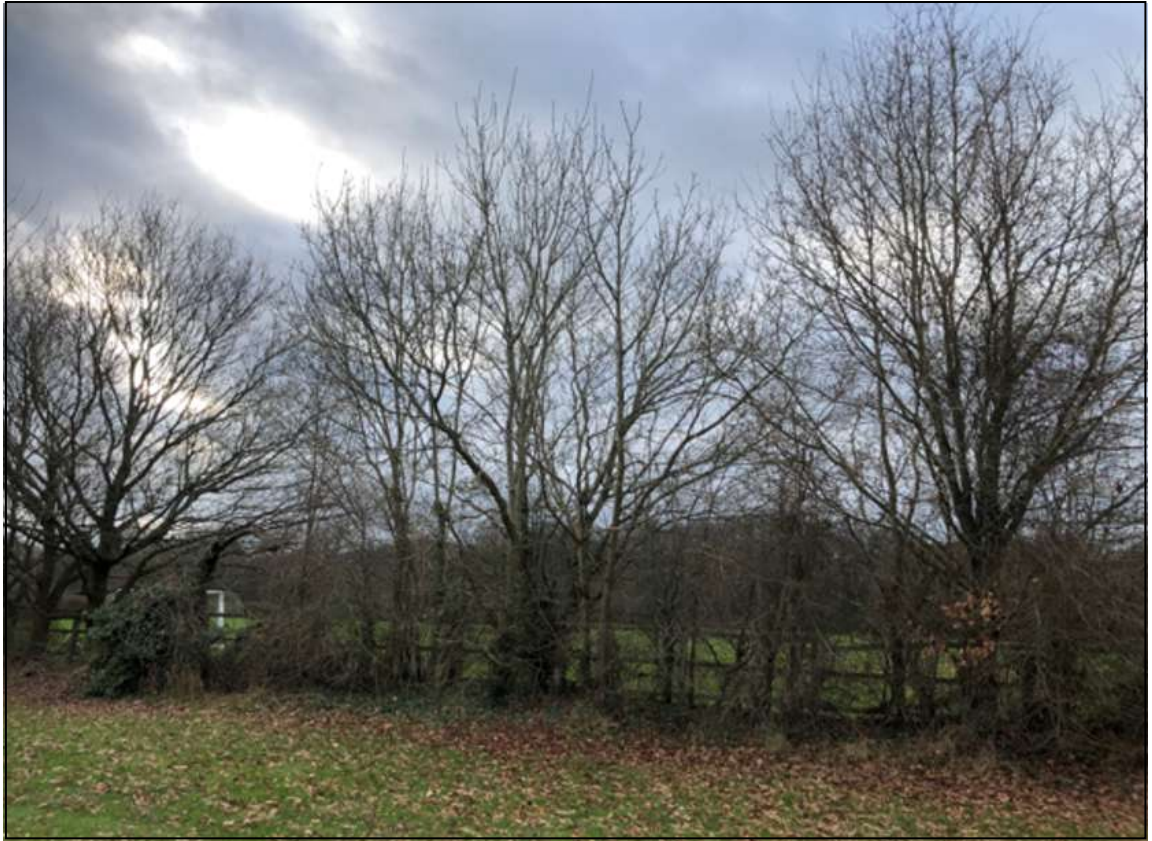
| Tree number | Species | Height (m) | Trunk Diameter (cm) | Crown spread (m) N, E,S,W | Crown height above ground (m) | Life stage | General observations | BS 5837 cat | Root protection area (m) |
|---|---|---|---|---|---|---|---|---|---|
| G5 | Ash x 4<br>( <i>Fraxinus excelsior</i> )<br>Oak x 1 | 5 | 18 | 3,4,3,4 | 2 | Semi mature | Oak - normal form and vitality, growing on neighbouring property<br>Ash - poor form and vitality - re-survey in leaf to check for ash dieback | C/R | 2.1 |

**Plate 5.** G4 and G5 comprising ash and oak with cherry

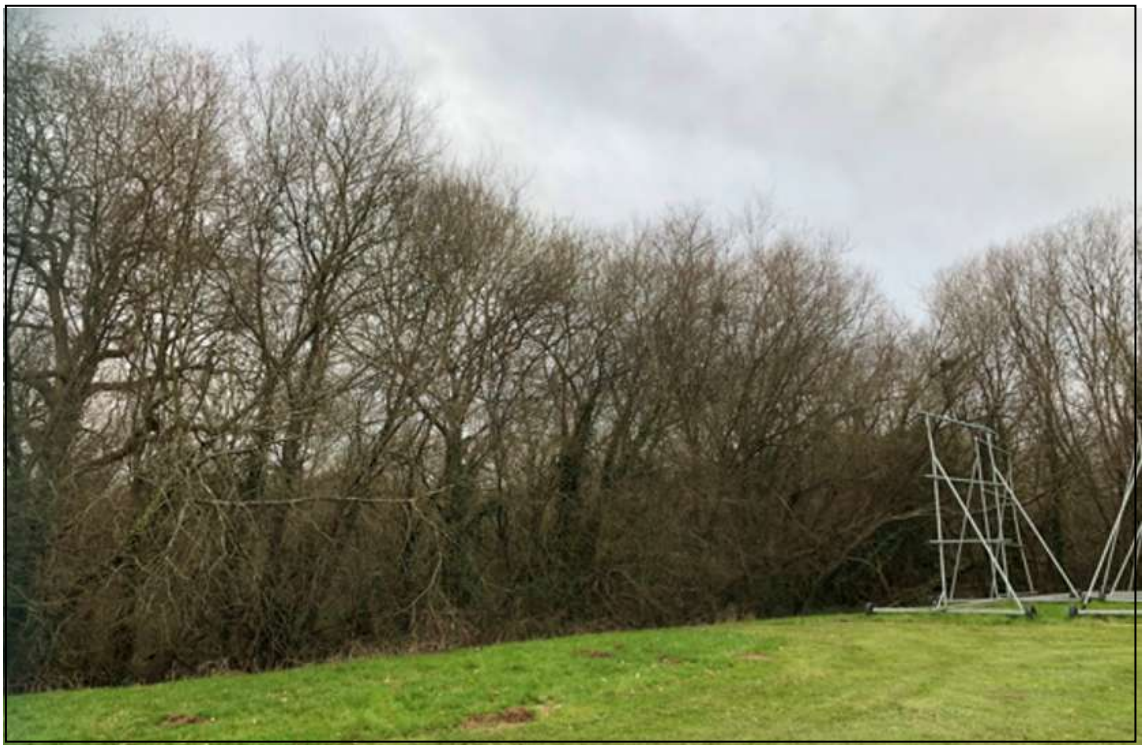
**Plate 6.** Goat willow with oak growing along the western boundary where it meets the culvert

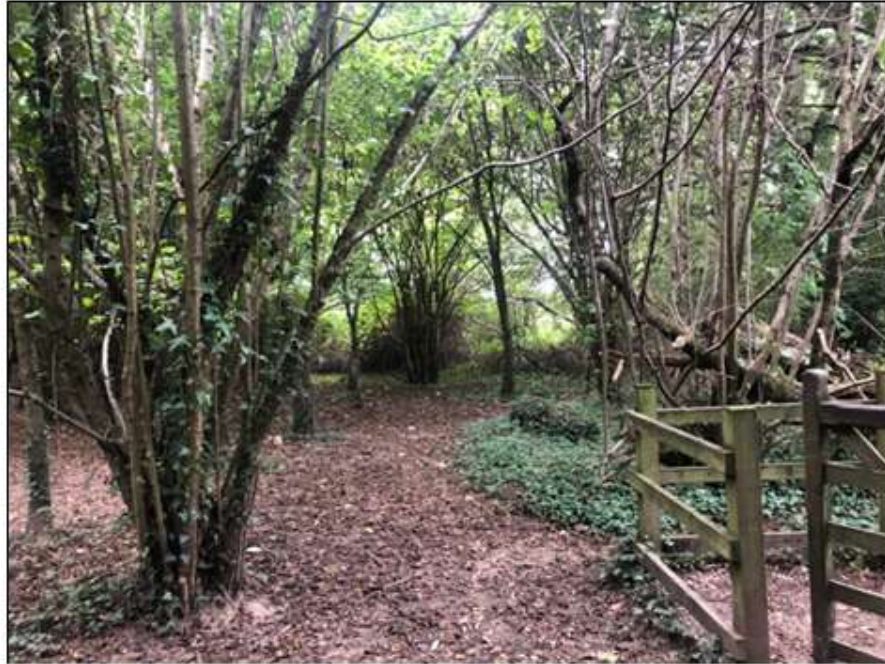
**Plate 7.** The proposed footpath route, looking west from the end of the existing board walk

The footpath is expected to bear low levels of pedestrian activity and will have a deciduous bark chip surface which will allow sufficient load bearing to protect the tree roots from compression. The bark chip will be held in place with timber edging and under laid with a geotex membrane. The footpath surface will comprise 100mm of deciduous bark chip with a sub base comprising 50mm thick layer of geotextile membrane (TRP 4000). The bark chip has sufficient load bearing capacity to protect the tree roots from low level pedestrian use while the geotextile membrane is permeable to allow water percolation and gaseous exchange. Where adjoining rolls of textile membrane meet, there will be an overlap of 300mm to ensure bark chip does not mix with the soil beneath. Excavation will be limited to the removal of a nominal soil layer no deeper than 50mm, to be carried out by hand. There will be no further excavation. The geotextile membrane will be retained by an edging of wooden boards secured by driven wooden pegs. The restrictions on excavation and the use of a geotextile membrane and bark chip in accordance with Section 11 of BS 5837:12 will limit the risk of damage to tree roots to within acceptable parameters. A detailed specification for the footpath is attached as Appendix 3.

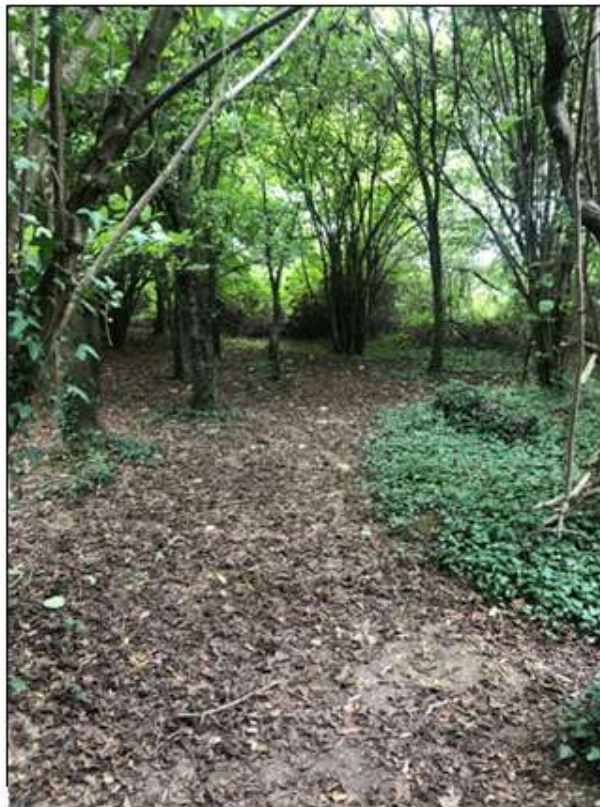
**Plate 8.** The same view as plate 7 but showing the space availability more
