# Tree Management plan - 2023 update

12 Hamblewood

# River Copse

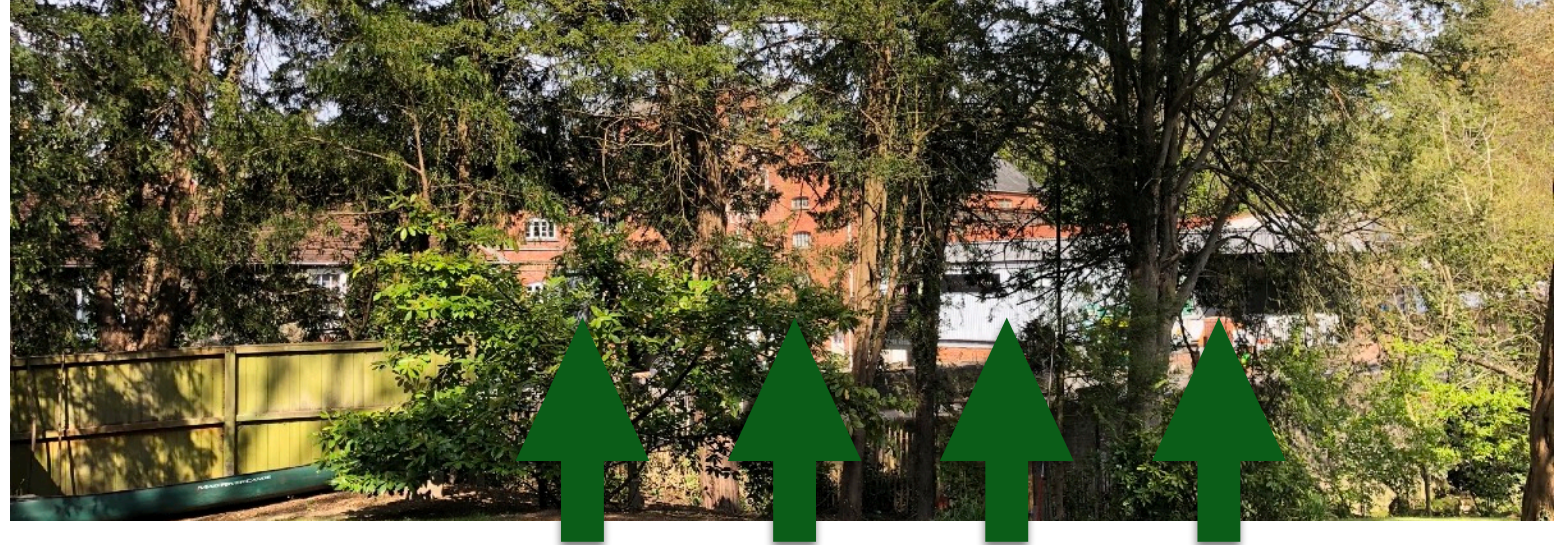
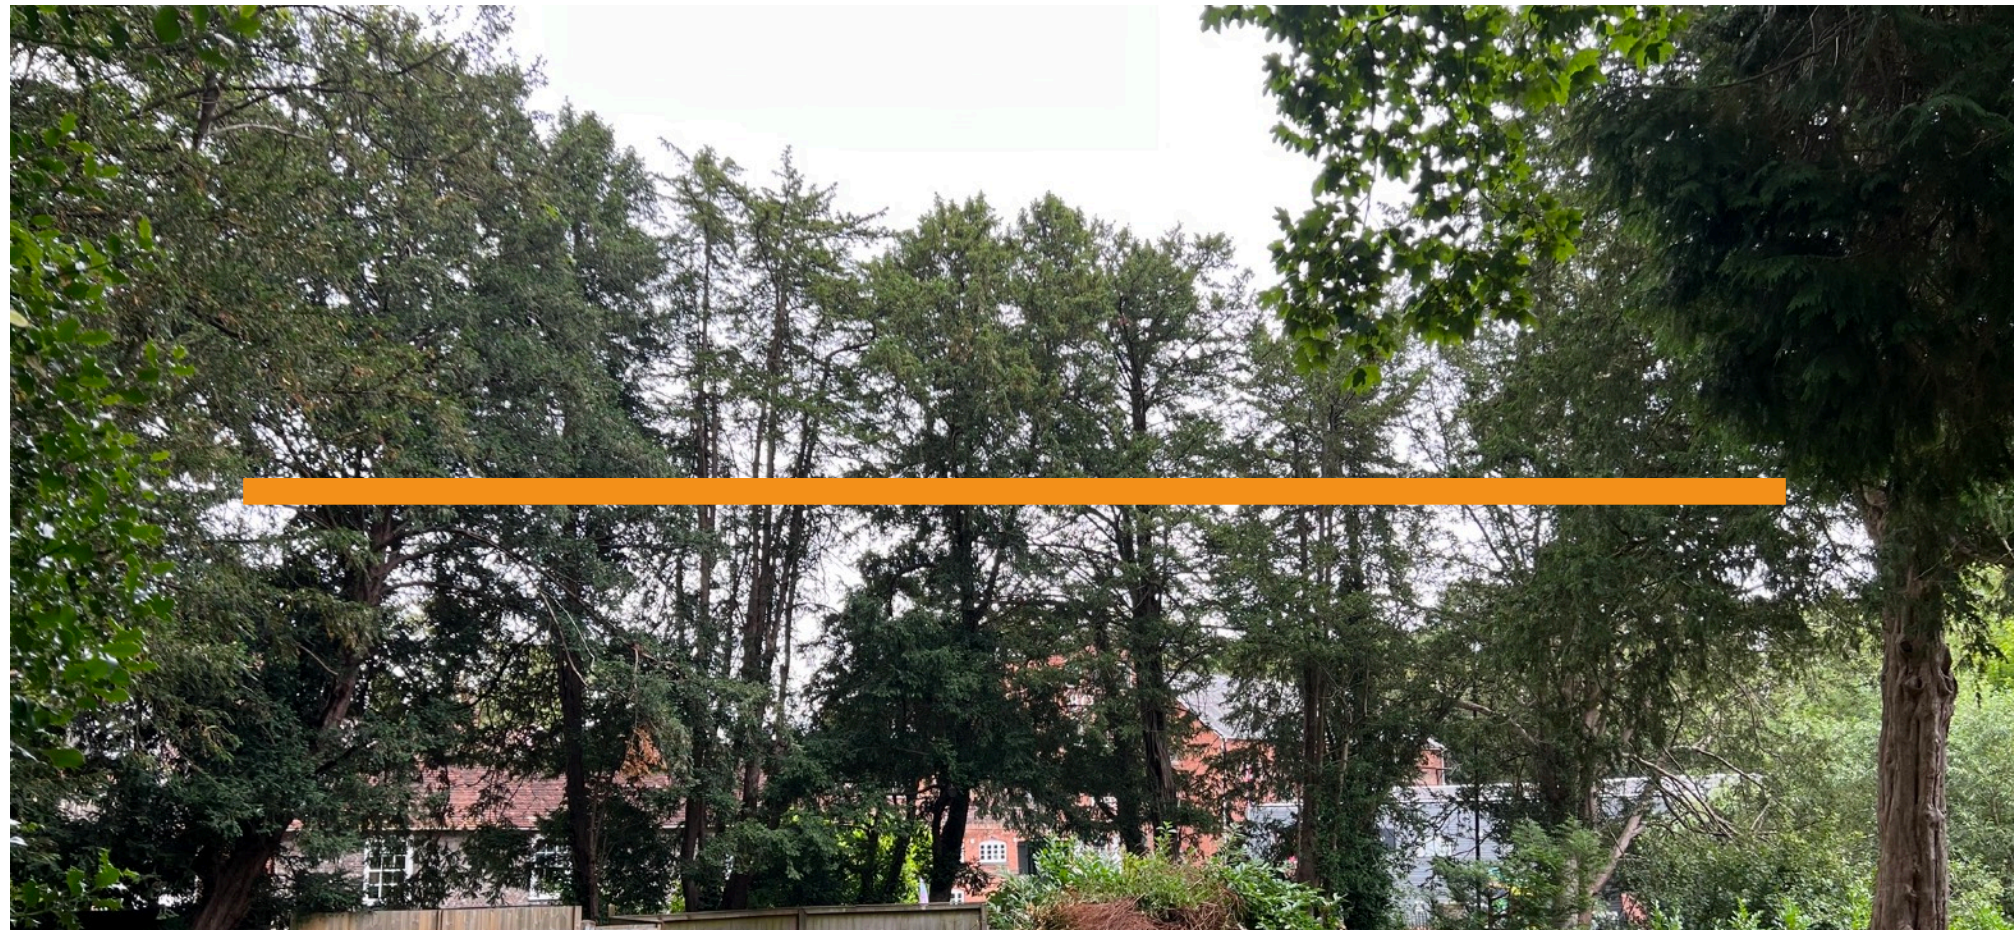
## Yew border (G1 & T1)

- Previous efforts to encourage natural shape & symmetry of border unsuccessful. Manipulate yew border to close gaps from previous tree removals.
  - Remove protruding branches to restore natural shape.
  - Reduce overall height to match street light height
  - Maintain target width of border.

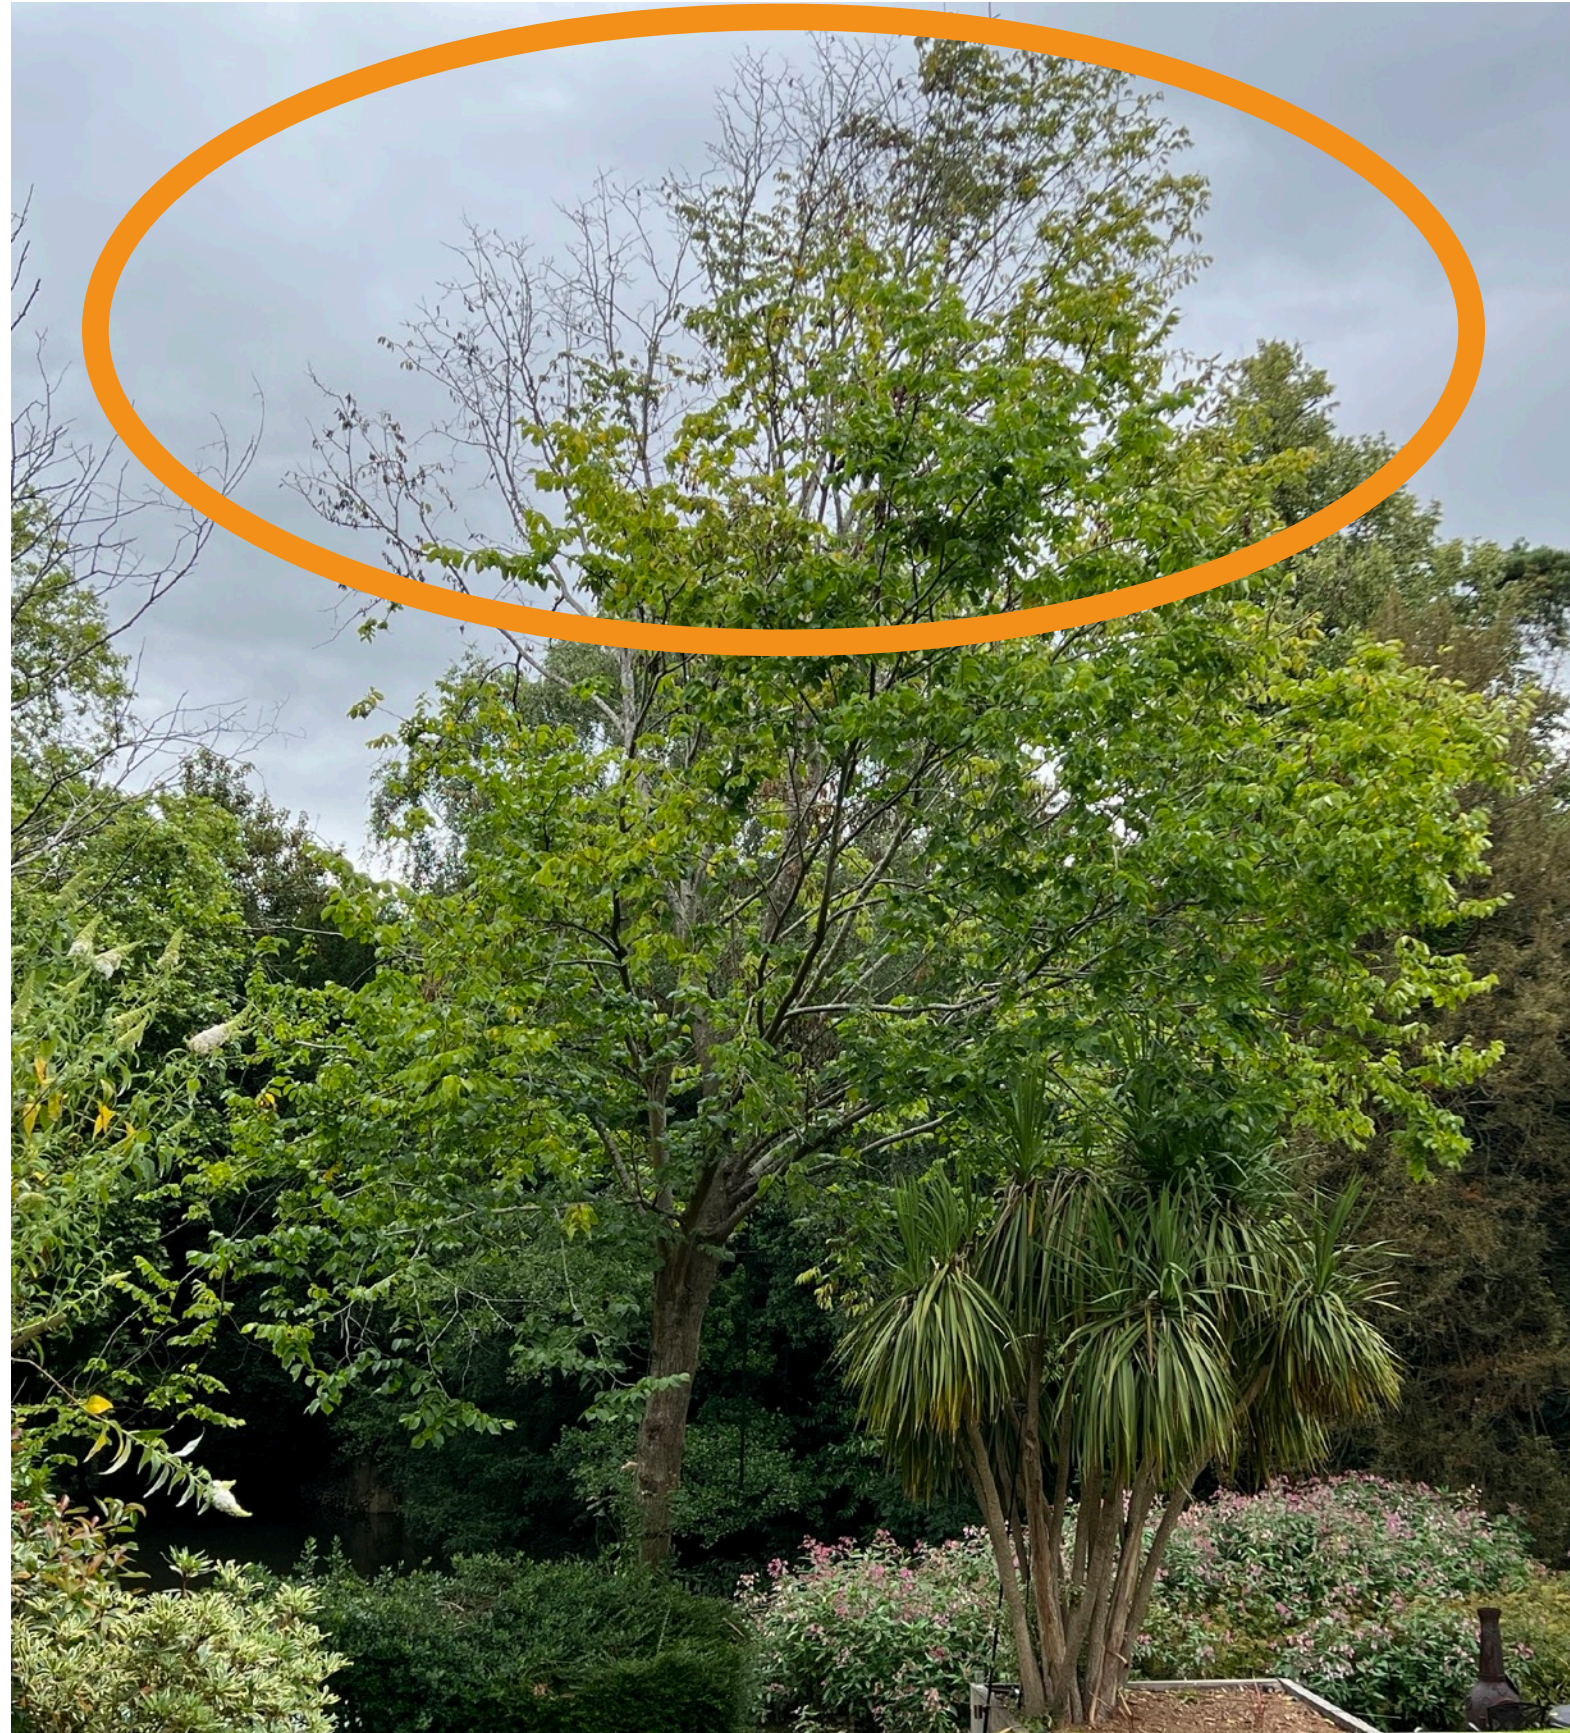
## Wych Elm (T24)

Experiencing dieback following the repair of river wall which reduced water supply.

Reduce crown to counter dieback.

- Reduce limbs showing **dieback** to common union
- Reshape crown to achieve natural shape
