## Memorial Hall – Bishopstoke Heritage Statement

## Heritage Statement August 2023

**Memorial Hall  
17 Riverside  
Bishopstoke  
Eastleigh  
SO50 6LQ**

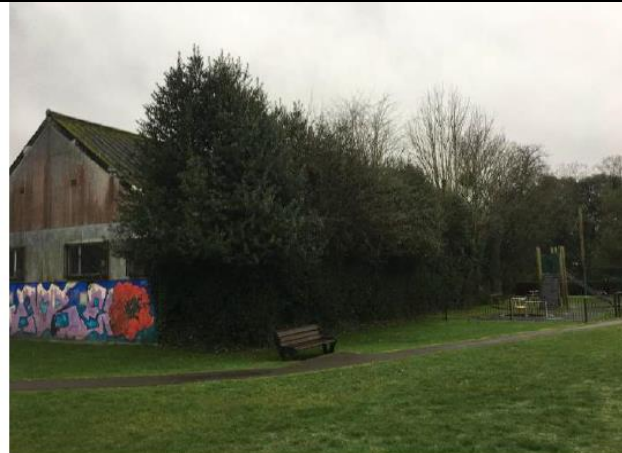
Photograph 3 -  
Mature Trees close  
to western side of  
building
