Ref: 23155

**Willow Bee, Allington Lane, Eastleigh, SO30 3HP - F/23/95507  
Drainage Statement**

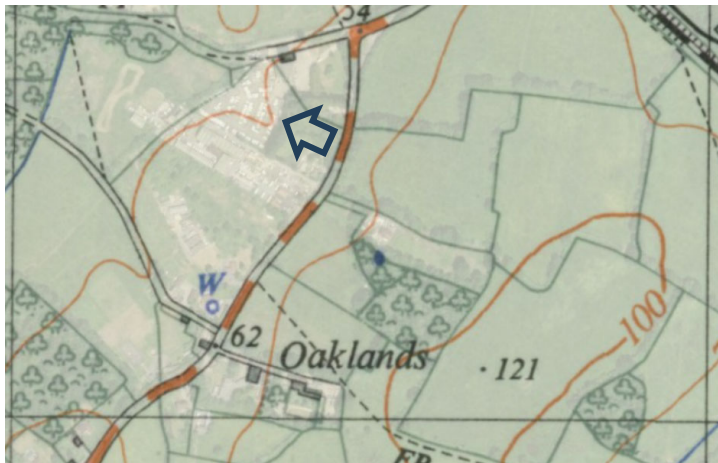
Fig 1: Extract from historic 1937-1961 1:25,000 map with local terrain contours and current aerial photograph underlay.

A review of mapping for the site locality indicates the land falls to the northwest away from Allington Lane (Fig 1)

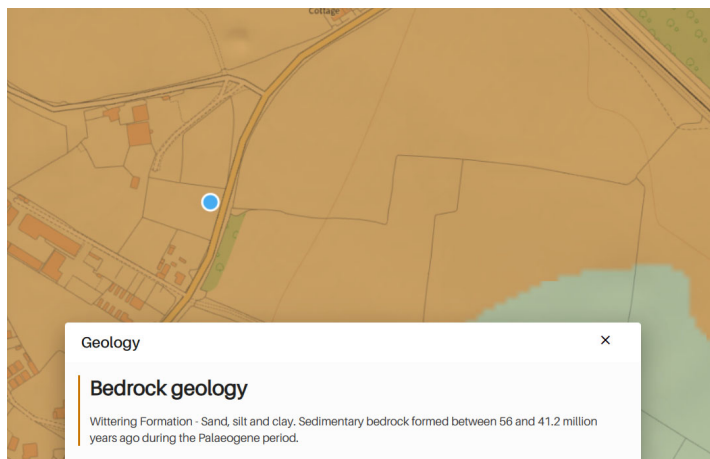
Fig 2: Extract from local BGS mapping

A review of British Geological Survey mapping indicates no superficial soils at the site and bedrock geology of the Wittering Formation- Sand, Silt and Clay ( Fig 2)

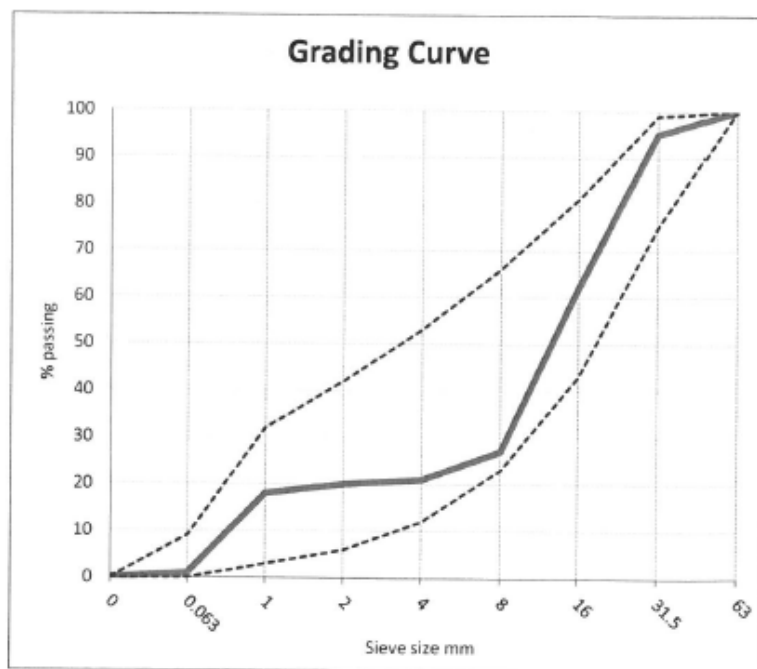
Fig 3 typical Type 1 grading curve

The LPA case officer in their email of 3<sup>rd</sup> October 2023 states the hardstanding material appears to be “*granular sub-base with an uncompacted stone topping.*” We made a site inspection on 11<sup>th</sup> October 2023. The hardstand comprises unbound graded granular crushed natural stone aggregate of primarily gravel fraction size and interstitial sand grading fraction on a geotextile fabric. In soil description terms a sandy gravel. The appearance of the material is consistent to the ‘granular sub-base’ attribution made by the case officer and we suspect given the location at the vehicular gateway into the land that this material is likely to be a Type 1 sub-base material or similar grading. A typical type 1 grading curve is shown in Fig 3

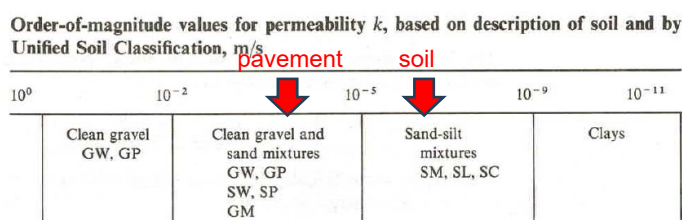
Fig 4 relative permeabilities

The permeability of the pavement material is anticipated to be one or two order of magnitudes greater than the permeability of the site soils ( Fig 4 refers). Therefore developed infiltration characteristics will remain regulated by natural soil formation as the pavement will not reduce the natural infiltration rate.

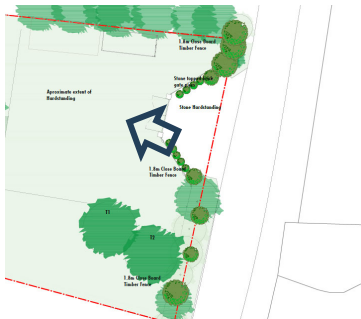
Fig 5 current fall direction

During the site inspection the fall direction of the pavement area was measured with a spirit level. This maintains the predevelopment fall direction to the northwest see Fig 5.

There is therefore no change in flood flow direction as a result of the development.

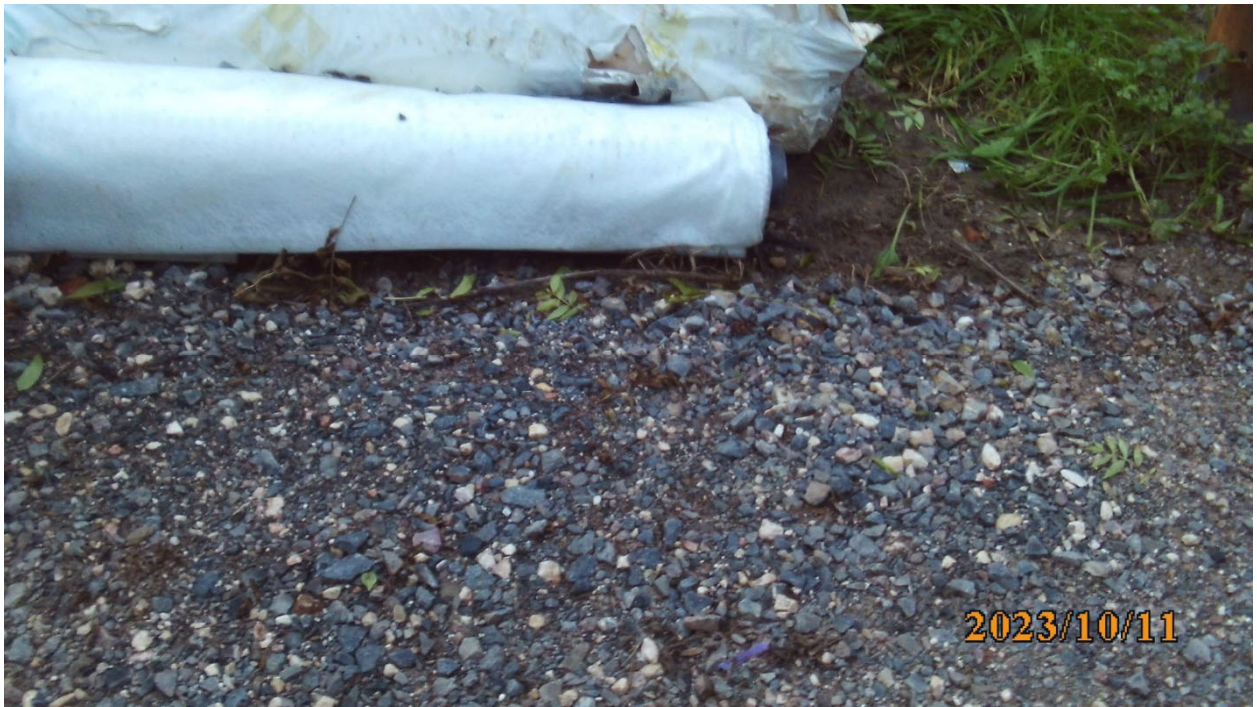
The pavement area comprises permeable construction of sandy gravel granular sub-base ie unbound material over the natural site soils. Rainfall will pass through permeable construction and there is no impermeable surface so no increase in runoff.

Granular pavement material

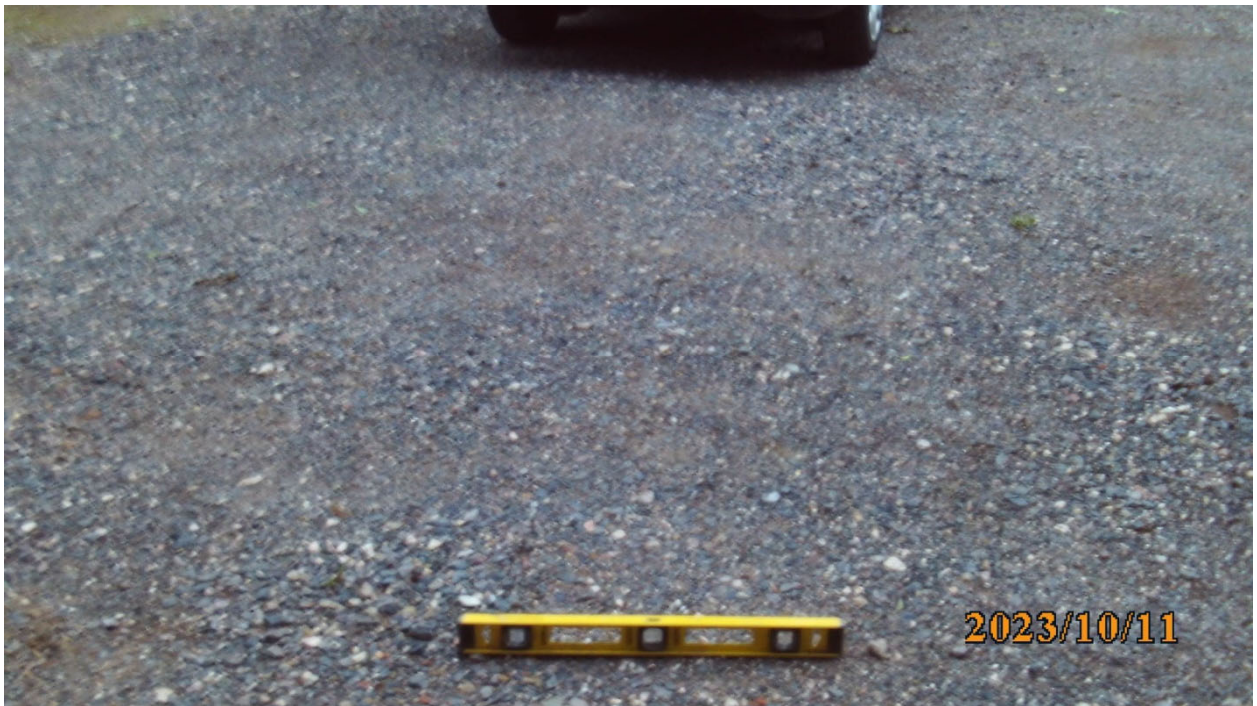
Pavement fall to the north west
