# PHASE 1 DESK STUDY

**LAND AT BOORLEY GARDENS,  
FIELDFARE ROAD, BOORLEY GREEN,  
HEDGE END, HAMPSHIRE SO32 2BX**

**HEDGE END CARE HOME LTD**

**23/12718/GO**

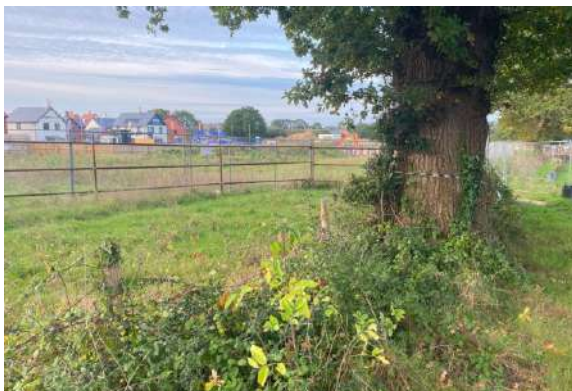
**Mature oak tree from public footpath**

The site is indicated as being within an area of moderate risk of shrink/swell hazards associated with the underlying Wittering Formation. The presence of two mature oak trees on the northern site boundary is likely to influence foundation design depending on the proximity of the proposed structure.

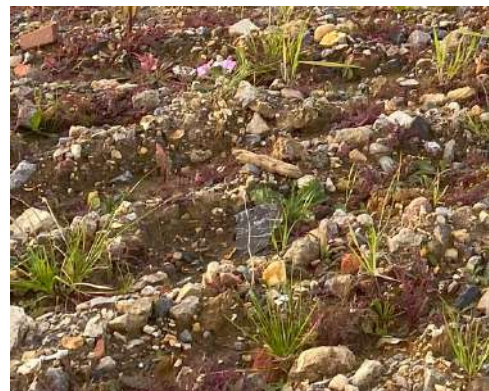
**Rubble at surface in west of site**

The presence of rubble at surface in the west of the site is presumably a temporary solution to assist in the storage of materials for the adjacent development. It should be appreciated however, that coarse or cobble-sized fragments of rubble, brick or concrete are unsuitable in areas of soft landscaping or gardens. This can be addressed as part of the normal ongoing development of the site.

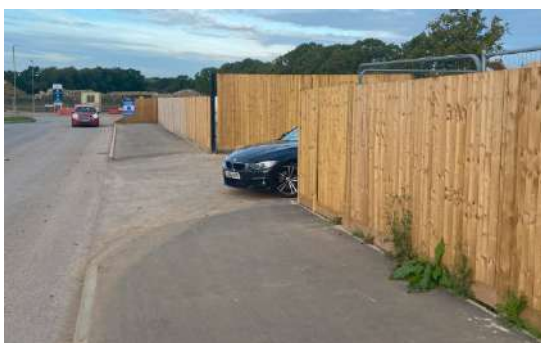
**View west along Fieldfare Road with secure access to wheelwash beyond gate**

The site has evidently had some itinerant use for storage of building materials and a wheelwash system however, these are both considered to be low risk activities. The wheelwash is a closed loop system with integral settlement tanks for separate off-site disposal of silt.

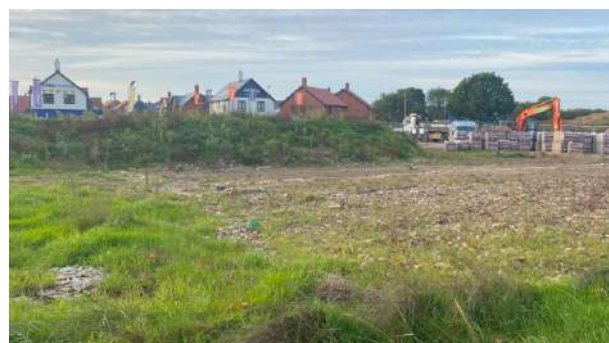
The mounds of earth noted on earlier street view imagery are still present, now being vegetated and are presumably comprised of site won materials which were excavated as part of the adjacent construction of Fieldfare Road. During the visit several photographs were taken which provide a general impression of the site at the time of the visit and these are included as Figure 2 and a selection below.

**View of site looking south west with earth mound evident and wheelwash obscured behind**
