# Arboricultural Implications Assessment

**12, Malcolm Road, Chandlers Ford, SO53 5BG**

Ref: KTML26-469-12MalcolmRdCF-AIA-1.0

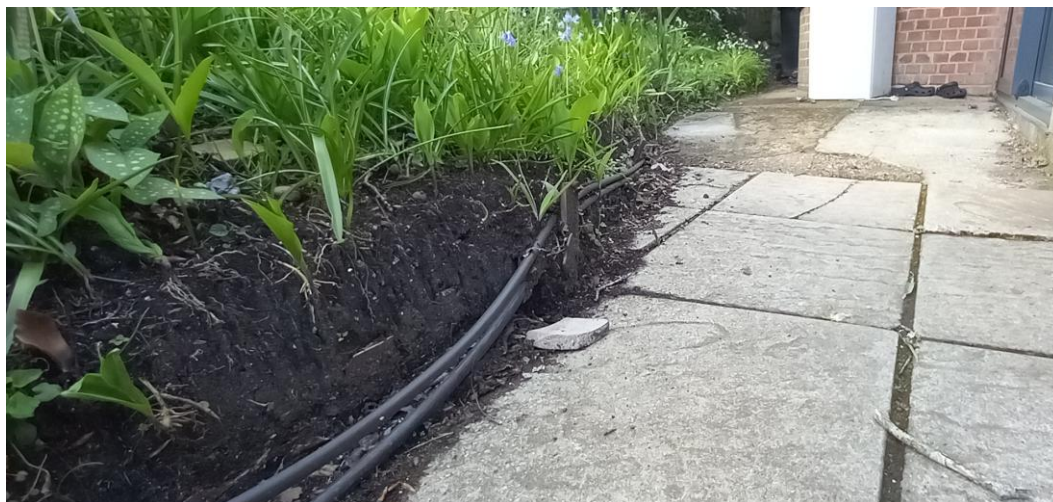
- 6.1 The proposal is single phase, low impact improvement to the existing dwelling. A 1.5 storey side extension to the south sits at the end of the existing drive. The existing ground level for the extension is below the expected rooting area of T1. A low wall has been removed, and no roots are visible in the exposed soil:

Photo 1 Low retaining wall removed to east of T1. The paving is the patio area in the drawing below

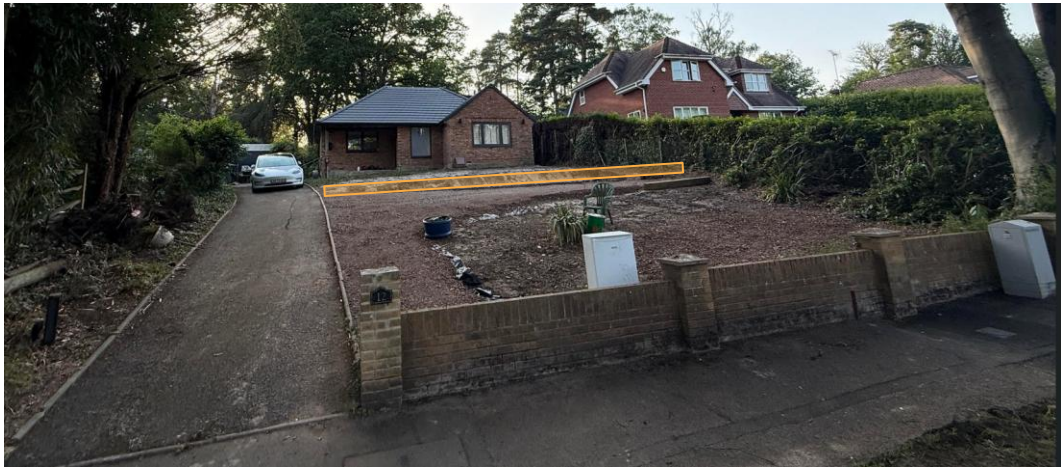
small amount of regrading and the construction of a low retaining wall to the west of the parking indicated by an orange rectangle on the photo below. There will be no new excavation near the tree.

*Photo 2 Location of retaining wall west of parking area. Viewed from road.*
