16<sup>th</sup> July 2026

Report Number MB260710

## **REPORT FOR 145 LEIGH ROAD, EASTLEIGH**

### **SITE SPECIFIC ARBORICULTURAL METHOD STATEMENT**

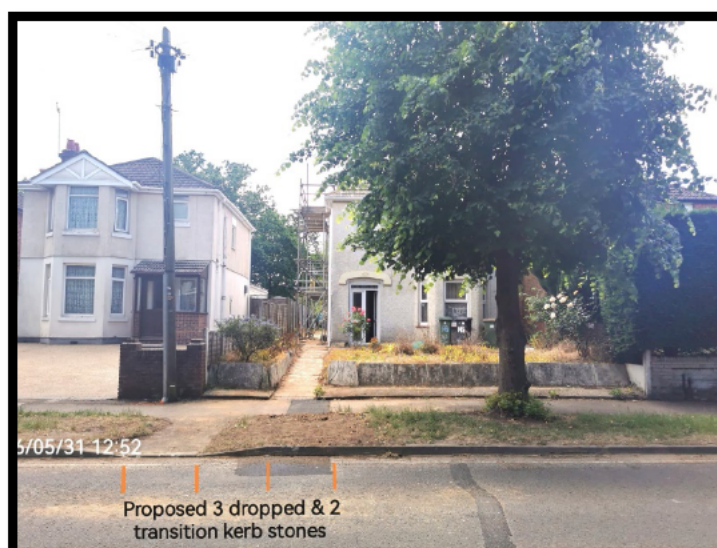
The area where the driveway will be positioned is shown on Plate 1.

Plate 1: Proposed driveway route.

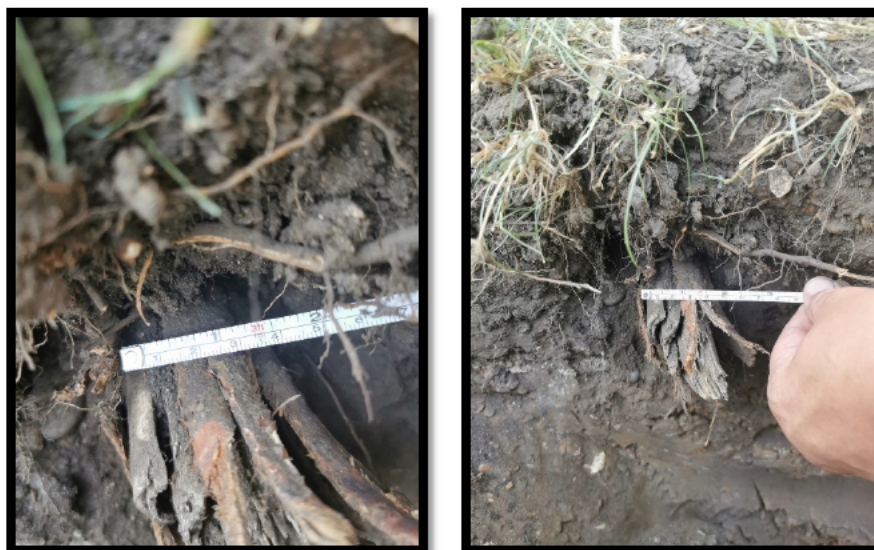
Second stage works from the water meter to the main road took place in May 2026. (Hampshire Highways ref LQ002SWAT14538092-01: 26.5.26-29.5.26). The works took longer than anticipated as there were difficulties locating the pipe. Unfortunately, excavation of the pipe by mechanical digger resulted in root damage to the tree.

Plate 2 & 3: Tree root damage.

There were no surface roots located during the excavation works. The largest roots between surface level to 40 cm depth were at 20 cm depth and were under 2.5 cm wide in size. There were a number of larger roots located at a distance of 40 cm and more below ground level. It is therefore deemed that the work to construct the proposed driveway will not impact on the tree.

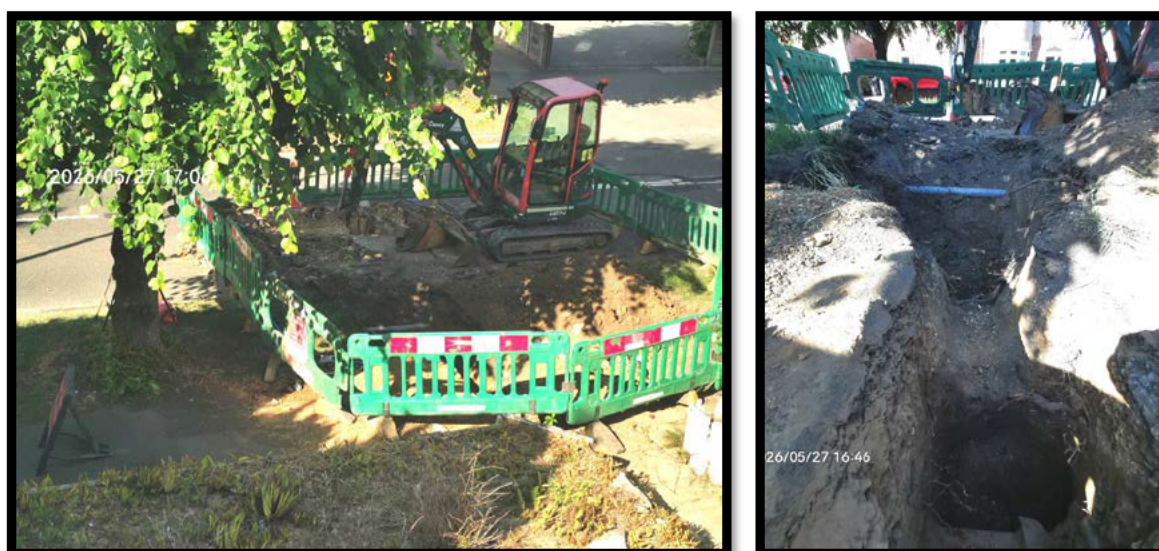
Plate 4 & 5: Extended trenching towards stem to locate pipework.

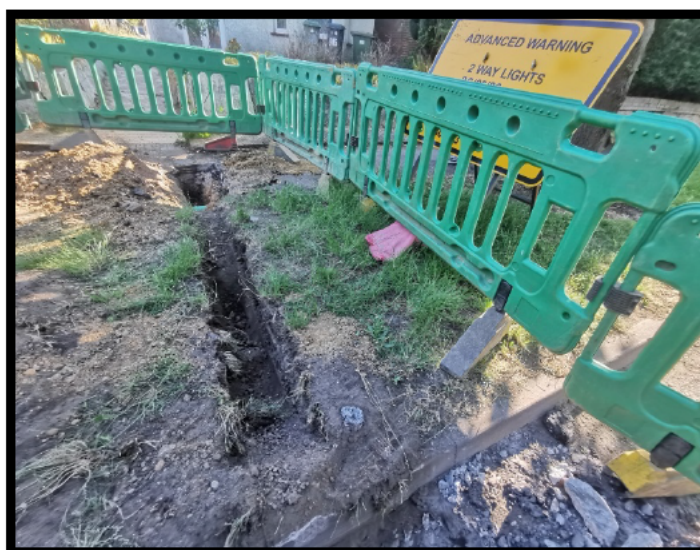
The root damage has been documented and due to the loss of these roots it is deemed that the installation would not affect this tree directly. The fibrous roots beyond the tree damage will now die off and it is likely that the stub of the root will generate new roots to compensate for this loss. European Lime trees are chosen specifically for the hostile environment in which they are planted. A species that can tolerate urban pressure throughout the northern hemisphere and includes the middle-east and parts of Asia.

**The root severance has occurred close to the distance from the stem that the driveway is proposed to be installed. It can be seen at Plate 6, that the roots to the east (left of picture) are no longer connected to**

the tree. It is deemed that any work in the upper surface of that section of land is now void of live plant material. The following statement is requested for consideration by the Planning Officer: This is a very important note when deciding the application.

**Plate 6: Root severance by Southern Water.**

1. Supervise 200mm of soil removal from the highway verge and build up to the required levels in traditional construction materials.
2. Infill with approx. 100mm of MOT Type 1 sub base with a finished material of between 80 to 100mm of Tarmac.
3. The added stone would be separated from the soil below with a TRP4000 geotextile material which will prevent migration of the stone through the soil and the soil from coming up contaminating the stone. Due to the calculated loadings on this small area of the verge being miniscule this is deemed the most sensible option.
