# **ARBORICULTURAL IMPACT ASSESSMENT, METHOD STATEMENT AND TREE PROTECTION PLAN**

**11 Brownhill Road,  
Chandler's Ford, Eastleigh,  
Hampshire, S053 2EB**

**Date – 15<sup>th</sup> September 2026**

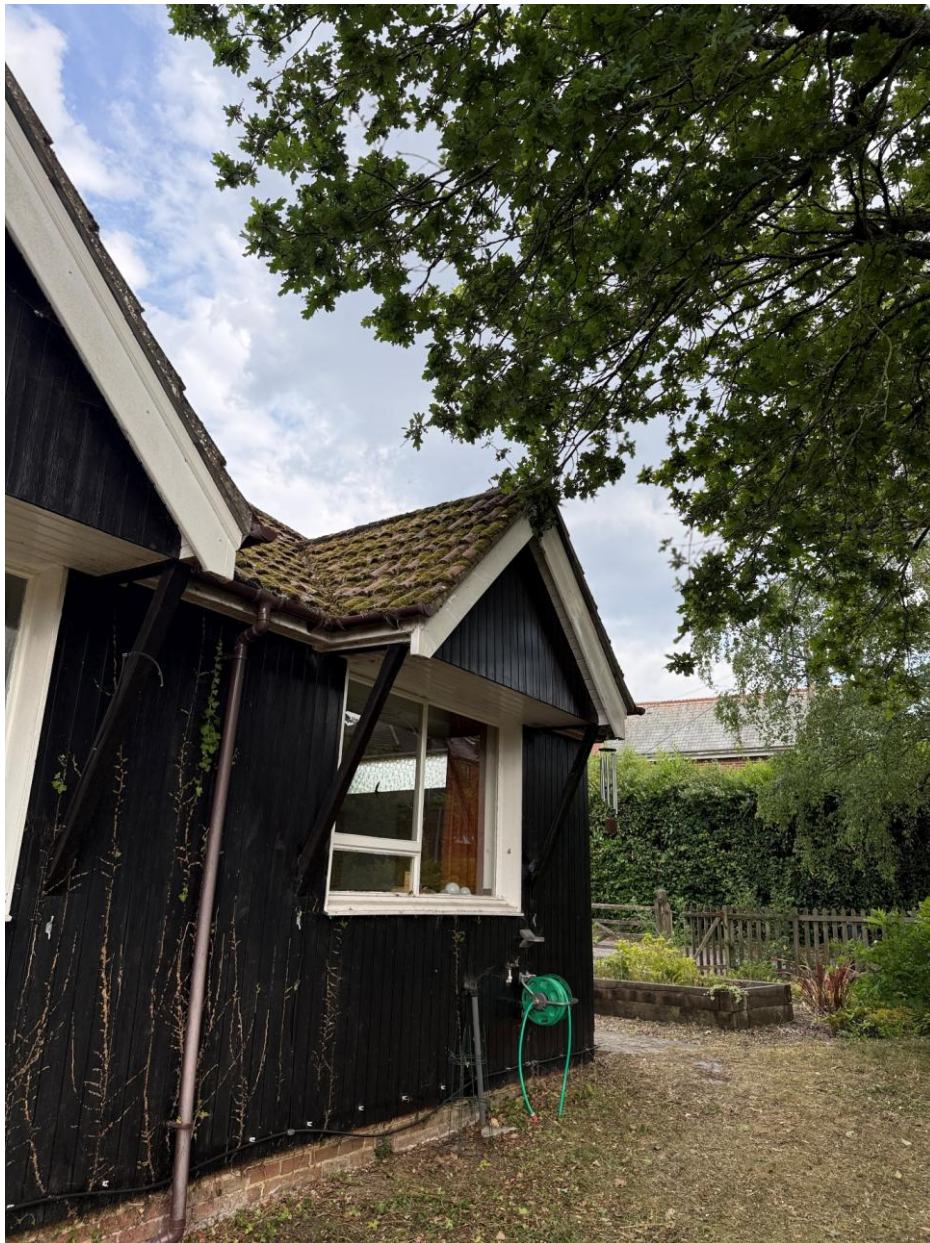
5.6 T1, an Oak is potentially impacted upon by contractor movements and to the external alterations to the property. Branches already touch the roof of the dwelling and would need to be cut back regardless of the proposals to prevent damage occurring to the roof. Contractor working space has the potential to compact the soft ground and therefore either fit for purpose ground protection will be required or a scaffold framework will provide for an off the ground working platform to complete the external works. With the correct and timely erection of tree protection and site barriers these trees will not be impacted by the site works.

**Photograph 1:** Showing T1 Oak and the proximity of branches to the roof line.

8.3 Pruning of the work will be undertaken to provide approximately 2.0m separation between the roof line and the branch tips. This will provide separation to prevent branches touching the building (current and proposed) and give space for new growth.

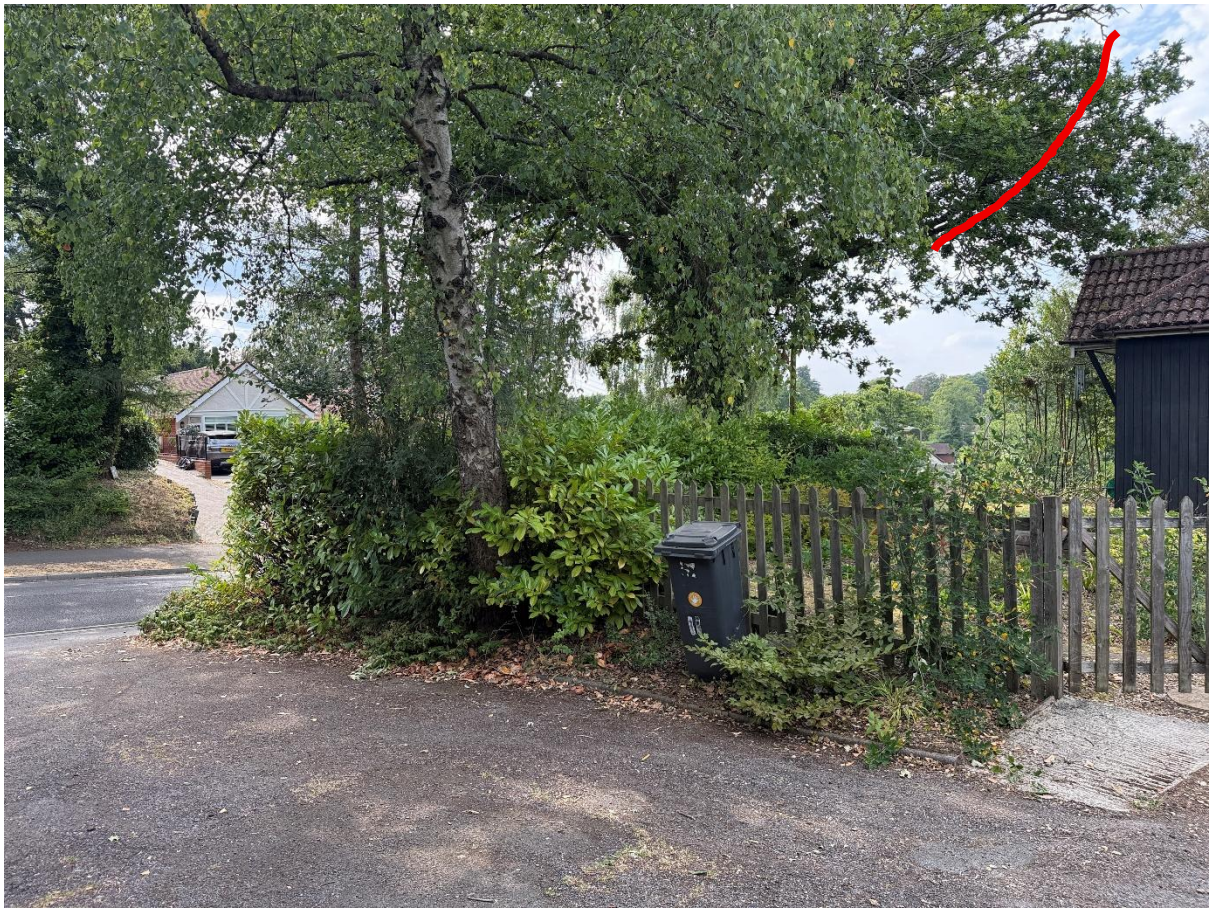
**Photograph 2:** Showing T1 Oak and the proximity of branches to the roof line and the approximate line of pruning.

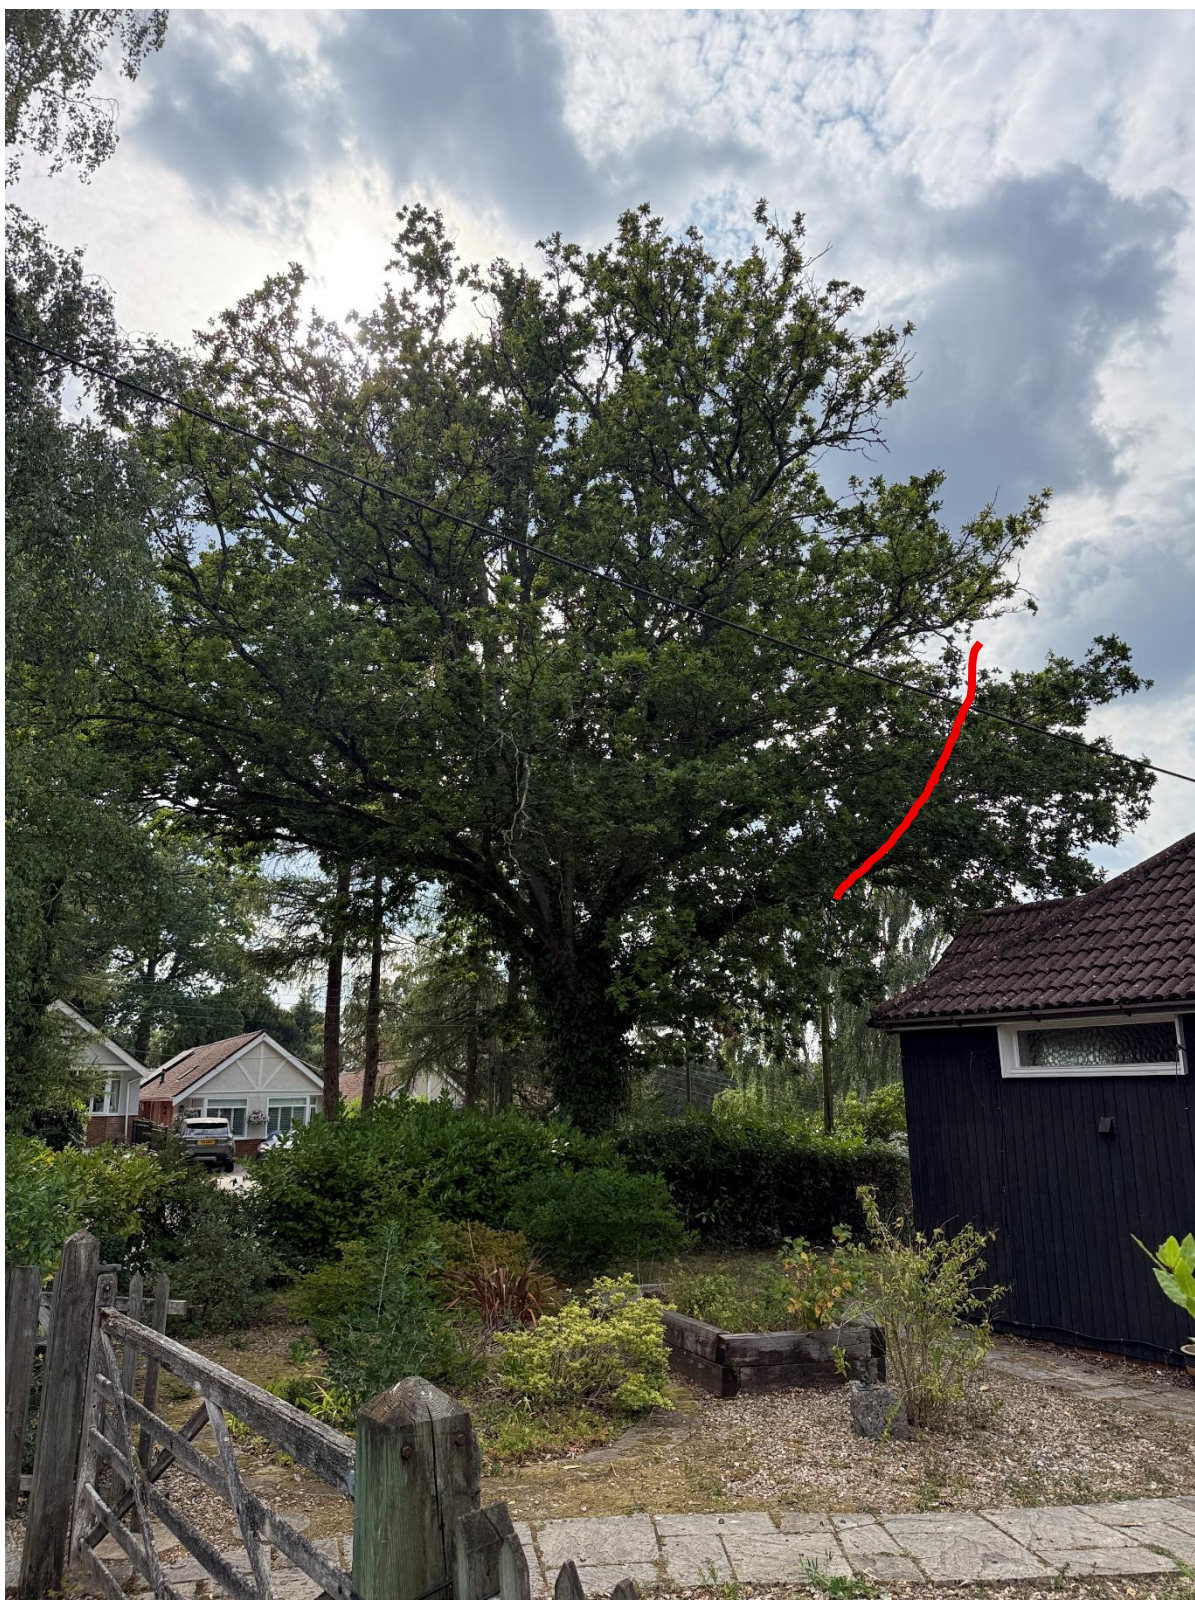
**Photograph 3:** Showing T1 Oak and the proximity of branches to the roof line and the approximate line of pruning.
