**EASTLEIGH BOROUGH COUNCIL**

**PROOF OF EVIDENCE**

**Appeal Site: Broadway Farm, Broad Oak, Botley, Southampton, SO30 2EU**

**Planning Inspectorate Reference: APP/W175/X/23/3331326**

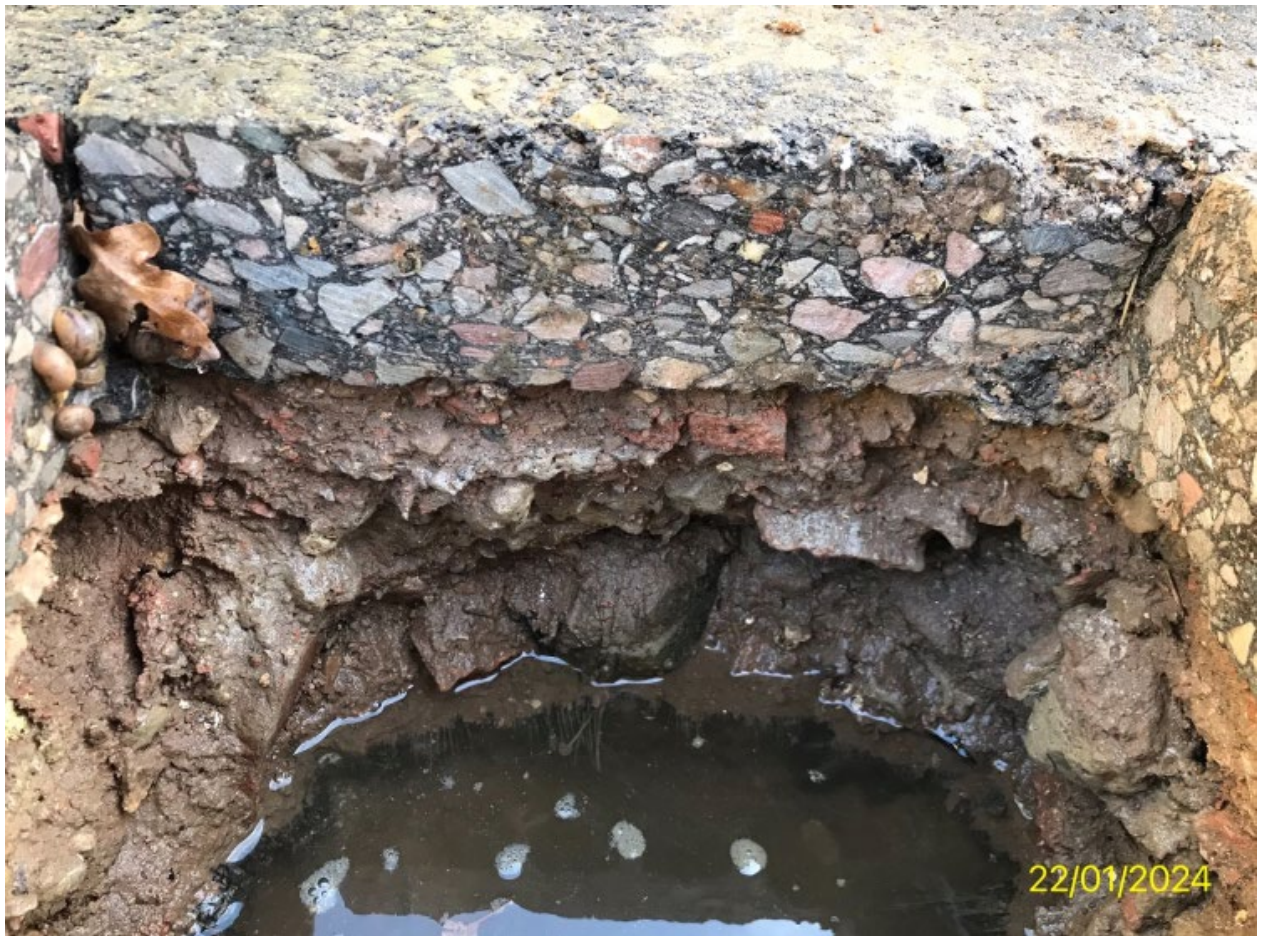
#### **Trial Hole 1: Southwest corner**

- 3.11 From visual inspection of the trial hole, I could see by eye that there was a layer of tarmac approximately 80-100mm thick. Below this there appeared to be a single layer of stone hardcore (crushed concrete) that had been laid on top of a geotextile membrane.

- 3.12 The depth of the trial hole between surface to geotextile was assumed to be between 300-400mm. Despite the hole being half full of water, there did not appear to be any presence of a grasscrete layer below the tarmac. By using

physical touch of my fingers, I was able to establish the material immediately below the tarmac was of a compacted, but loose to touch nature.

**Image 2: Trial Hole 1 – tarmac layer and below this was a single layer of stone hardcore, the geotextile membrane is visible in this photo just below the waterline.**

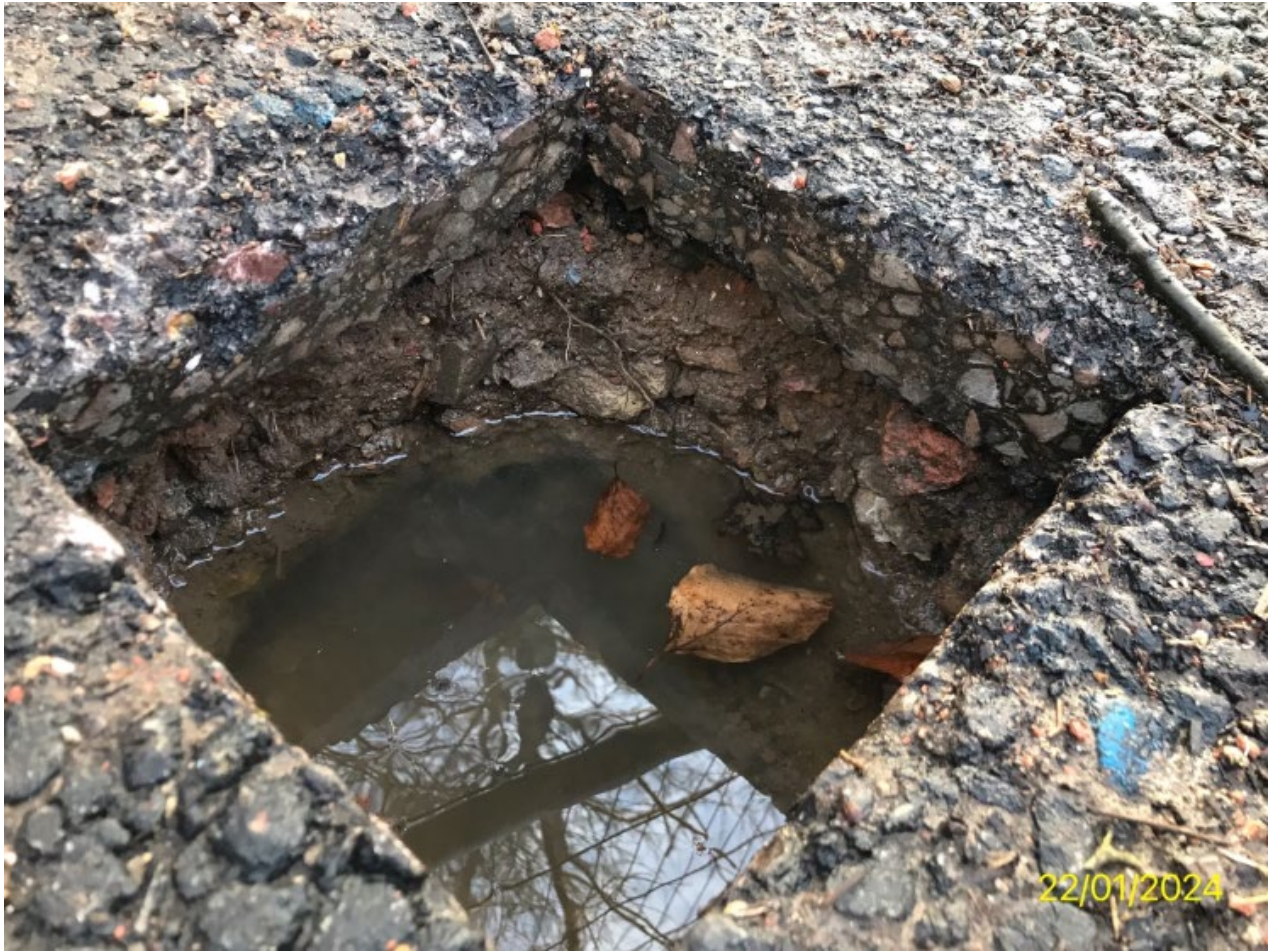
### **Trial Hole 2: Southeast corner**

- 3.16 From a visual inspection of the trial hole, I could see by eye that there was a layer of tarmac approximately 80-100mm thick. Below this there appeared be a single layer of stone hardcore (crushed concrete) that had been laid on top of a geotextile membrane.

- 3.17 The depth of the trial hole between surface to geotextile was assumed to be between 300-400mm. Despite the hole being half full of water, there did not appear to be any presence of a grasscrete layer below the tarmac.

- 3.18 By using physical touch of my fingers, I was able to establish the material immediately below the tarmac was of a compacted, but loose to touch nature. A grasscrete layer if present below the tarmac would remain of solid construction and show visible pockets of organic material in between the concrete grid/ mesh formation.

**Image 3: Trial Hole 2 tarmac layer and below this was a single layer of stone hardcore, the geotextile membrane is not visible in this photo because of the water.**

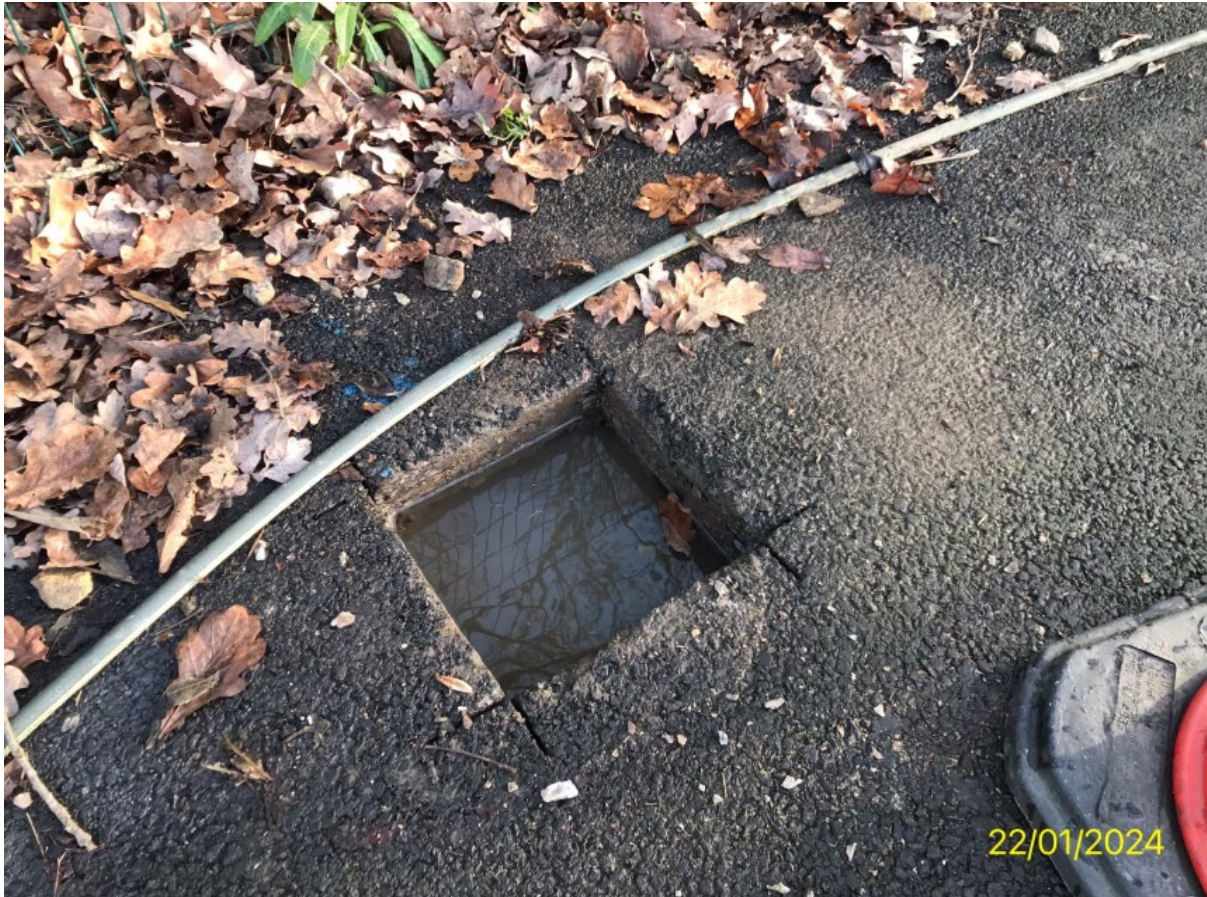
Trial Hole 3: Northeast corner

- 3.21 From visual inspection of the trial hole, I could see by eye that there was a layer of tarmac approximately 80-100mm thick. Below this I was not able to determine the visual makeup as the hole was filled to the top with water. By the use of my hand, I was able to establish that the layer below the tarmac was likely to be stone hardcore as it was reasonably loose to touch. I was not able to establish if a geotextile was present at the bottom of the trial hole, and I was not able to establish a depth.

- 3.22 From my feeling around below the water line with my hands and the evidence of loose stone material, I was able to conclude that there did not appear to be a presence of a grasscrete layer below the tarmac.

- 3.23 By using physical touch of my fingers, I was able to establish the material immediately below the tarmac was of a compacted, but loose to touch nature. A grasscrete layer if present below the tarmac would remain of solid construction and show visible pockets of organic material in between the concrete grid/ mesh formation.

**Image 4: Trial Hole 3 tarmac layer, but and below this not visible in this photo because of the water.**

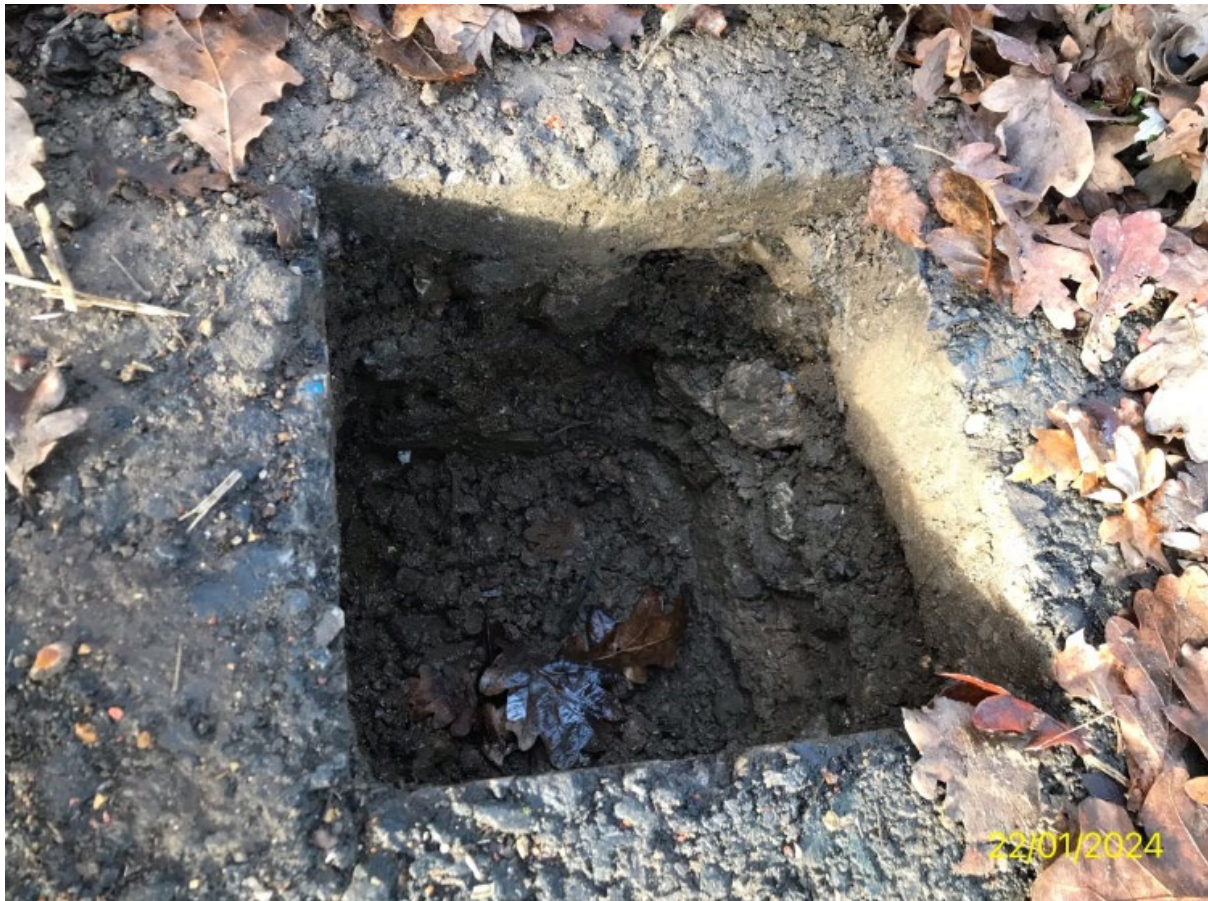
Trial Hole 4: Northwest corner

- 3.26 From visual inspection of the trial hole, I could see that there was a layer of tarmac approximately 80-100mm thick. Below this there appeared be a single layer of stone hardcore (crushed concrete) that have been laid on top of a geotextile membrane. At the time of inspection, the geotextile membrane was buried below soil at the base of the trial hole. I was able to establish the presence of the geotextile by moving the soil away with my hand.

- 3.27 The depth of the trial hole between surface to geotextile was assumed to be between 300-400mm. There did not appear to be any presence of a grasscrete layer below the tarmac. By using physical touch with my fingers, I was able to establish the material immediately below the tarmac was of a compacted, but loose to touch nature.

**Image 5: Trial Hole 4 tarmac layer and below this was a single layer of stone hardcore, the geotextile membrane is not visible in this photo because of soil that has buried it over time. Trial hole 4 is visually similar to trial hole 1.**
