**From:** Griffin, Tim (Contractor)  
**Sent:** 15 August 2024 17:43  
**To:** Harrison, Liz  
**Cc:** Dyer, Tim; Ellison, Mark; Oliveira, Marta (Contractor)  
**Subject:** Re: F/23/96629 Land at Fieldfare Road - landscape comments on revised scheme

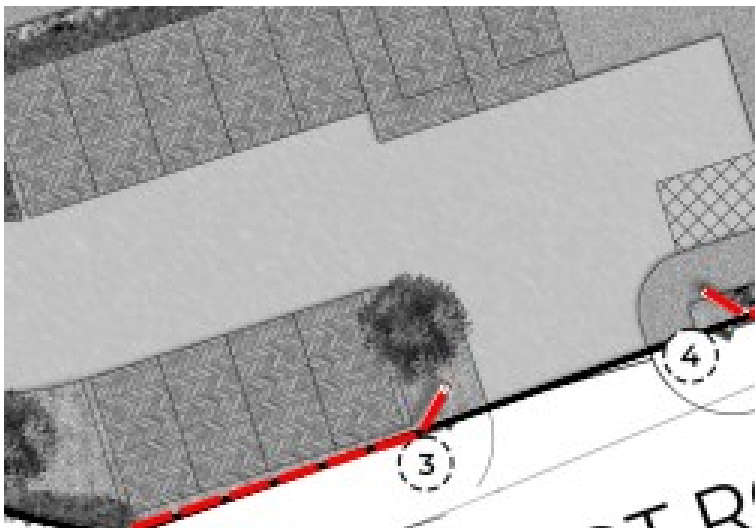
The suggested boundary brick wall and railings will create significant issues for the suggested hedge planting as the concrete footing will reduce rooting volume. I recommend that wherever a boundary hedge is shown that the enclosure should be railings only as these require much reduced footings. The brick wall and railings could be retained either side of the entrance where there is no space for planting (red dashed lines below).

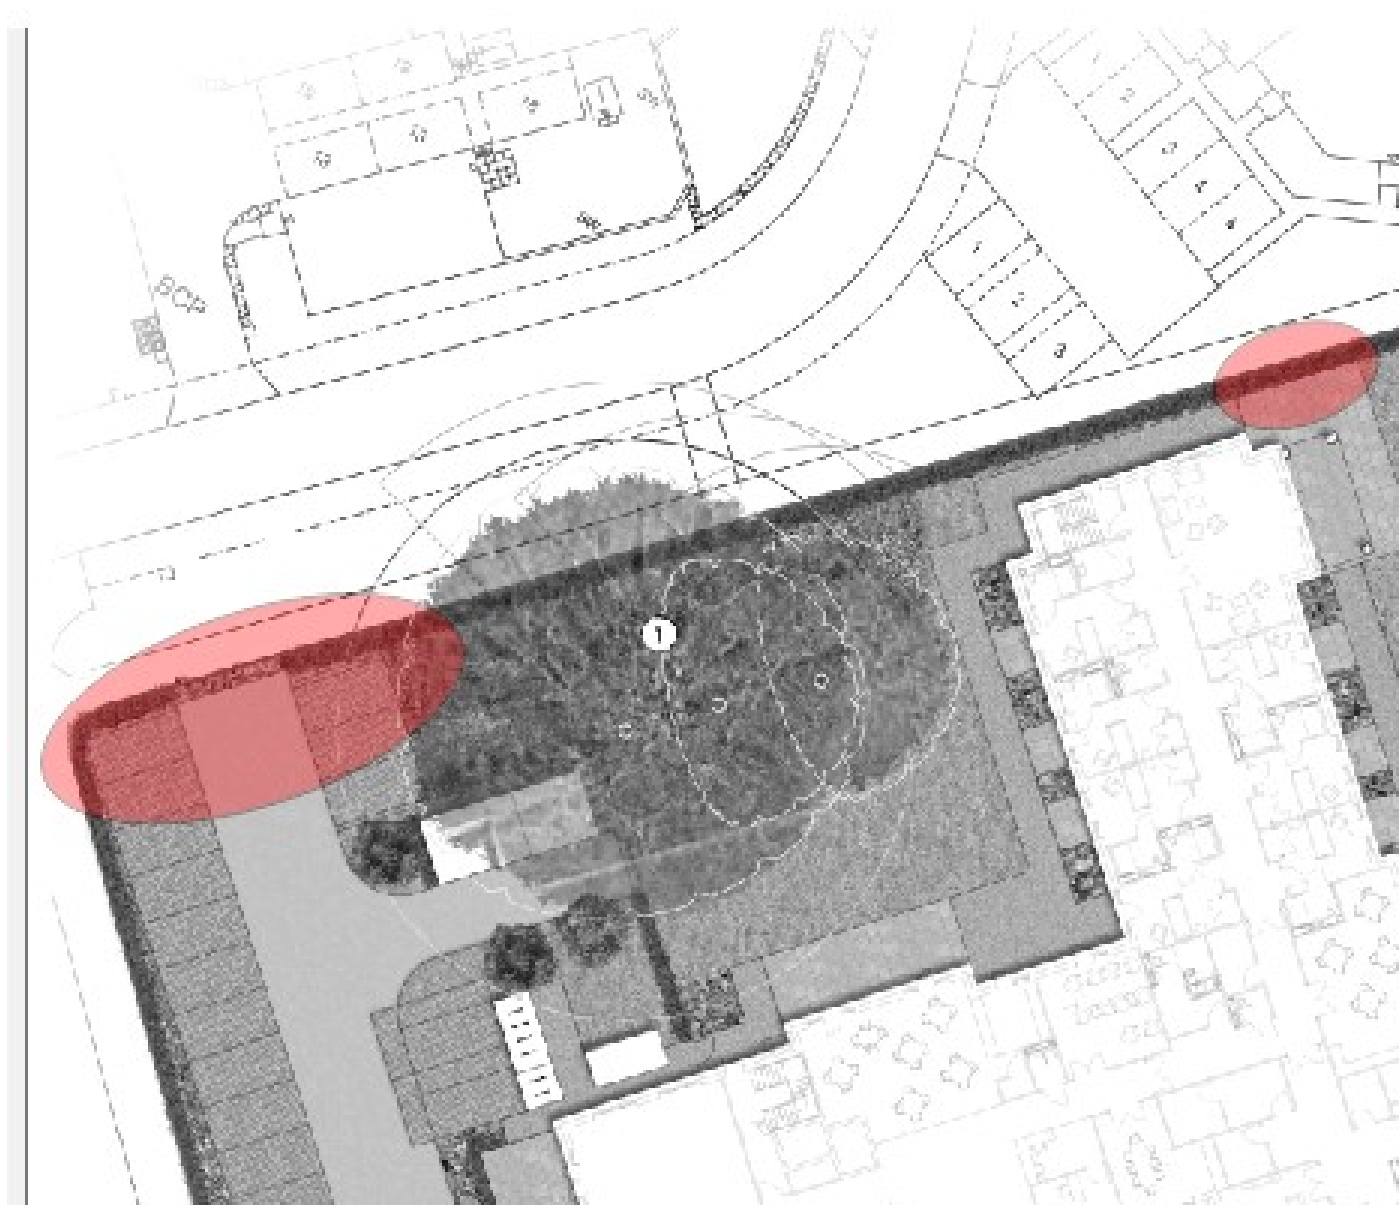
In the areas highlighted below the new hedge is predictably likely to fail as the rooting area is too restricted. This will open up gaps in boundary screening:

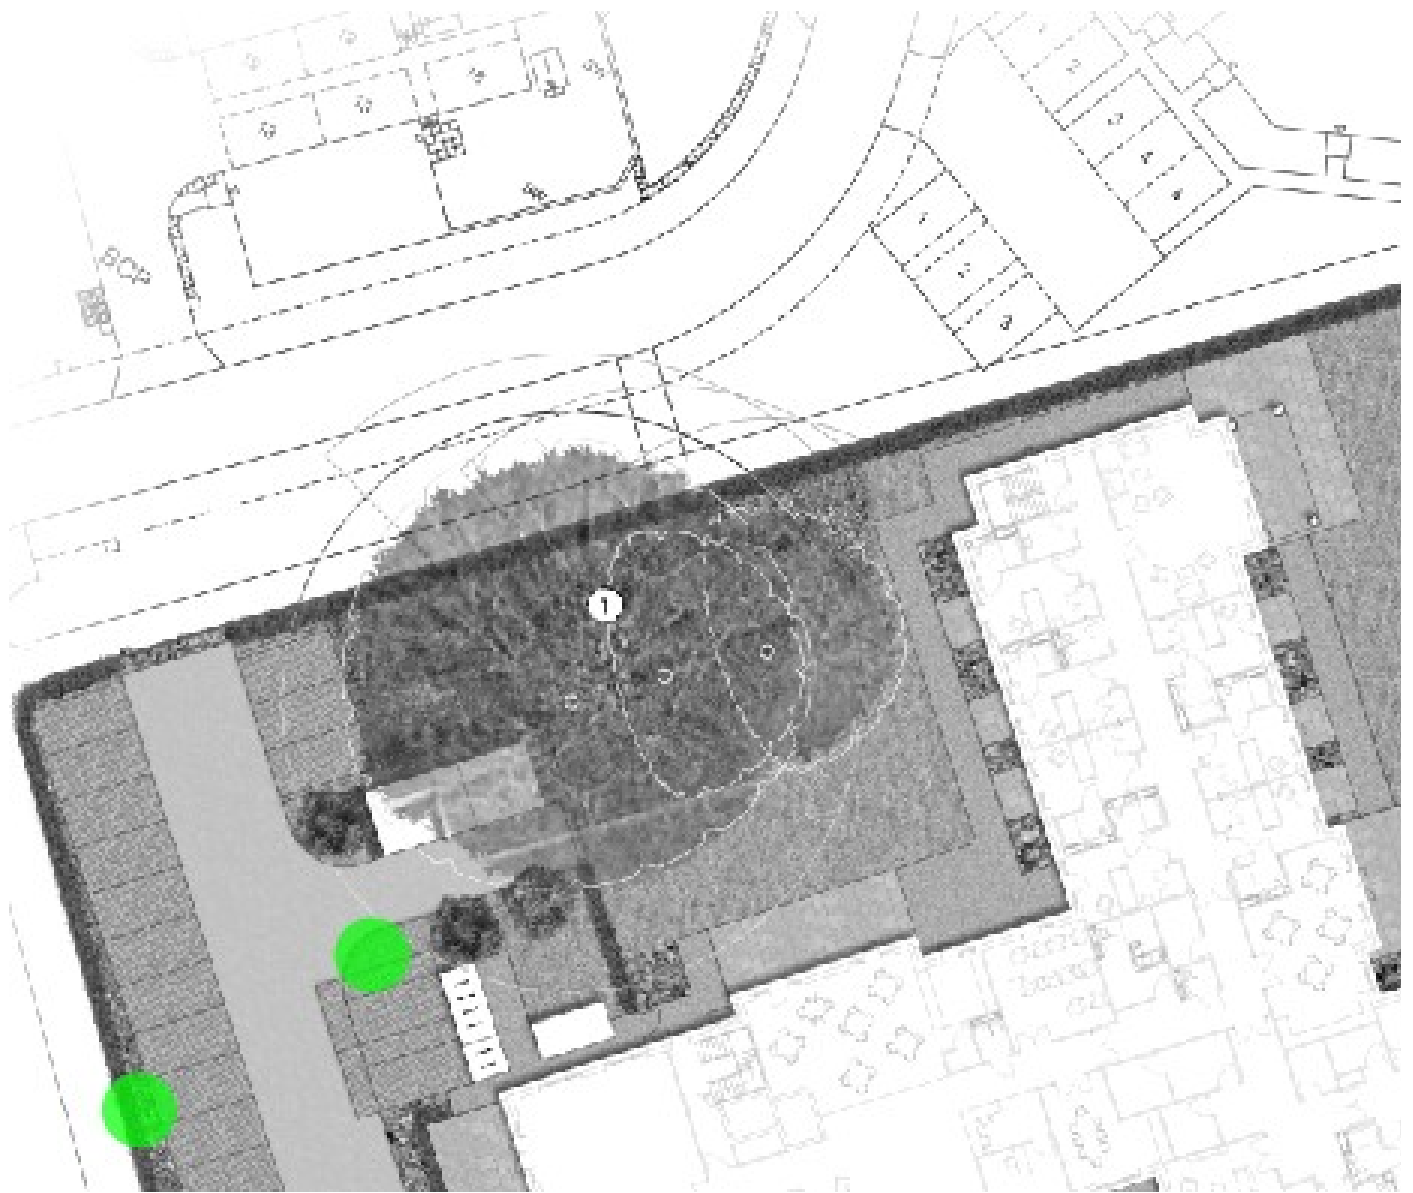
There are too few new trees planted on the site and additional trees should be introduced in locations below. This may require (in places where rooting volume is limited) specialist tree cell tree pits to ensure the planting is deliverable:

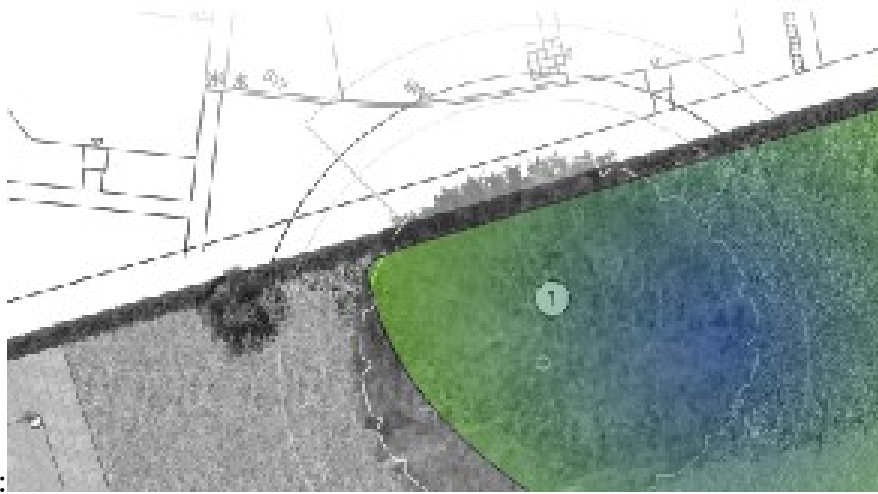
The shape of the proposed meadow is rather awkward and a sweeping curved area as below would

be more attractive:
