## Preliminary Ecological Appraisal and Preliminary Roost Assessment

Ropley, Botley Road, West End, Southampton, SO30 3HA

Pitter Properties Ltd

This report is prepared to inform a planning application for the demolition of the existing garage and construction of two dwellings with associated access road and landscaping

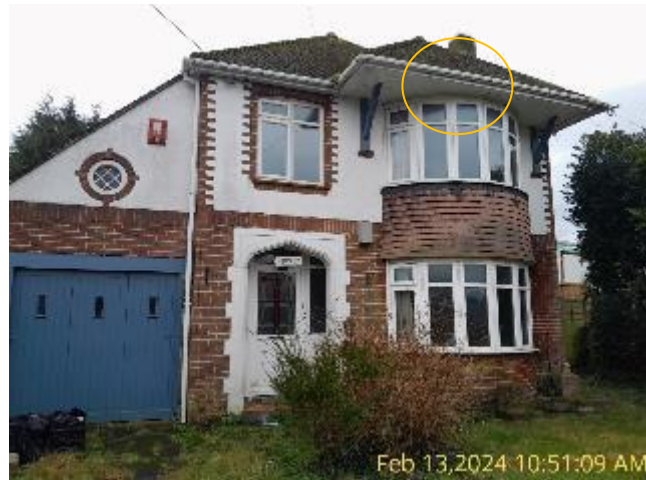
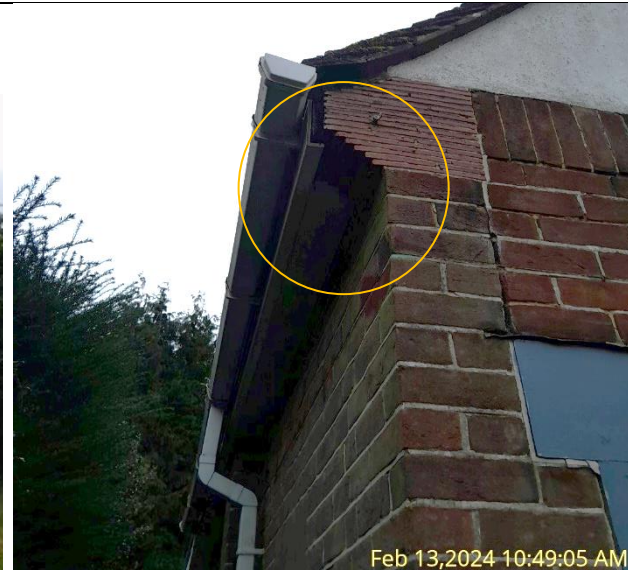
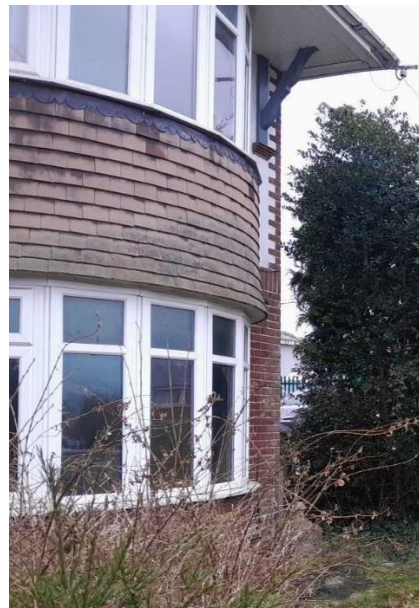
B1 is a two-storey red brick residential dwelling with clay hanging tiles and slate tile roof with white PVC soffit boxes. The slate tiles are completely flush to the roof with no visible gaps. A single-storey garage is attached on the eastern side. The roof is composite, with one chimney sealed with lead flashing, the northern, southern and western elevations are hipped, with shed and flat roofs on the eastern elevation. Windows are plastic PVC, sealed with silicone, there are two bay windows on the northern elevation, embellished with decorative detailing. The garage door is made of wood and painted blue.

There are gaps within the hanging tiles, soffit boxes, brick work and lead flashing on B1 that have potential for roosting bats. These have been circled in yellow on the photographs and their corresponding elevations.

| <i>Recommendations</i> | <p><u>B1</u></p> <p>Two bat emergence and re-entry surveys are required during the active bat season (optimal May to August, suboptimal September) to confirm presence or likely absence of a bat roost in B1. The survey should be completed during the optimal survey period mid-May to August inclusive.</p> <p>Infra-red cameras should be used as an aid. Surveys must be a minimum of three weeks apart.</p> <p>Three surveyors are required to provide full coverage of the building.</p> <p>If bat roosts are confirmed in the building, one additional survey may be required to characterise the roost and to inform an EPSL application to Natural England. The EPSL application requires that surveys have been undertaken within</p> |

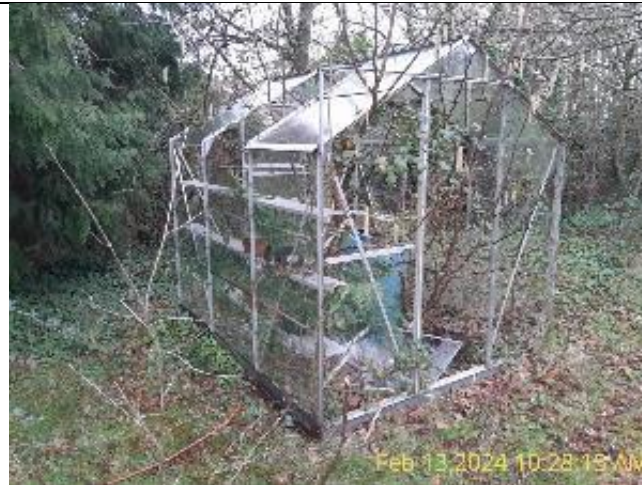
B2:

B2 is a single-storey greenhouse with glass panels, it has been left unmanaged with several broken panels. B2 has no features for roosting bats.

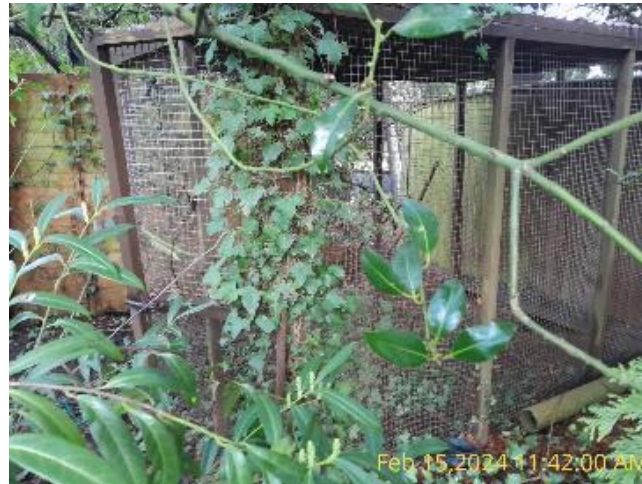
B3:

B3 is a dog kennel/enclosure made of wood with metal mesh columns, it has been left unmanaged with sparse areas of vegetation within. It has a flat roof made of wood. B3 has no features for roosting bats.

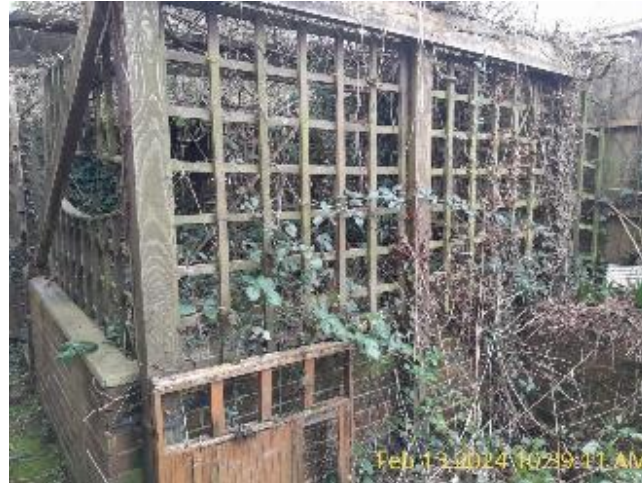
B4:

B4 is an open structure with partial red brick structure and wooden panels. B4 has an open roof, with wooden panels across the top to keep its structure. B4 has no features for roosting bats and too much exposure to the elements.

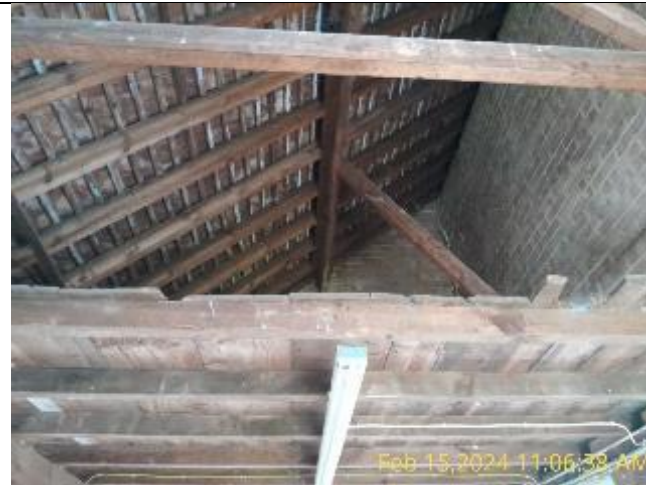
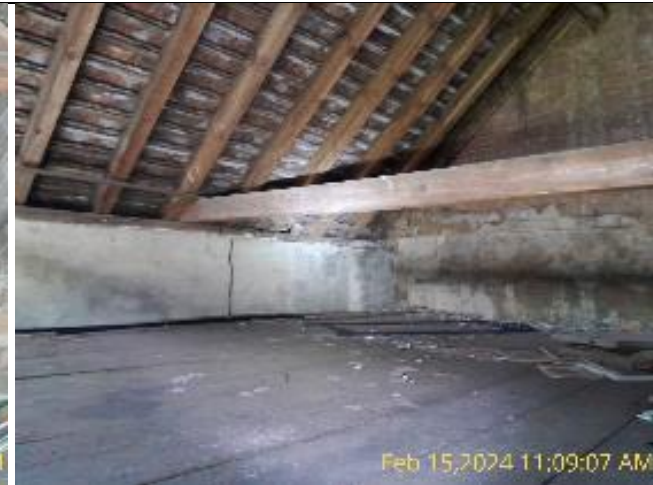
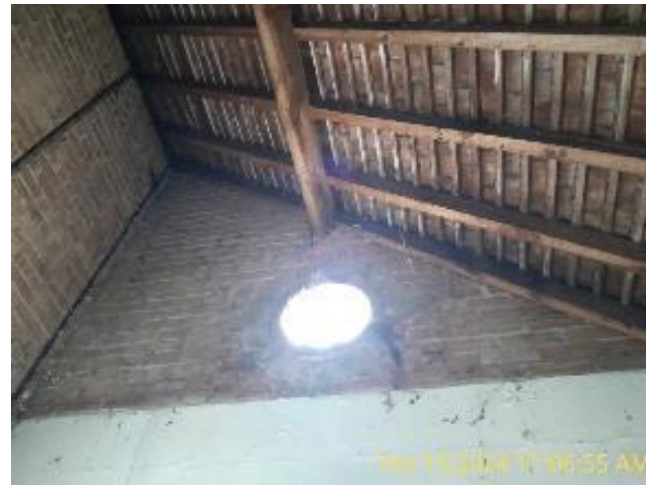
B1 - garage void/eastern elevation:

The attached garage on the eastern elevation had a sloped roof, there was no lining, and the underside of the roof tiles were exposed with wooden beams. These were in good condition, with no visible gaps. Daylight was visible due to the circle window on the northern elevation.

The ambient temperature inside the loft space was 16°C, with 78% humidity which was the same as the outside temperature and humidity during the survey.

No droppings were found within this area.

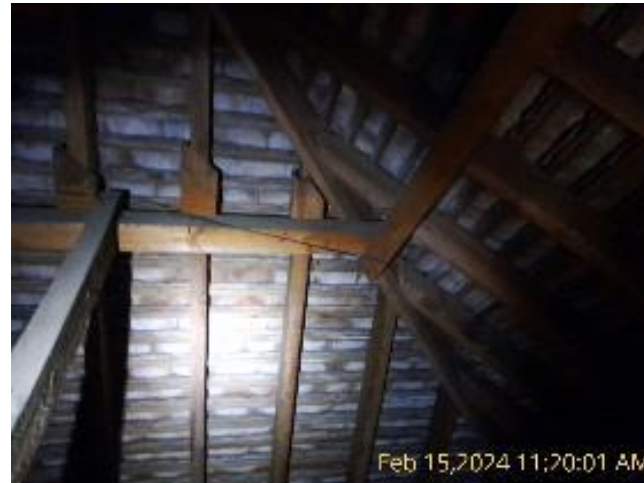
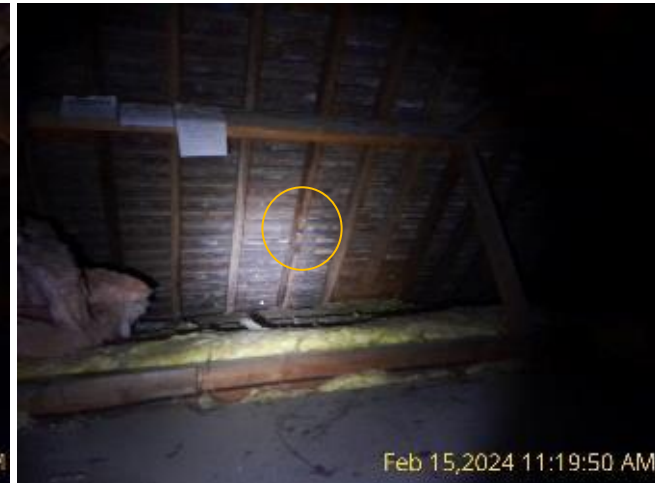
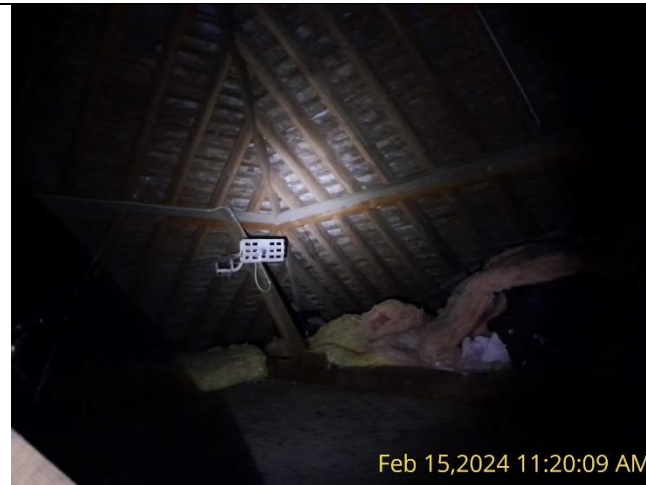
B1 – Main dwelling void

There was no lining, exposing the underside of the tiles and wooden beams across. The loft space provides roosting potential for void dwelling bat species. Wooden panels covered the floor with areas of wool lining. The only daylight visible within the loft void was from a gap within the western elevation (as circled in yellow above). The ambient temperature inside the loft space was 16°C, with 78% humidity which was the same as the outside temperature and humidity during the survey. Therefore, the temperature within the void is unlikely to remain consistent.

Rat droppings were found on the floor near the loft opening.

No bat droppings were found within the loft void, however due to health and safety reasons not all areas of the void were assessed.

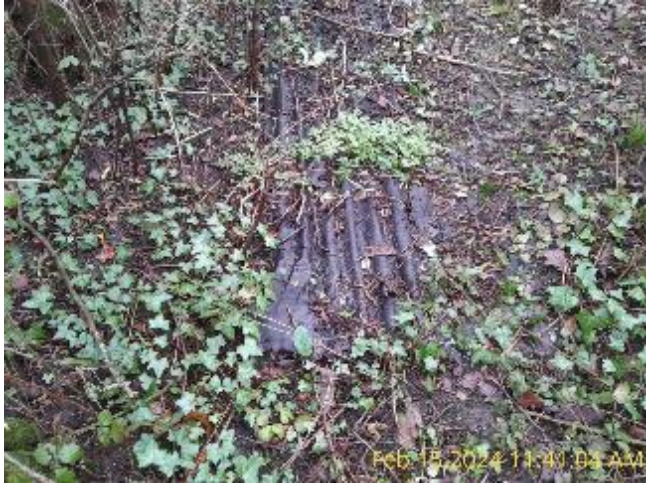
| <i>Summary of Survey Findings</i> | <p>The areas of scrub, vegetated garden and hedgerow provides suitable habitats for reptiles, for foraging, hibernation and commuting. There are areas of metal and other materials left on the ground within the vegetated garden, creating refugia for reptiles.</p> <p>Feb 15, 2024 11:41 D4 A44</p> |

| <i>Recommendations</i> | Reptile surveys will be required to determine presence or likely absence of reptiles on the site. This will comprise the deployment and monitoring of artificial refugia over seven visits and such surveys must be undertaken between April, May and September, in accordance with current survey guidelines (Gent & Gibson, 2003). |
