# Arboricultural Method Statement

## Rebuild of failed retaining wall

Site Address:  
43-66, Runnymede Court, West End  
Southampton, SO30 3DP

Ref: KTML42124-AMS

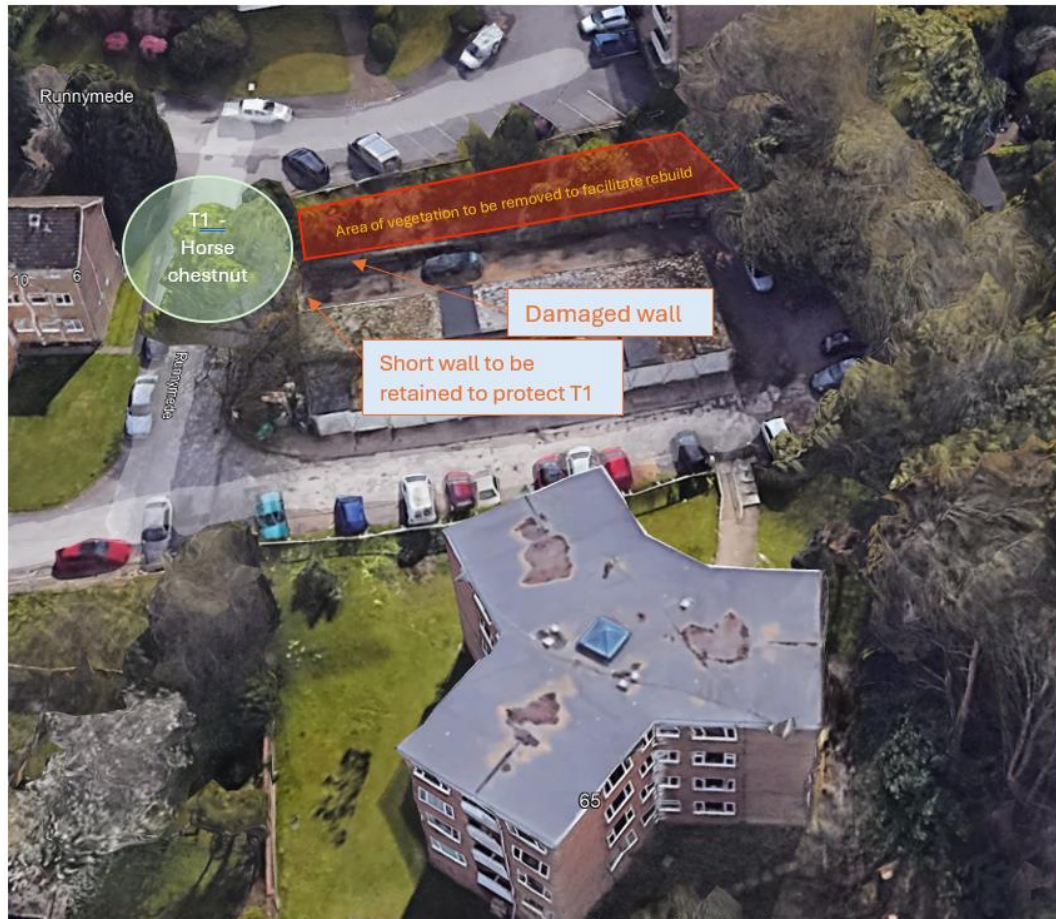
The short wall supports the soil volume for T1. It is anticipated that only fine roots belonging to T1 will be found behind the long section of the wall and these can be pruned with little detriment to T1. See *image 1 below*.

Viewed from south to north – images courtesy of Google Earth Pro/Landsat/Copernicus

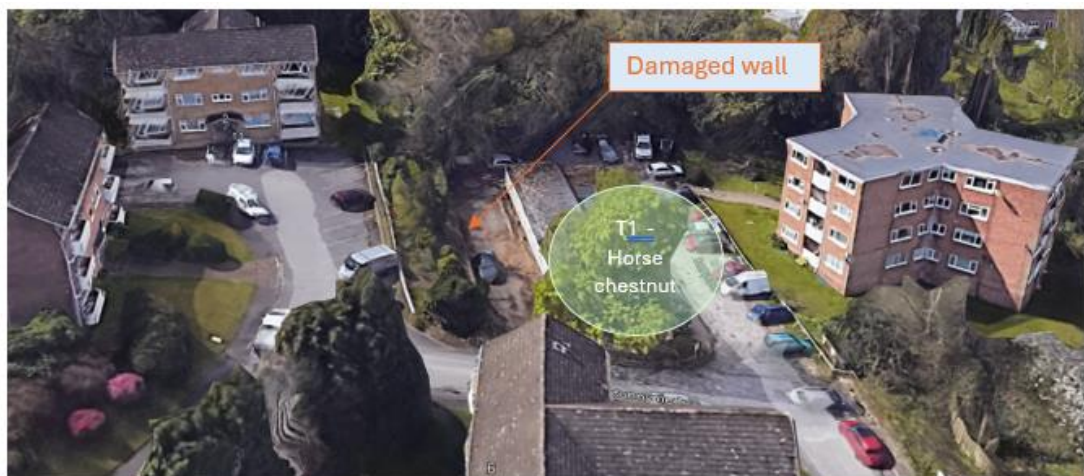
View from east-northeast illustrating soil level differences.

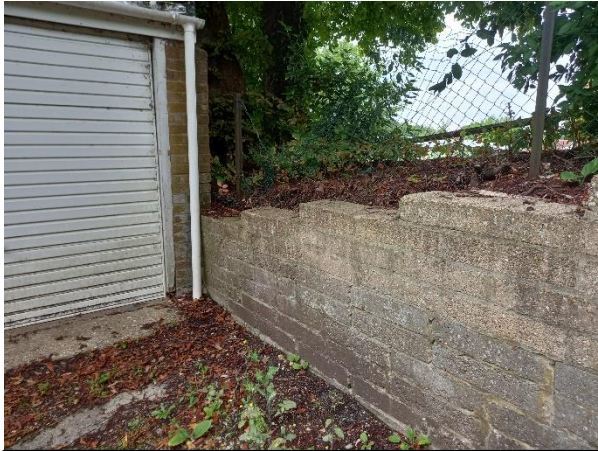
*Photo 1: Eastern end of car park where wall adjoins garages. The horse chestnut is in the centre top.*

NO works are to be done to the eastern end (the short return wall) to safeguard T1's rooting area.

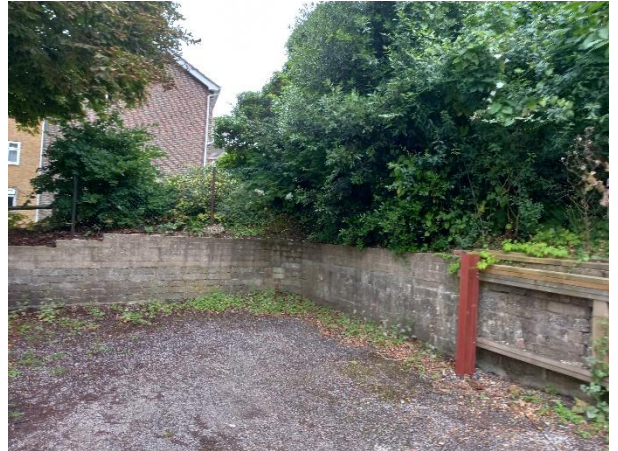
The replacement is necessary as the weight of the bank is too great for the current wall and it is being pushed over. Temporary supports have been installed but these are not a permanent solution.

*Photo 2: Eastern end of car park where wall turns to form southeastern boundary. Note temporary support.*

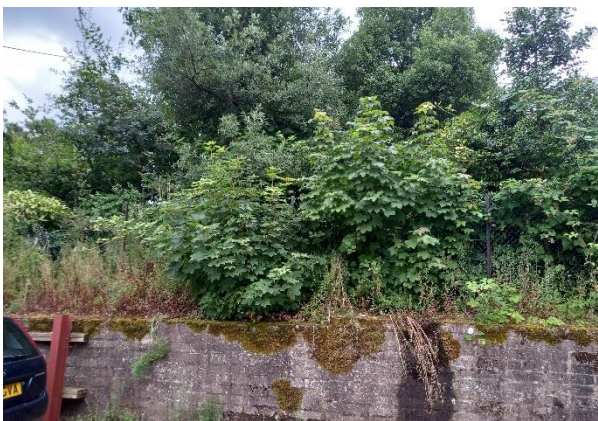
*Photo 3: centre section of long run*

I am advised that a minimum 5m excavation needs to be done behind the long wall section cutting back into the bank to facilitate the rebuild. This has been queried but confirmed as necessary. See detail on drawing 20 of project 2024.442 titled 'Proposed Ret. Wall Construction Site Plan Structural Scheme Details' Aug '24.

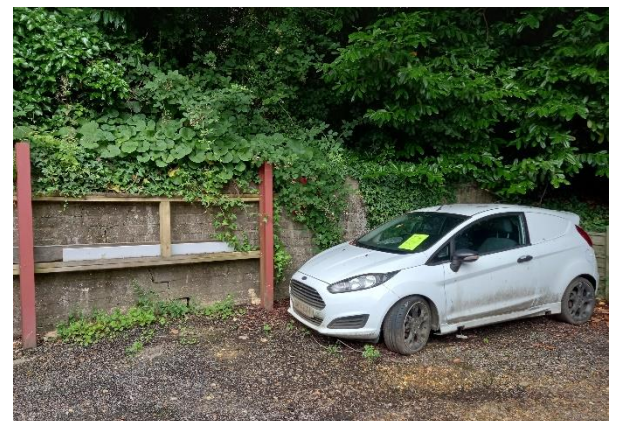
*Photo 4: southwestern corner. Note cracks in wall.*

Works at western end of wall to be done under arboricultural supervision to determine extent of damage and to advise on how to retain other trees.
