## **Assessment of Significance and Heritage Statement Incorporating the Design Access Statement**

Site: The Old Cottage, High Street, Bursledon, Hampshire, SO31 8DJ

Client: Mr & Mrs Kyd

Date: 25<sup>th</sup> January 2025

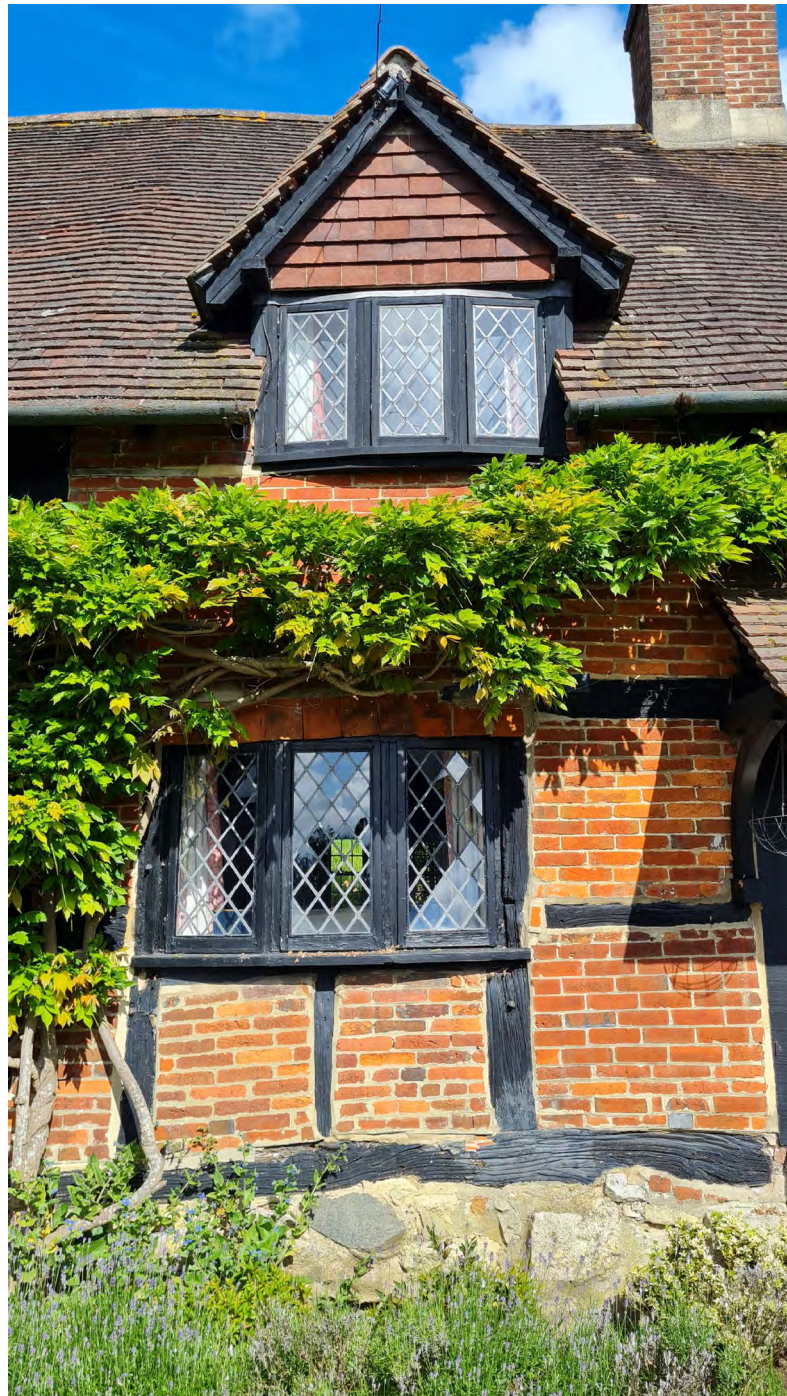
inserted at a difficult height with regard to the timber frame, in that it has led to the wall plate being cut out in this location. This has caused the plate to spread slightly on each side and in turn led to movement in the masonry panels to each side of the window, which are now projecting considerably beyond the timber frame.

Figure 11; View of the bay of the South-East elevation which contains the dormer. Note also the tiles covering the floor girt above the ground floor bow window.

In addition to the localised timber frame repairs, we would propose to address the movement in the frame around the dormer window, which has led to the surrounding masonry panels moving outwards, which if unchecked, could lead to their falling into the street. This would involve the careful removal of the panels concerned, the insertion of a new oak framing rail below the window to help reinforce the existing frame and make up to some extent for the loss of the wall plate, and then the making good of the dormer. The masonry panels would then be re-built using the same bricks where possible in a lime mortar to match the original.

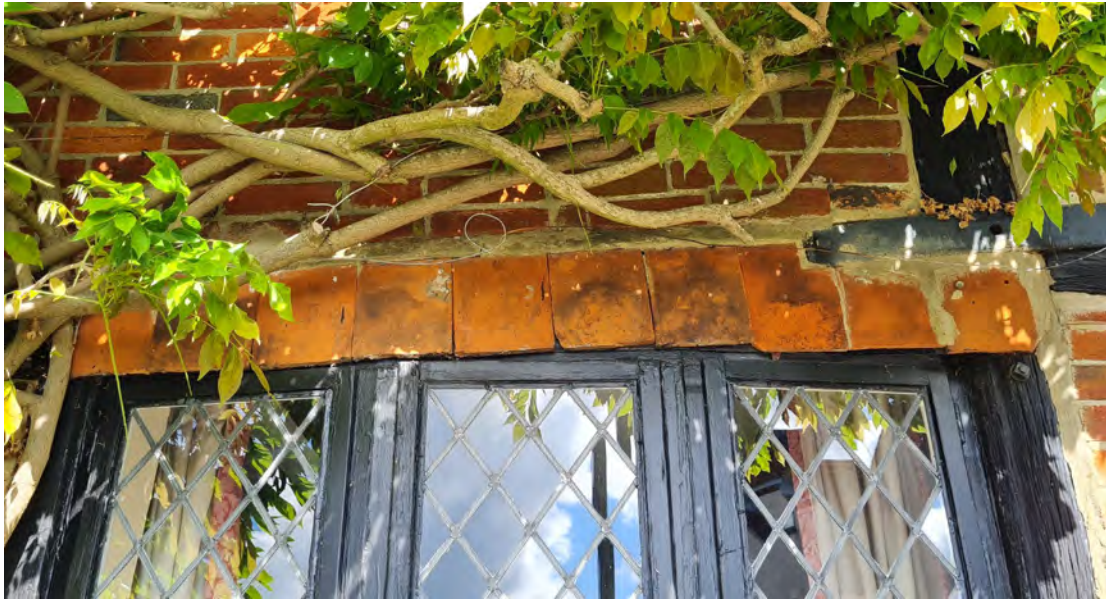
The timber frame shows signs of decay and earlier resin repairs in addition to some good quality timber repairs toward the South-Western end. There are a number of areas where the frame has been covered by bedded tiles, together with examples of face-fixed iron straps, which suggest significant decay or loss of members behind these coverings and failure of the original joints. The earlier resin repairs are also a potential cause for concern in that the remaining timber around these will be unable to breathe and may suffer as a result in the longer term.

Figure 12; Close-up view of a section of tile covering above the window head. Note also the poor quality of the modern bow window.

To the frame repairs are illustrated on the proposed elevations as included above. Whilst the exact extent of repairs cannot be understood until work on them begins, this would include the removal of the earlier resin repairs and scarfing in of new sections of oak to re-form the traditional joints of the frame. It would also include the removal of the tiled-over sections to allow the repair of the underlying timber frame so that it can be visible again.

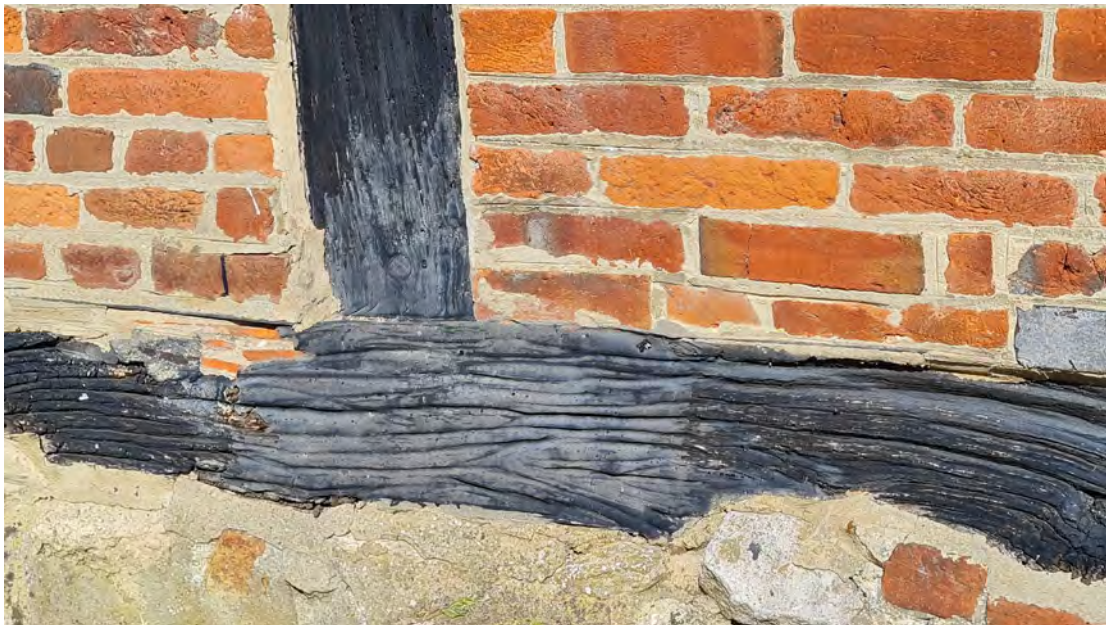
Figure 13; Close-up view of a section of cill beam, with the resin repair to the cill and lower section of the post clearly visible, despite the attempt to disguise this with fake 'grain'.

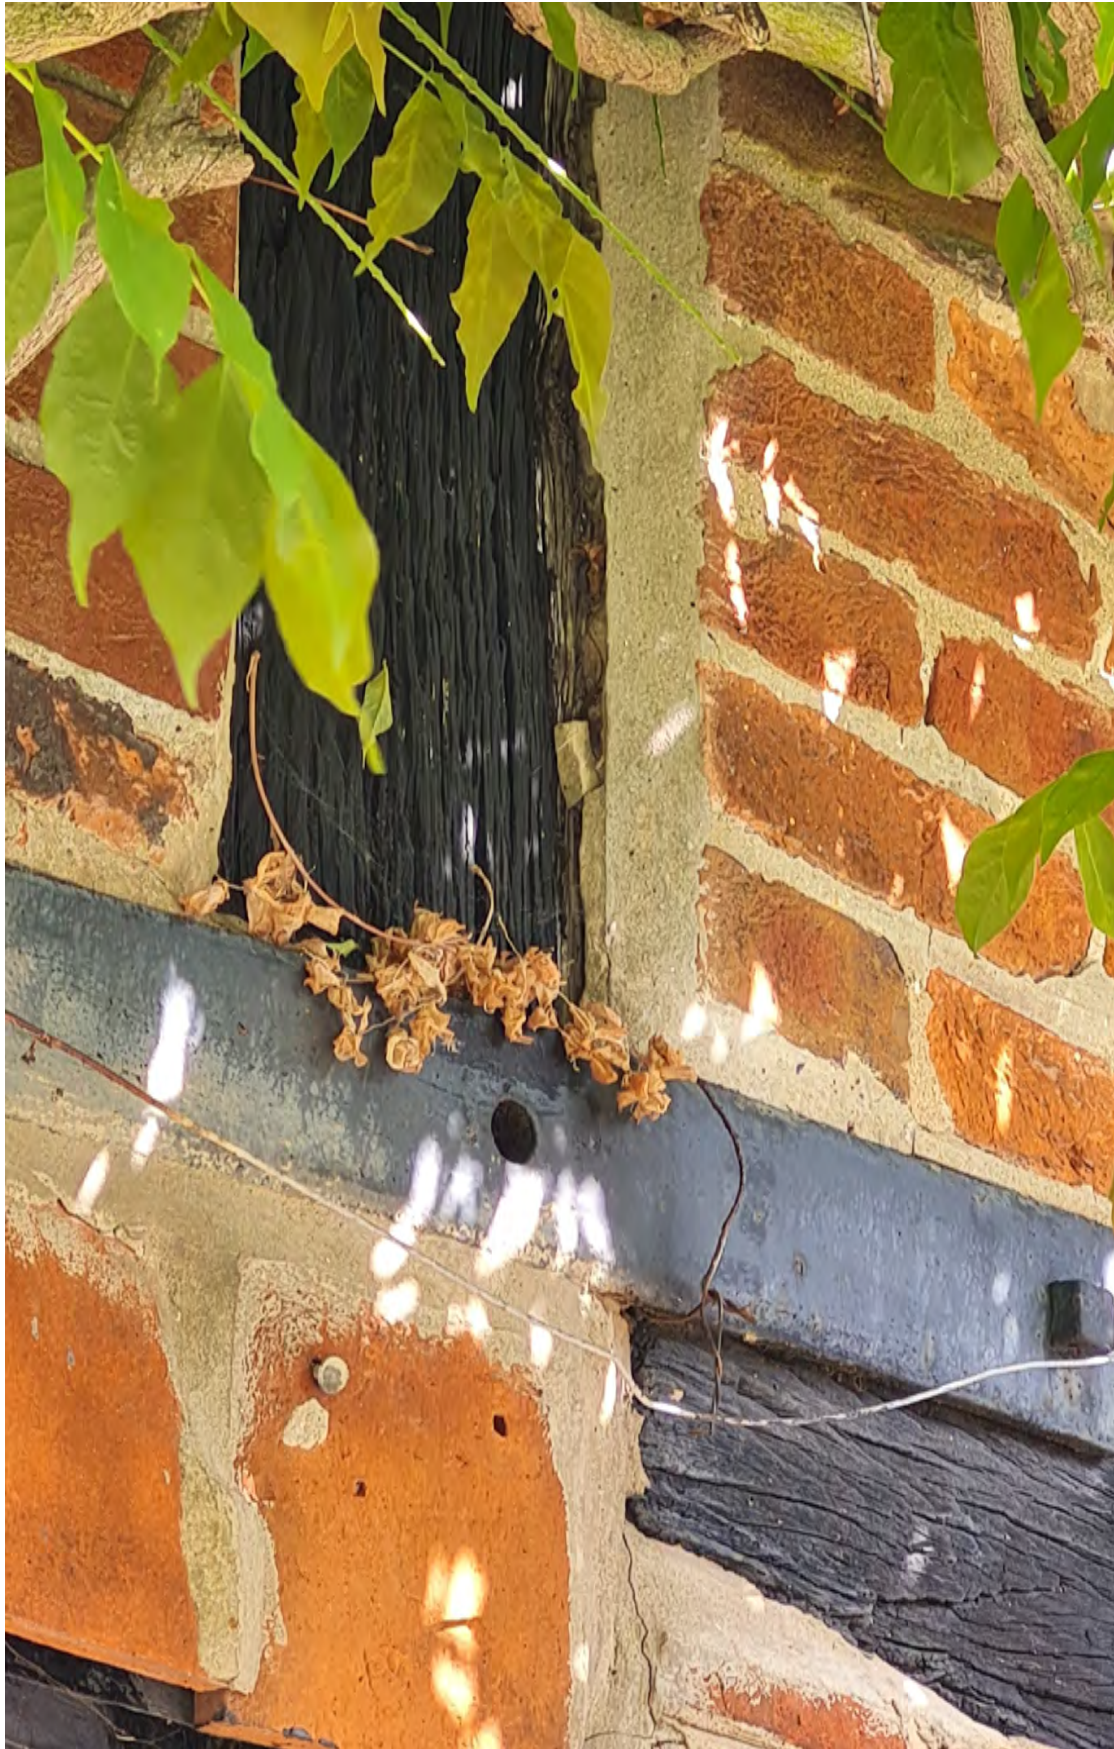
Figure 14; Close-up view of the junction of a masonry panel below the dormer window at its junction with the adjacent post to the timber frame. Note the outward movement of the panel, even beyond that from the cementitious shoulder which is itself relatively modern. The gapping gets worse as the panel leans outward toward the top, but this is obscured by the Wisteria.

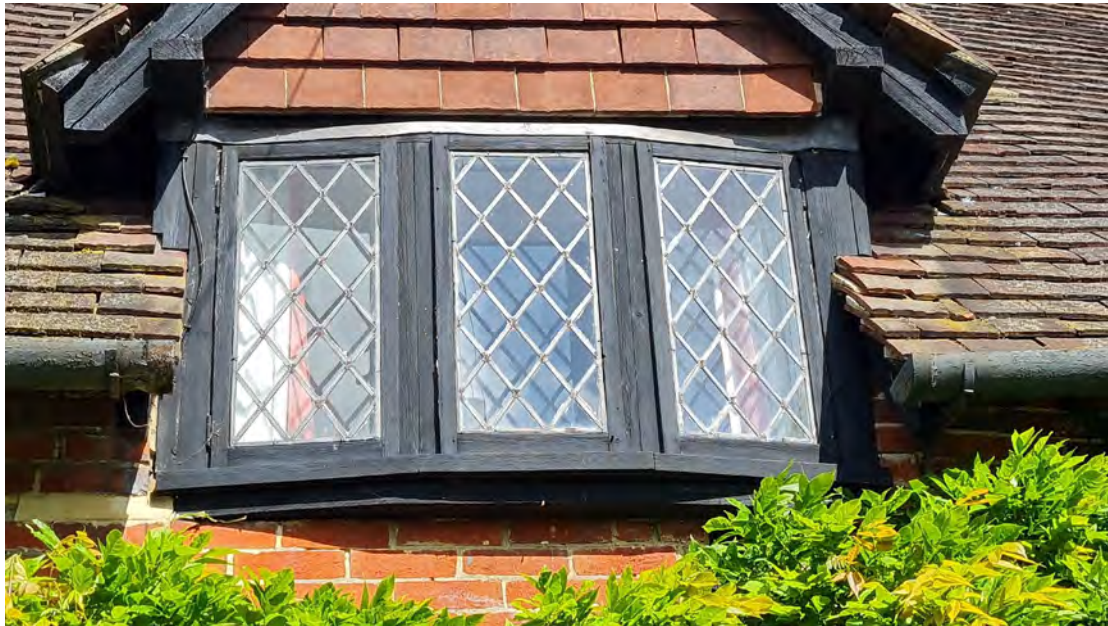
The glazing to this elevation is a considerable mixture of styles and ages, although the larger windows are generally of poor-quality design and materials and date from the C20. The two bow windows, one to the dormer and the other to the Living Room below, are particularly poorly detailed. They appear to be in softwood and are also in a poor state of repair.

Figure 15; Close-up view of the modern bow window to the dormer. In this photo the position of the wall plate can be judged relative to the window.

- The replacement of the poor-quality windows on the North-East elevation with more appropriate diamond lead-lighted hardwood casement windows.
- The replacement of the larger windows (the first and ground floor bow windows and the mixed window to the Dining Room) with new hardwood face-planted windows.

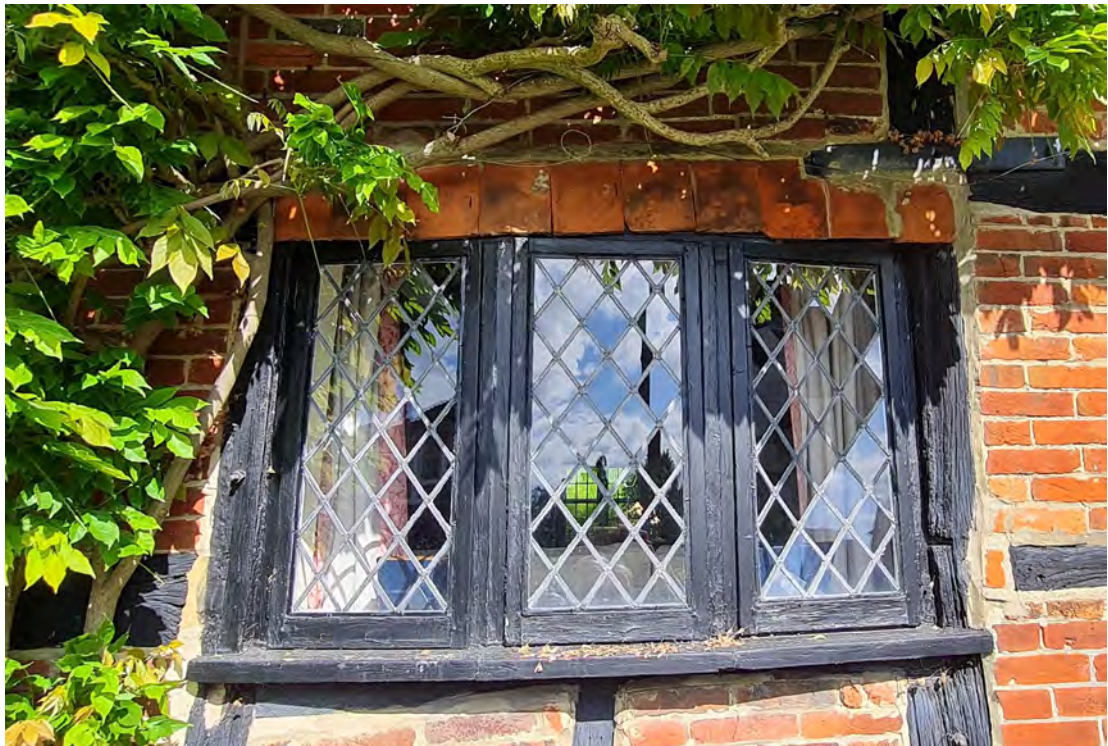
Figure 16; Close-up view of the modern bow window to the Living Room.

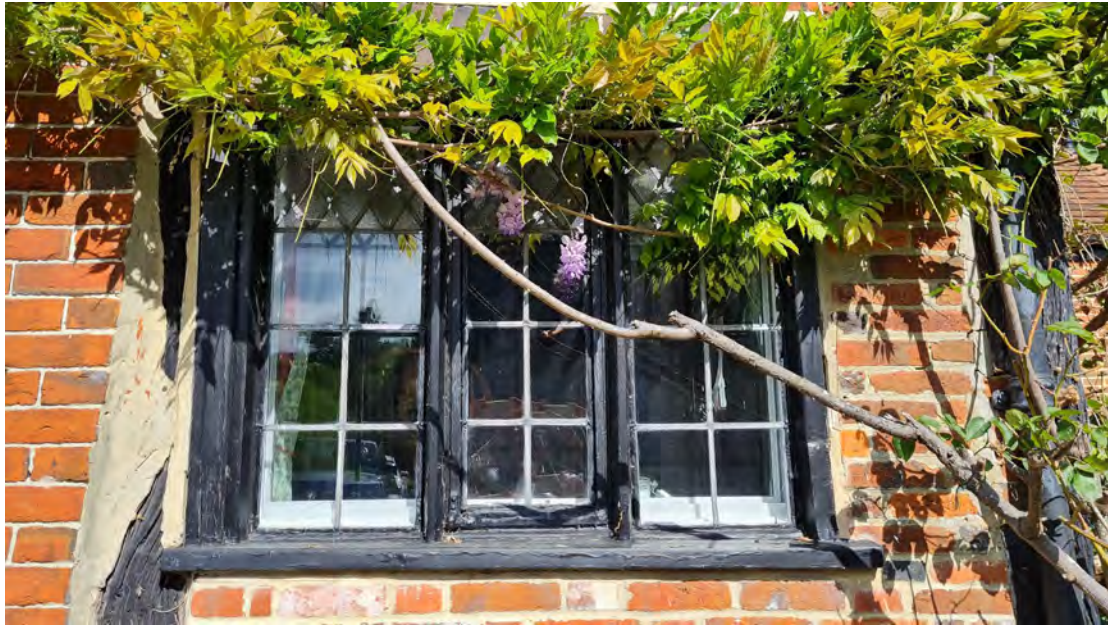
Figure 17; Close-up view of the ground floor window with the mixed lights set within steel frames to the Dining Room.

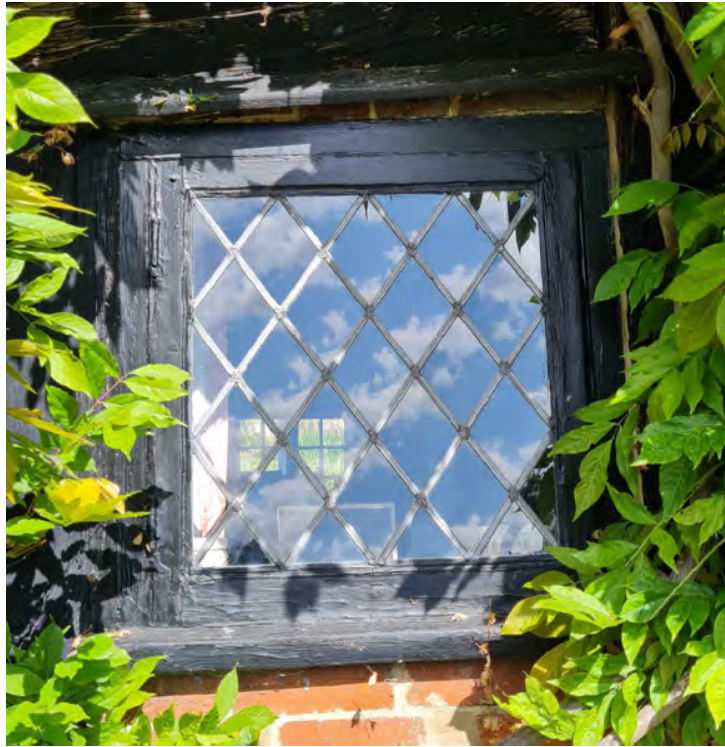
Figure 19; In contrast to the window in Figure 16, this almost square window to the South-Western end of the Living Room is of a jarring proportion for the age of the building.

- Replacement of the poor-quality casement windows the South-Western end of the front elevation with new hardwood casement windows with diamond lead-light glazing.

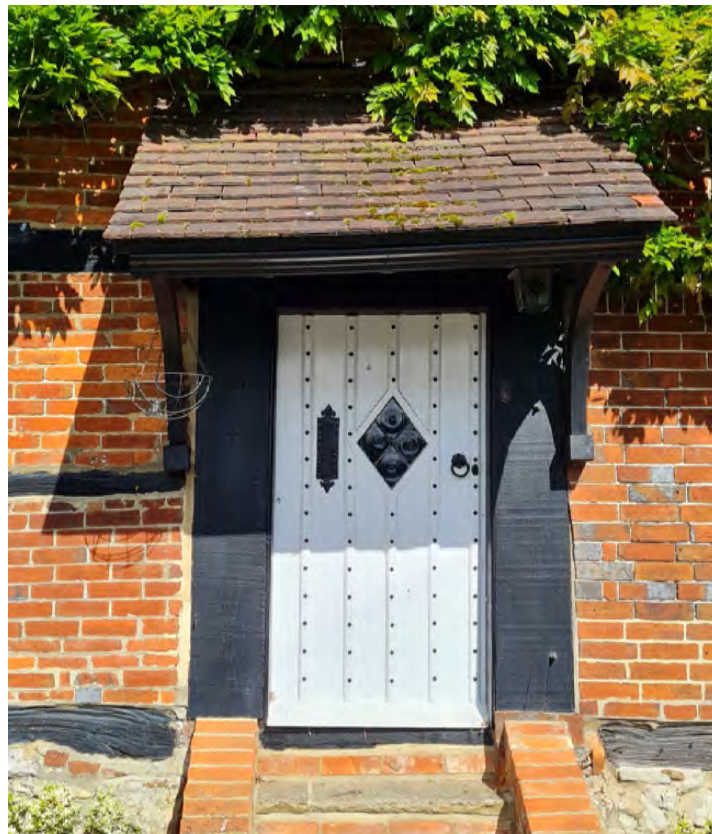
Lastly the porch to the elevation is worthy of some comment. It is also a relatively modern addition to the property, and is dropping on one side. Prior to any repairs, consideration should be given to whether it is the most appropriate form for the building.

Figure 20; View of the porch. Note also the wide cover strips to each side of the door, which appear oversized.

It is therefore proposed to remove the existing porch and replace this with a new, more subtle, flat lead and timber bracketed porch, as shown on the elevations. This will allow more of the timber frame to be seen. As part of this work, and in connection with the repairs to the timber frame, the modern cover boards to each side of the front door will be removed, and any necessary repairs to the original posts carried out.

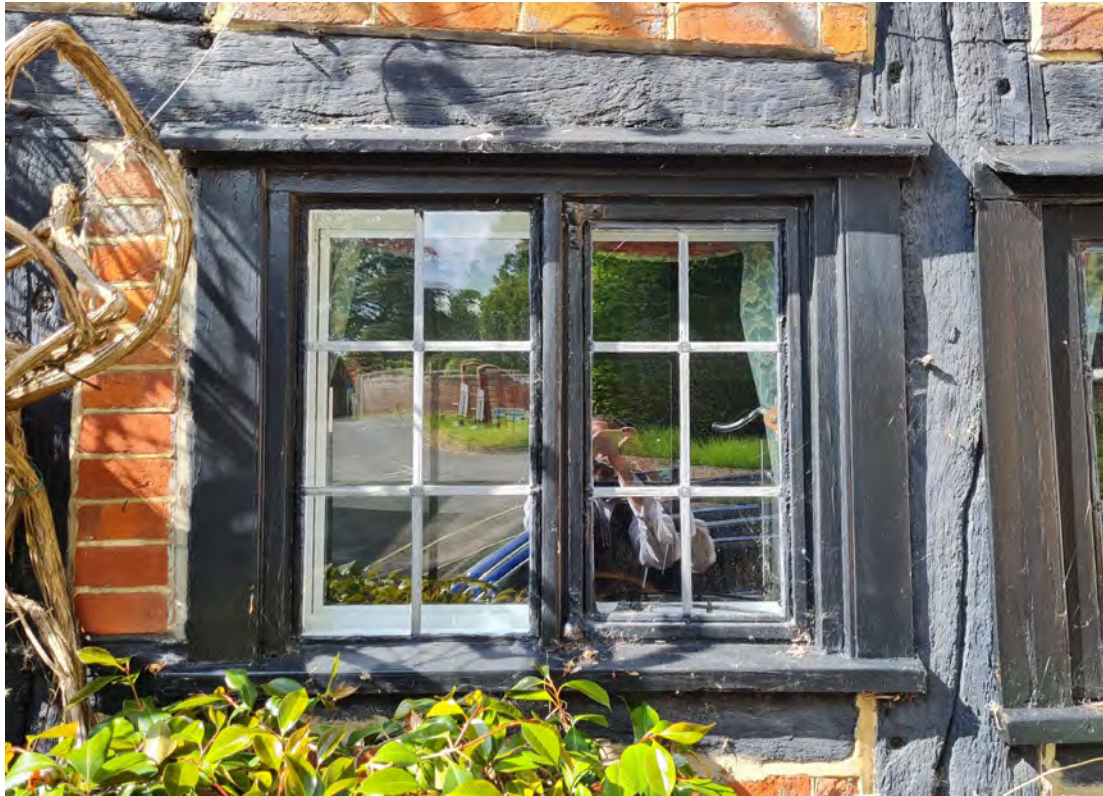
Figure 23; The left-hand of the ground floor windows to the North-East elevation, showing the steel casement, and basic rather poor-quality nature of the joinery.

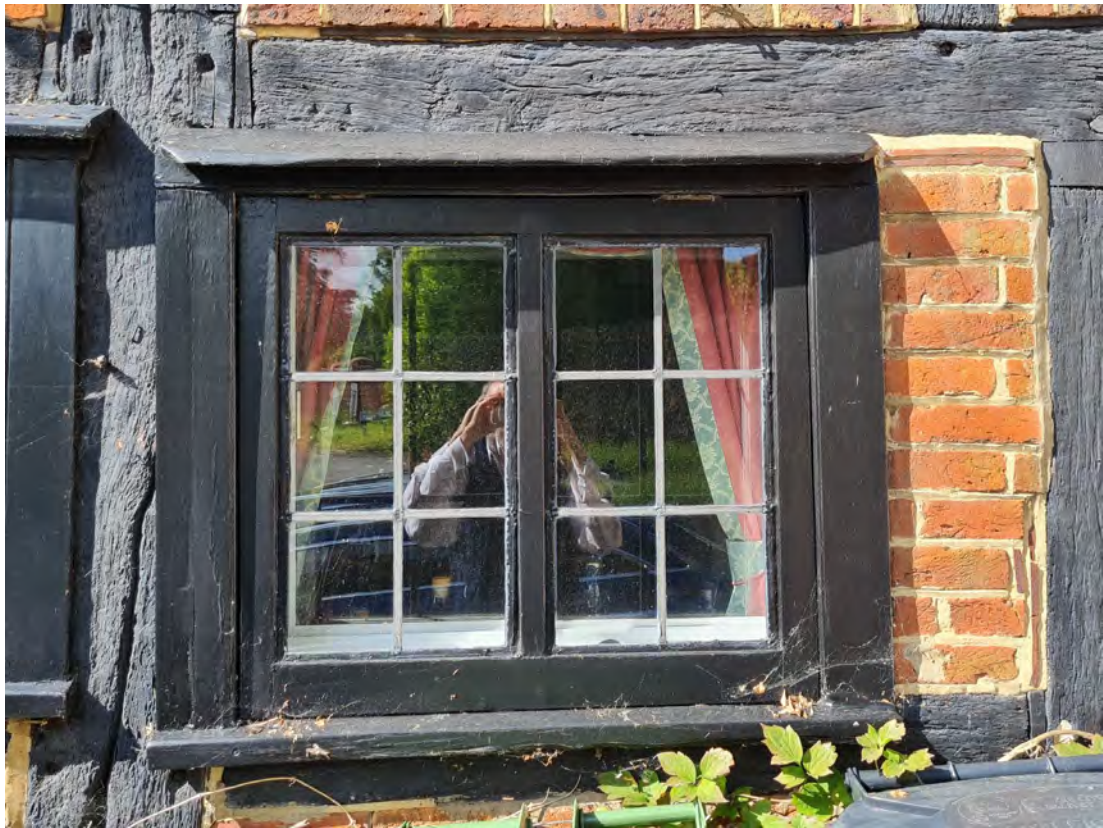
Figure 24; The right-hand of the ground floor windows to the North-East elevation, showing the modern top-hung casement.

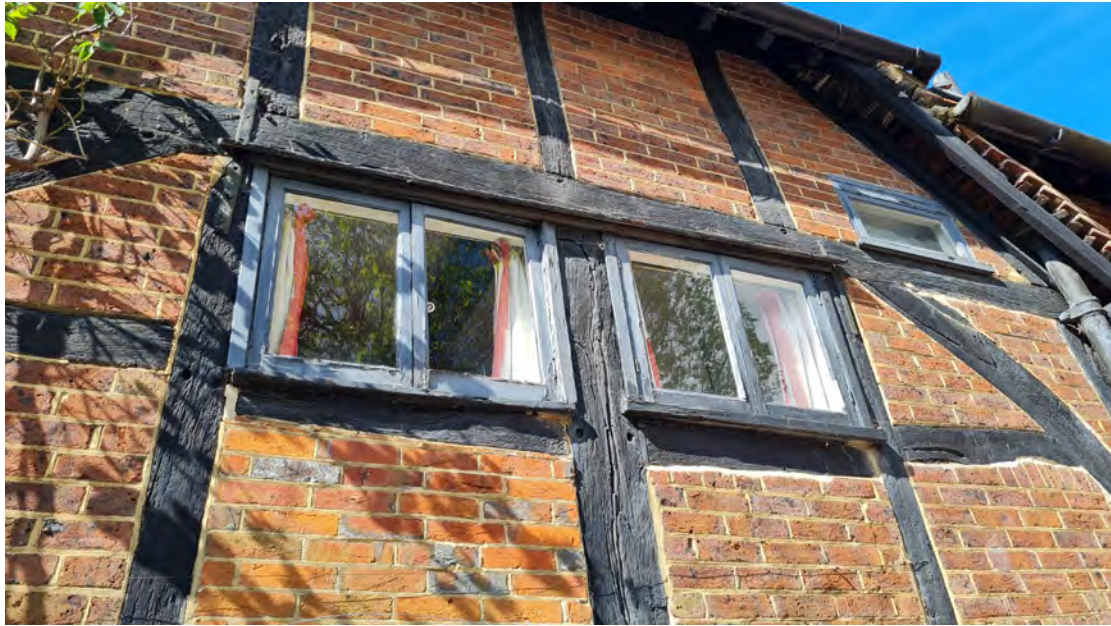
The first-floor windows are of a poorer quality still, being late C20 double casements to the bedroom and a top-hung single window to the bathroom. None of these have any glazing bars, and project a paucity of quality which spoils the elevation.

Figure 25; The very poor quality and poorly detailed modern first-floor bedroom windows to the North-East elevation, with the bathroom window up and to the right. Note the one more traditionally coloured brick panel above the girt is visible below the left-hand window.

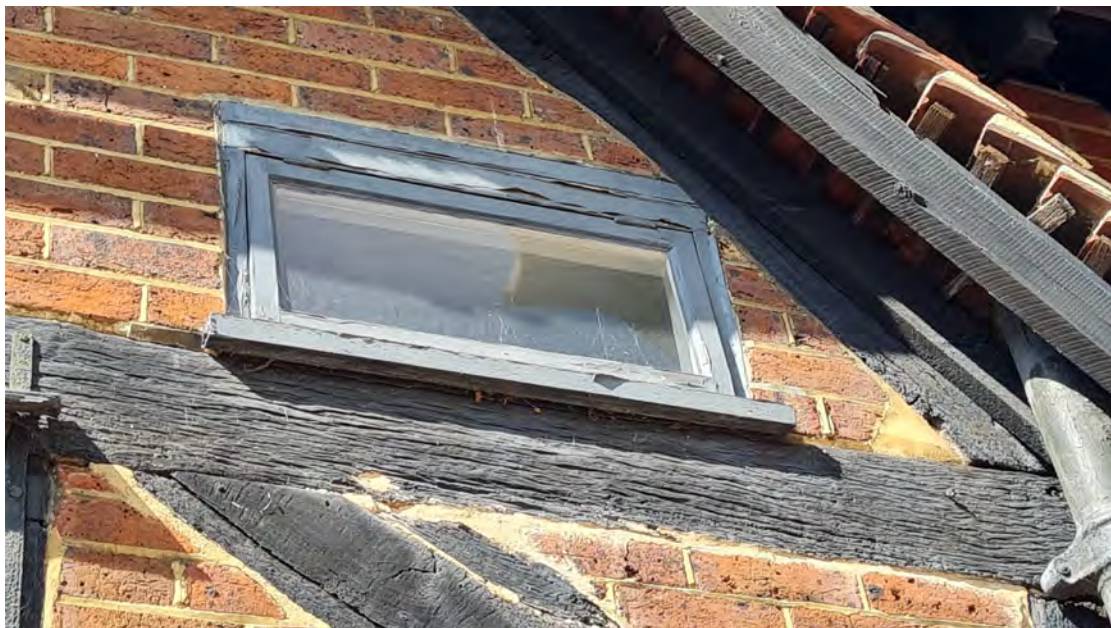
Figure 26; The equally poor quality, but even worse proportioned bathroom window.

Windows in gables above the tie beam are not uncommon in historic timber framed buildings, either to serve an attic space, or light a room from high level if the ceiling was raised. On that basis we have sought to find a form of window which is appropriate to such historic occurrences of similar windows found in other buildings.

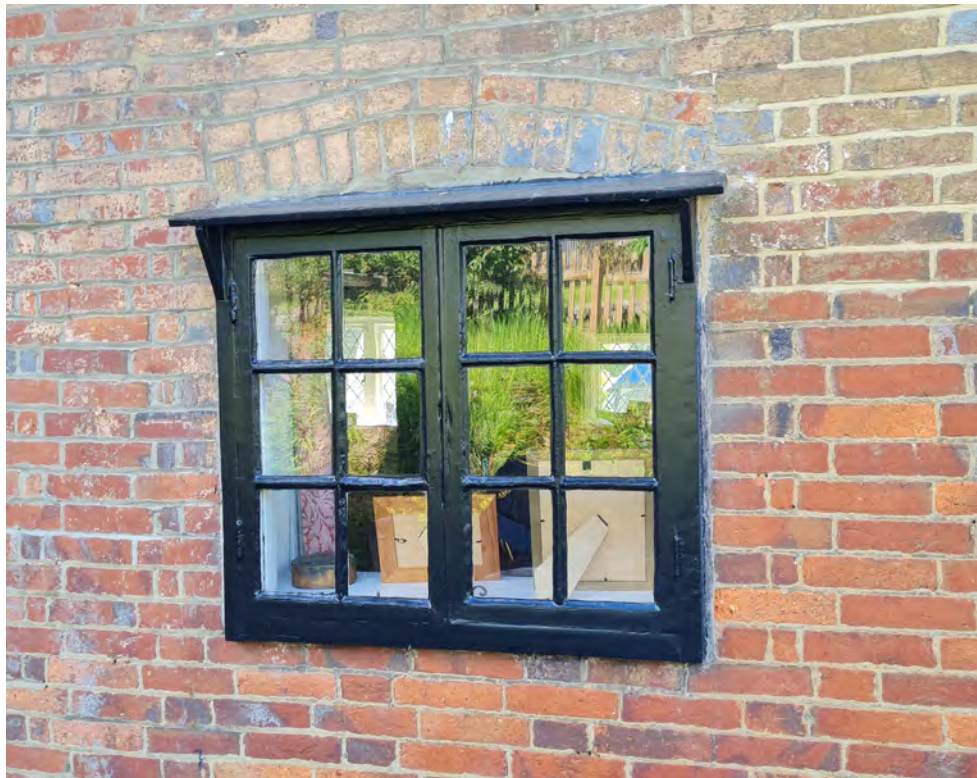
The windows to this section of the building are again of varying character. That to the first floor is a modern, late C20 or C21, double casement with lead lighting. To the ground floor, serving the Living Room, is a very characterful slightly face-planted two-light casement window with traditional but not overly ornate glazing bars and a simple weather hood. This sits below a brick arch to the opening in the wall. Further along, toward the kitchen, is a slightly cruder, but not unattractive three-light window with central glazing bars and lead-lighting to the panes above and below these.

Figure 30; View of the slightly face-planted window beneath the brick arch.

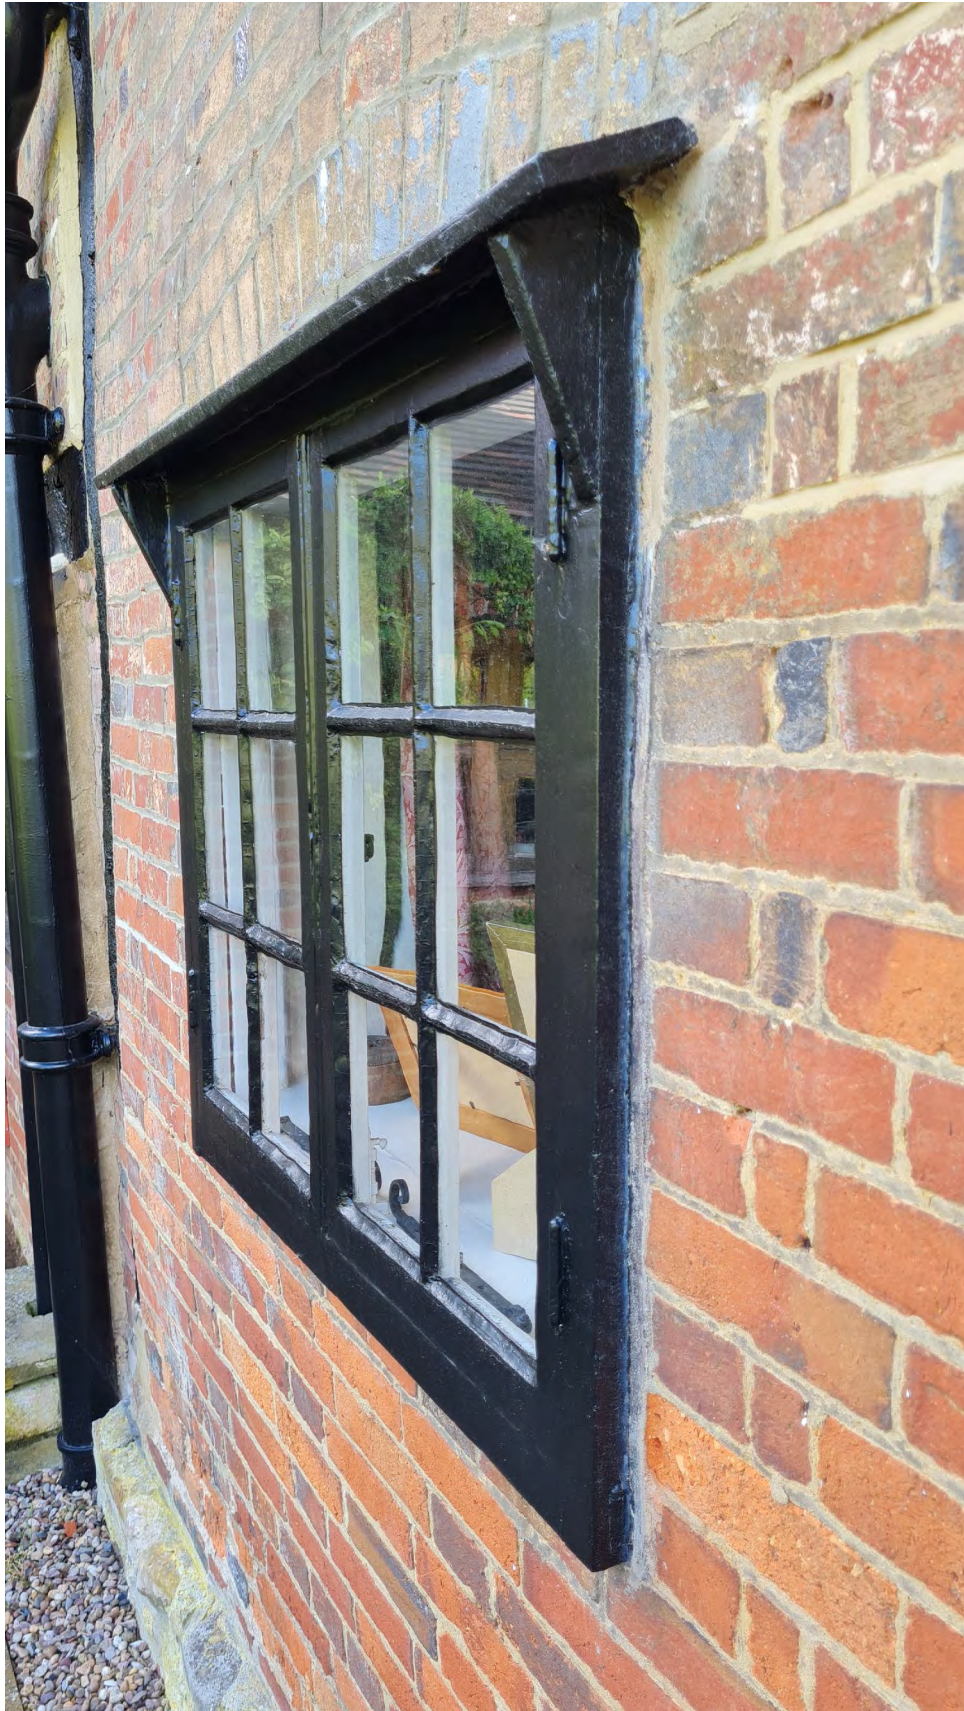
Figure 31; Image to show a close-up view of the frame sitting outside the face of the wall.
