## Mariners Retreat 1 Copse Lane Hamble SO31 4QH

T1- Oak sp.

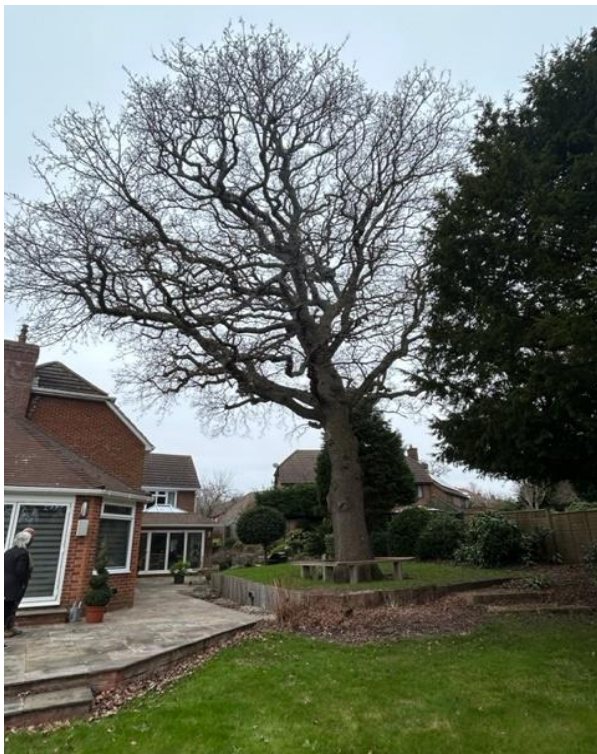
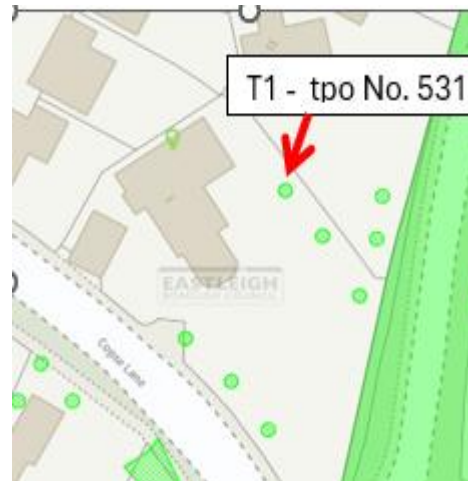
**REASON:** Works in order to try and increase sunlight to the property/patio area

The vendor has been a resident since 2004 (20 years). The natural light through the windows of the Lounge and Kitchen/Family room has been decreasing over this time, most notably during the last five years as a direct consequence in the increased density and growth of the Oak Tree canopy.

There is now no filtration of sunlight on the patio area outside the Kitchen until at least 15h00 (May ~ July being the optimum) due to the density of the Canopy. There is now no enjoyment in being able to sit out on this patio since 2022 due to the lack of sunlight.

**WORKS REQUESTED:** 15-20% canopy crown thin which will incorporate the removing of damaged, weakly attached, chaffing or diseased branches contributing to the crown thinning. Stem diameter branch foliage no greater than 25- 30mm. Crown clean major dead wood over 30mm

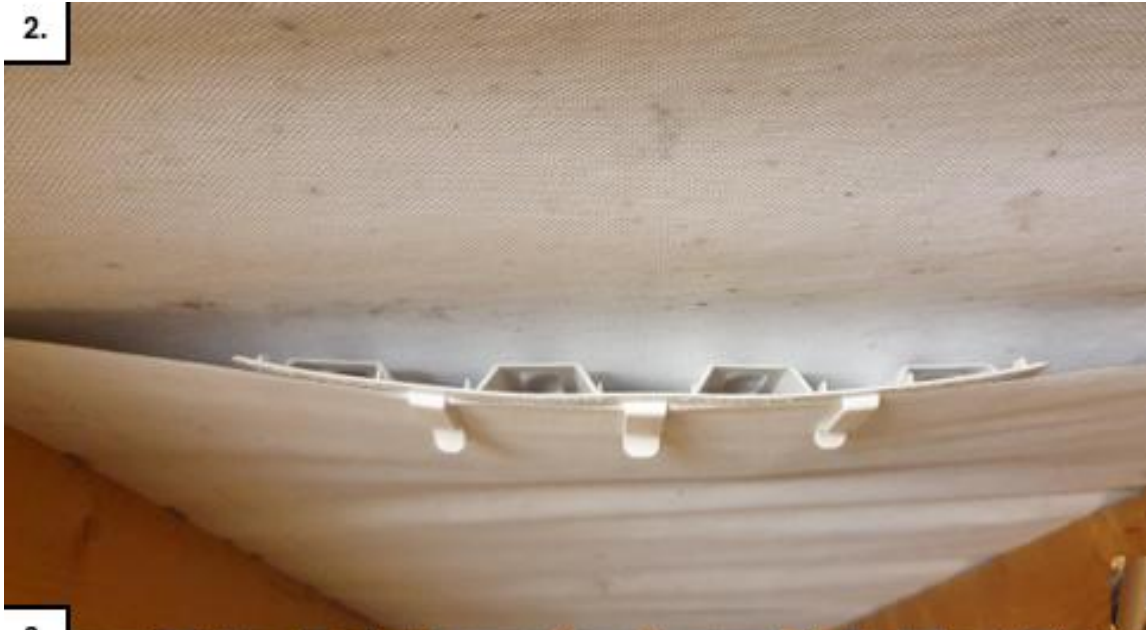
2.

There is substantial moss and algae accumulation on the southeastern aspect of the roof directly under the oak tree canopy (see photos). The accumulation of moss and algae has resulted in mould/mildew growth of the underlying breathable membrane (see photos) and a smell of damp present in this area of the loft. The mould/mildew is only present on the south and southeasterly aspects directly under the oak canopy. There is no mould/mildew on the west facing aspect. Ensuring the loft insulation (300mm thickness) is clear of all the ventilation soffits. To further improve air circulation, it has been fitted with baffles in-between the membrane layers and the installation of a fan which runs on a 24/7 basis (see photos). Subsequently the vendors are reluctant to run any electrical device in the unoccupied loft in case of a malfunction which could result in a fire.

Having contacted the National Federation of Roofing Contractors, they advise that is considered good practise to keep tree branches / canopies clear of roofs to an extent where moss/algae do not readily form. They also advise there is no fixed distance prescribed, as moss build-up will be dependent on several environmental factors unique to each location. They also advise that a persistent damp atmosphere where significant moss is present will accelerate the deterioration of the roof structure. It is noted that the conservatory roof does not have the same problem with moss, and it is probably because there is sufficient distance from the canopy to allow sufficient air flow to reduce local humidity and therefore moss formation.

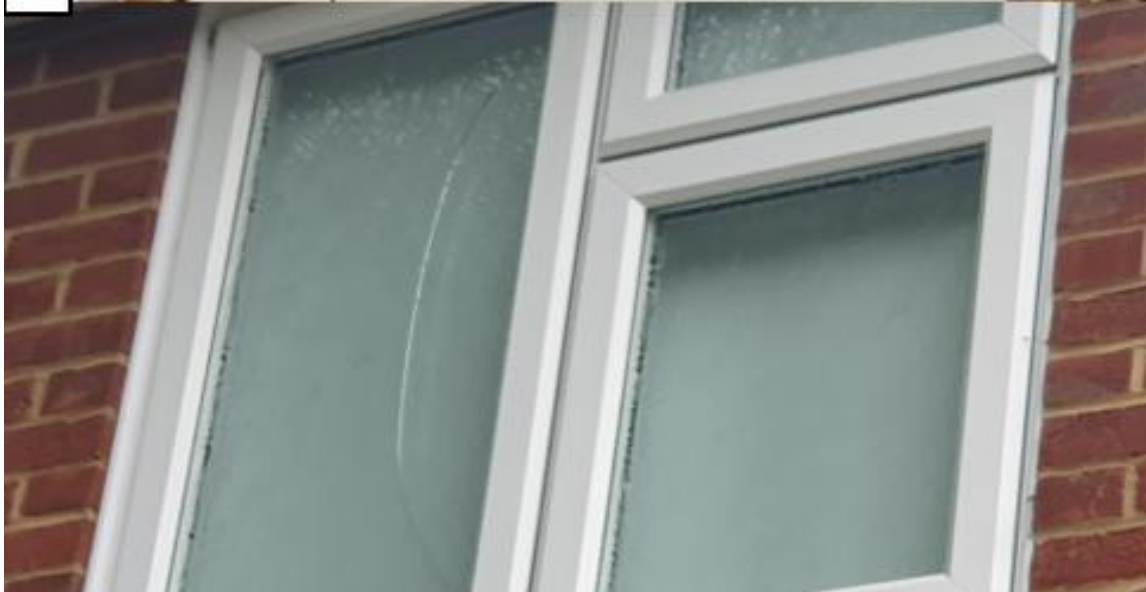
3.

There is a crack in an upstairs window directly under the oak canopy thought to be caused by a fallen branch (see photo). This window is part of the main bedroom dressing room area and is not accessible from inside without removing the dressing room furniture (built-in wardrobes).
