## **Preliminary Risk Assessment**

Navigator Quarter, Southampton  
Mitchell Way, SO50 5QJ

**For Blocwork (Eastleigh) LLP and AGS Airports Group Limited**

Report ref. 25/4362.A.1

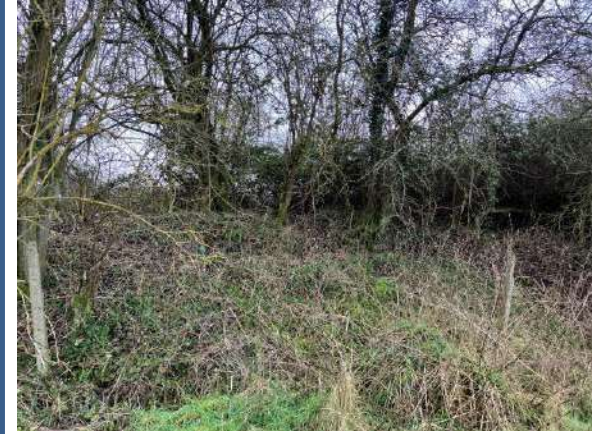
**Image 3:** Former railway embankment, densely vegetated

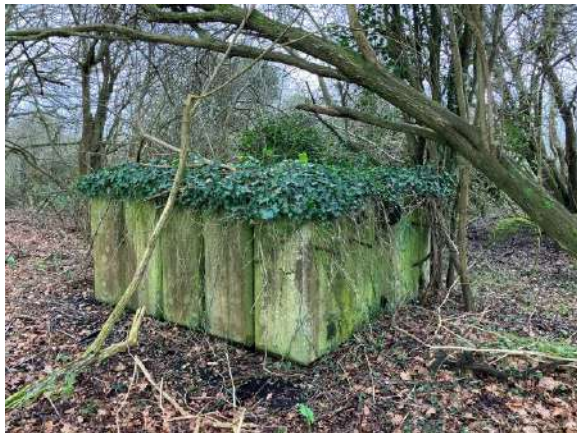
represent a former railway line. Concrete blocks and metal fragments were noted in the material of the embankment where bare ground was visible. Access to the northeastern field was via foot over the embankment or via a metal gate along the northern boundary. The northern access was noted to be flooded at the time of the walkover by c. 0.4 m of water. The track off-site to the north passed beneath the railway line via a brick tunnel.

**Image 4:** Remnant waste on former railway embankment

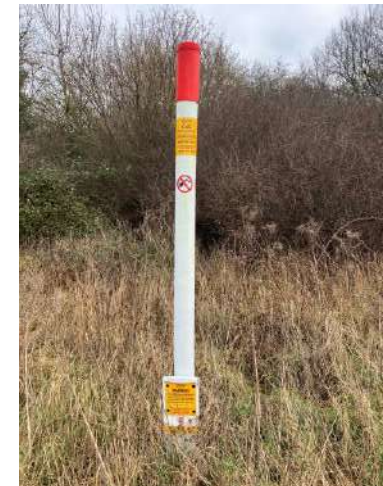
**Image 6:** High pressure gas main marker along northeastern boundary

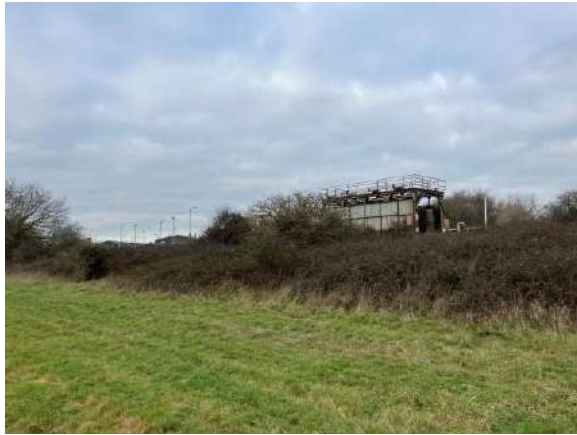
An above ground storage tank was noted off-site adjacent to the central northern area of the site.

**Image 7:** View along northern boundary, off-site tank

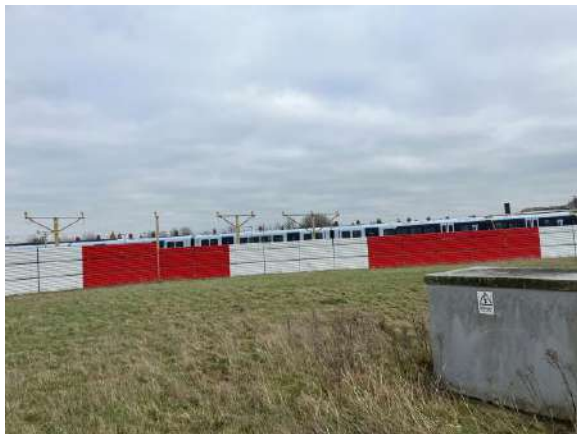
**Image 10:** Blast barriers in north

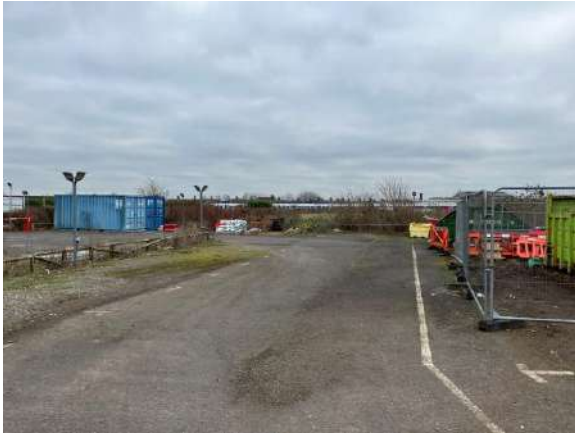
**Image 13:** Material storage in disused car parking

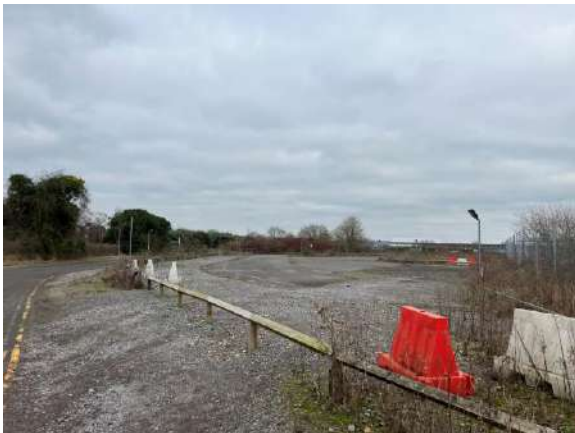
**Image 16:**Gravel disused car parking
