# Stroudwood Farmhouse

Listed Building application

Urgent Roof Repair Works

## Supporting Statement

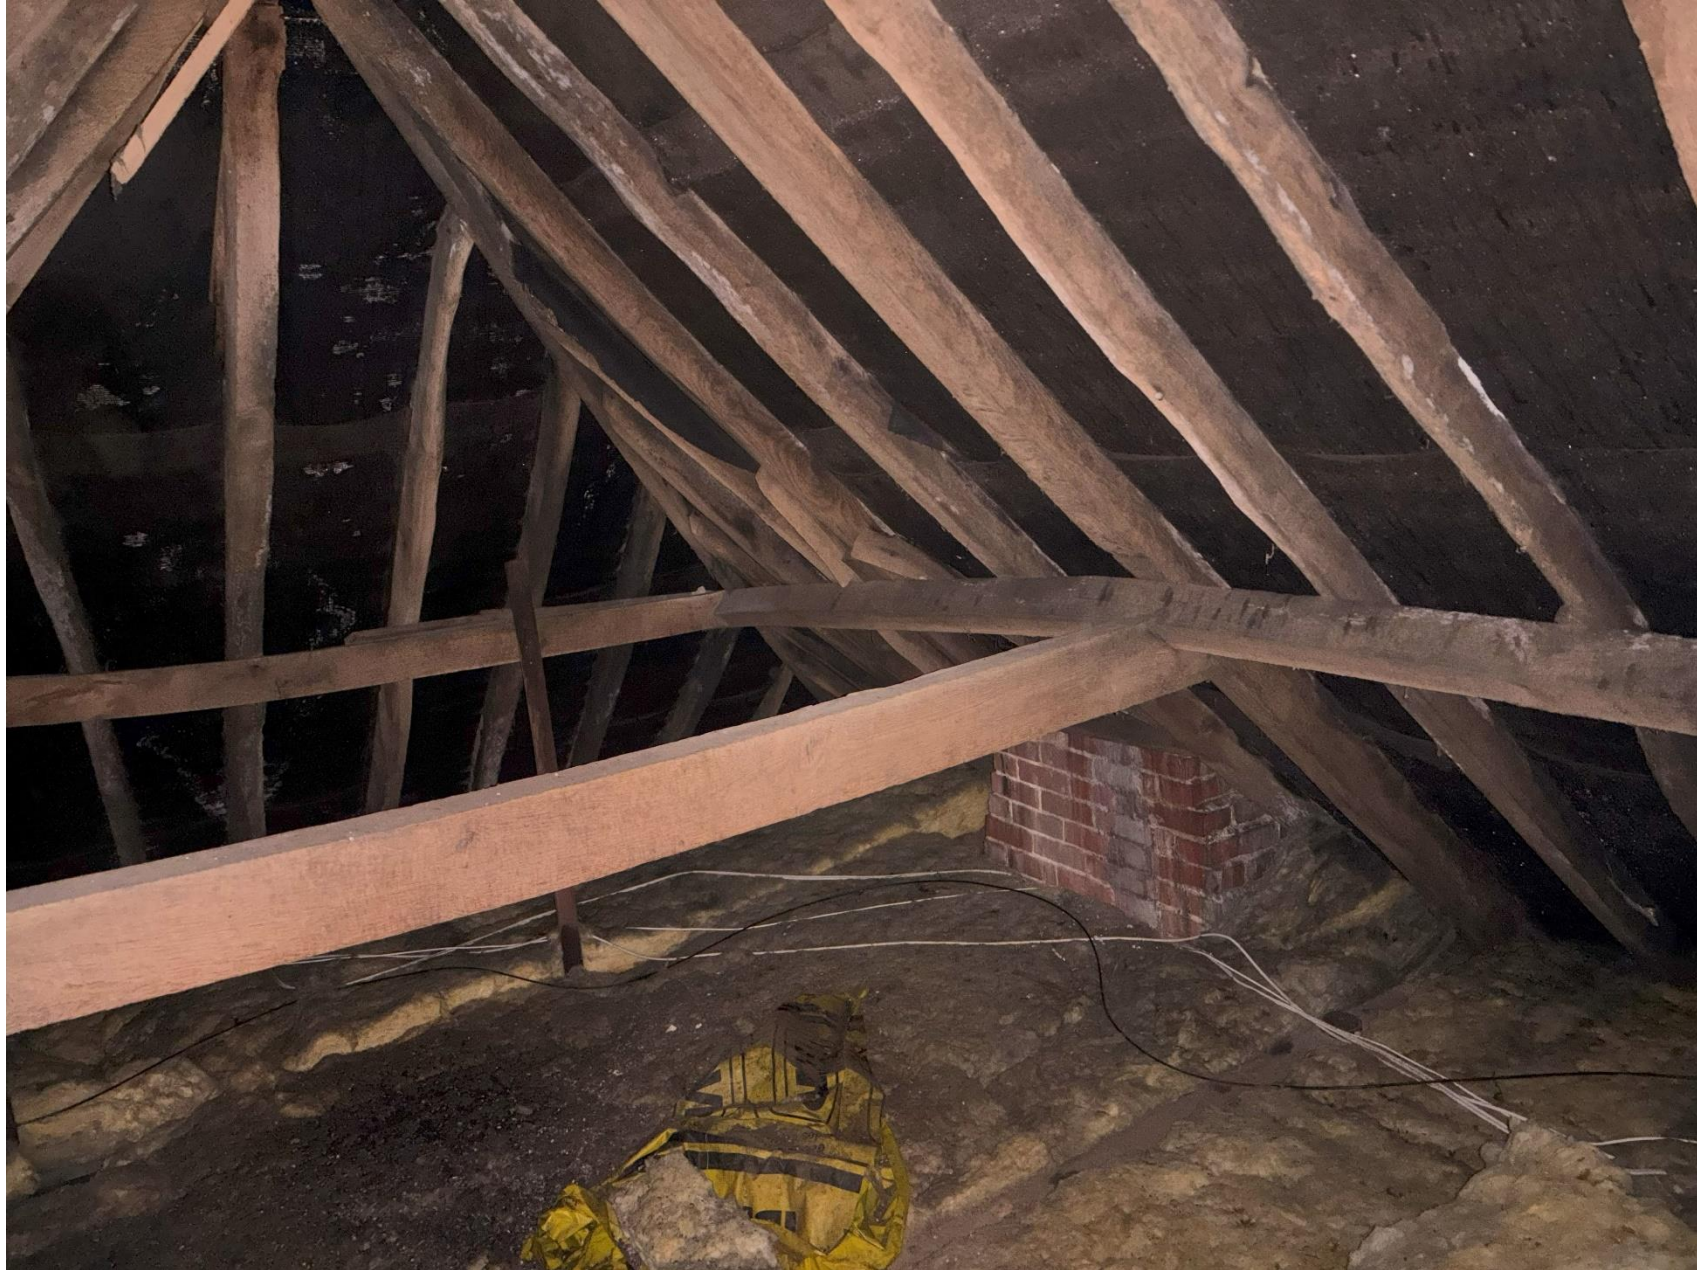
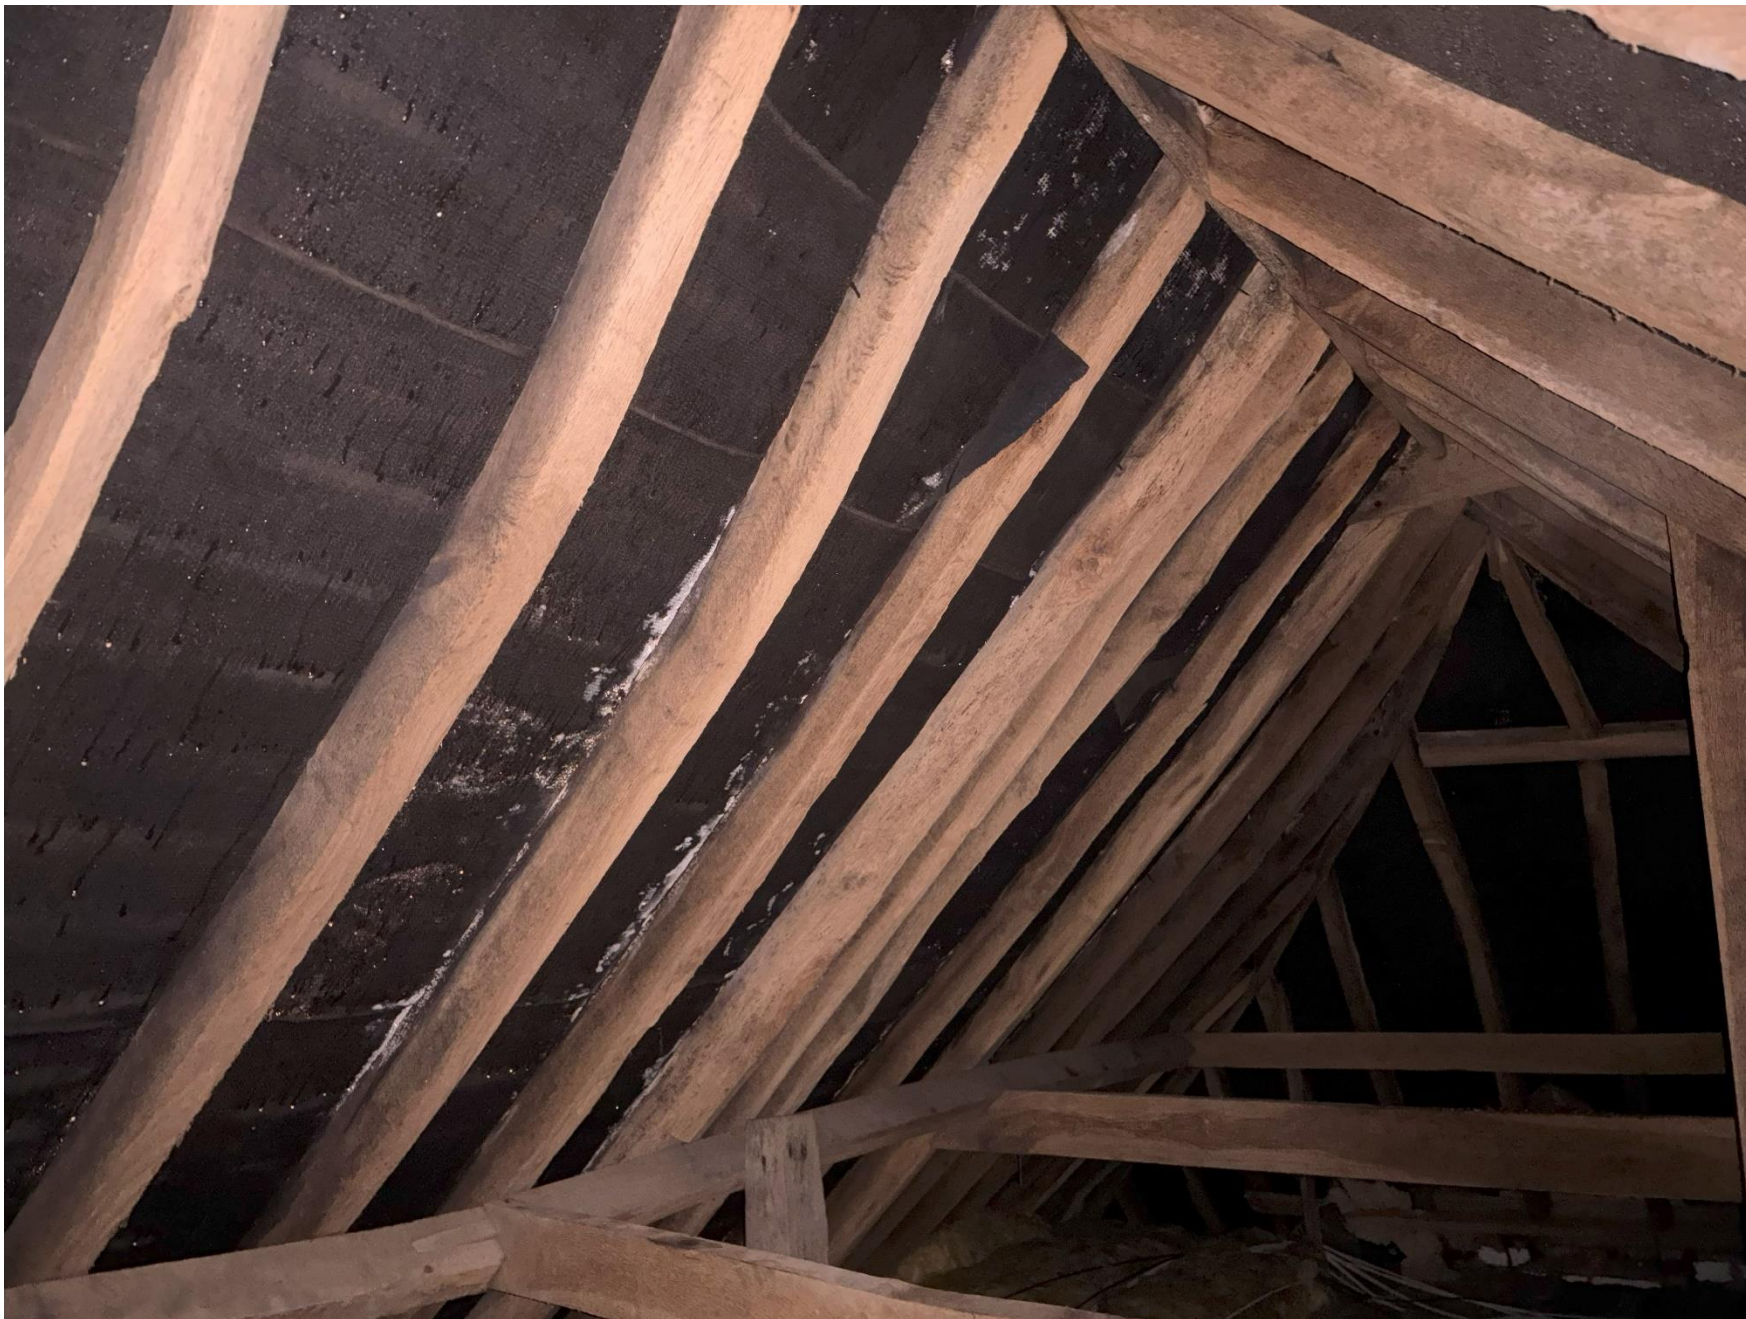
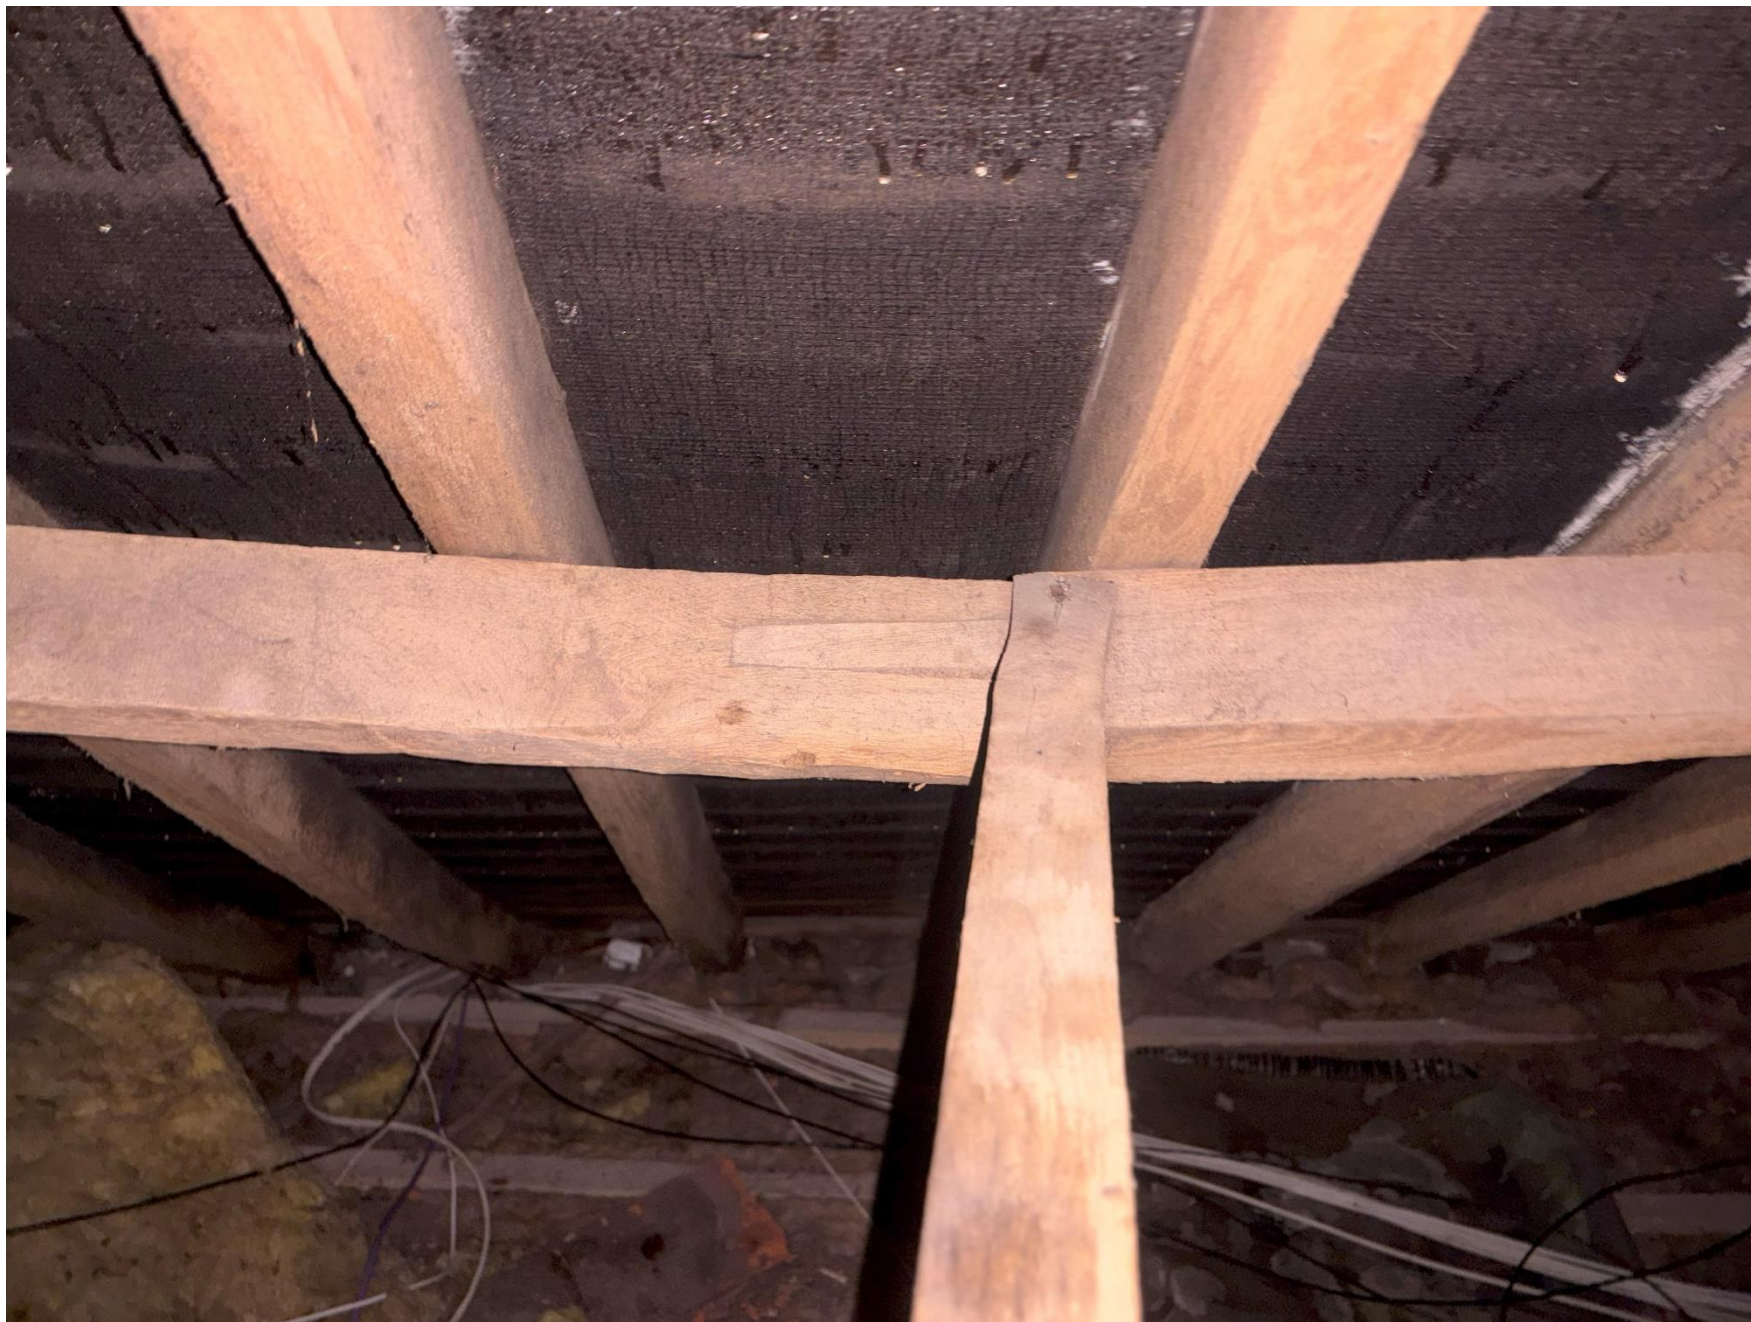
## APPENDIX 1 - Photographs

- Plaster had completely cracked with the edges separating to expose lath underneath. Ceiling bowing was easily visible with distortion measured as much as 100mm;

- The loft was poorly insulated with a single layer of 100mm quilt which was drawn back in places to expose the ceiling surface;
- Extensive evidence of damp was seen, in the form of water staining on the underside of felt and on timbers. Water condensation had formed in many places on both the felt and timber;

- Timbers showed extensive deterioration – rot and mould present, with many timbers extremely soft;
- Some joints were seen to have pulled apart or be pulling apart;

- Other timbers showed very significant deflection;
- Cracking and bowing in the ceilings below occurs at the location(s) of central cross-beams at ceiling level which appear to carry ceiling joists at mid-span;

- Piles of droppings were observed indicating that Bats were, or had been, present within the roof void;
- The owners observed that cracking in bedroom ceilings worsened significantly following a recent storm.

*The structural issues observed at Stroudwood Farm are predominantly linked to inadequate roof ventilation, timber deterioration due to prolonged exposure to moisture, and an unsuitable roof support arrangement.*

**In the current roof build up and structural arrangement, AWA would deem it as unsafe and require immediate remedial works.**

- Remove all tiles and set aside;
- Remove tile battens;
- Remove the existing bituminous felt;
- Remove existing mineral wool loft insulation;
- New wall plates to be installed across external and internal walls for new timbers to bear onto;
- Install 2 nr. new rough cut oak beam on new padstones at ceiling levels;
- New 100 x 50mm D30 oak struts to support purlins bracing onto new oak beams;
- Existing purlins strengthened with steel plates;
- Damaged ceiling joists to be replaced with 100 x 50mm D30 oak joists;
- New 100 x 50mm D30 oak ceiling joists to be installed at 300mm centres in addition to existing;
- Damaged rafters to be replaced with 100 x 50mm D30 oak joists;
- New 100 x 50mm D30 oak rafters to be installed at 300mm centres in addition to existing;
- Restraint straps to be installed.

- Replace bituminous felt over the roof structure, **maintaining adequate ventilation at ridge and eaves;**
- Apply battens over the bituminous felt;
- Re-fix the roof tiles that were removed;
- Loft to be re-insulated, maintaining ventilation paths at eaves and ridge.
