## **Arboricultural Impact and Mitigation**

### **Statement for Outline Development Proposals at:**

Birchwood Gardens  
Hedge End  
Southampton  
SO30 2AR

**Report Ref:** WT 069-24 AIA

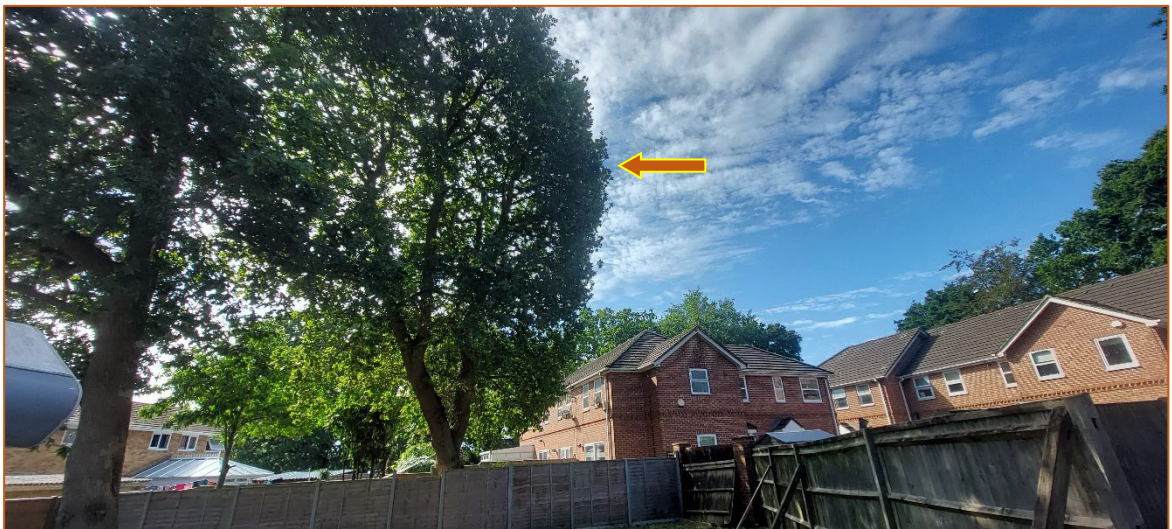
4.2 **Tree pruning to facilitate access/working space or future amenity space:** The closest trees (T002 and T003) have been reduced in the recent past (Image 4), so at this stage no pruning requirements are anticipated to accommodate these proposals. If this changes for any reason, I advise that these matters are considered at an early stage and agreed with the LPA prior to the work commencing. If it is decided that some pruning is required to facilitate the proposal, this should be done in accordance with BS3998: 2010 '*Tree Work Recommendations*', without harming the health or appearance of nearby trees.

**Image 4:** Trees T002 and T003 have been reduced in the past so their canopies have been contained around the edges of the site

- **Adequate space for the proposed dwelling:** It appears that consent has been given in the past to reduce trees T002 and T003 (Image 4), so the principle of some crown management has already been accepted by the LPA. On this basis, it is reasonable to assume that any potential future pruning management would be acceptable provided it in accordance with BS3998: 2010 '*Tree Work Recommendations*'. In this context, the trees are healthy so this could be easily done on a regular basis without adversely affecting their health or appearance.

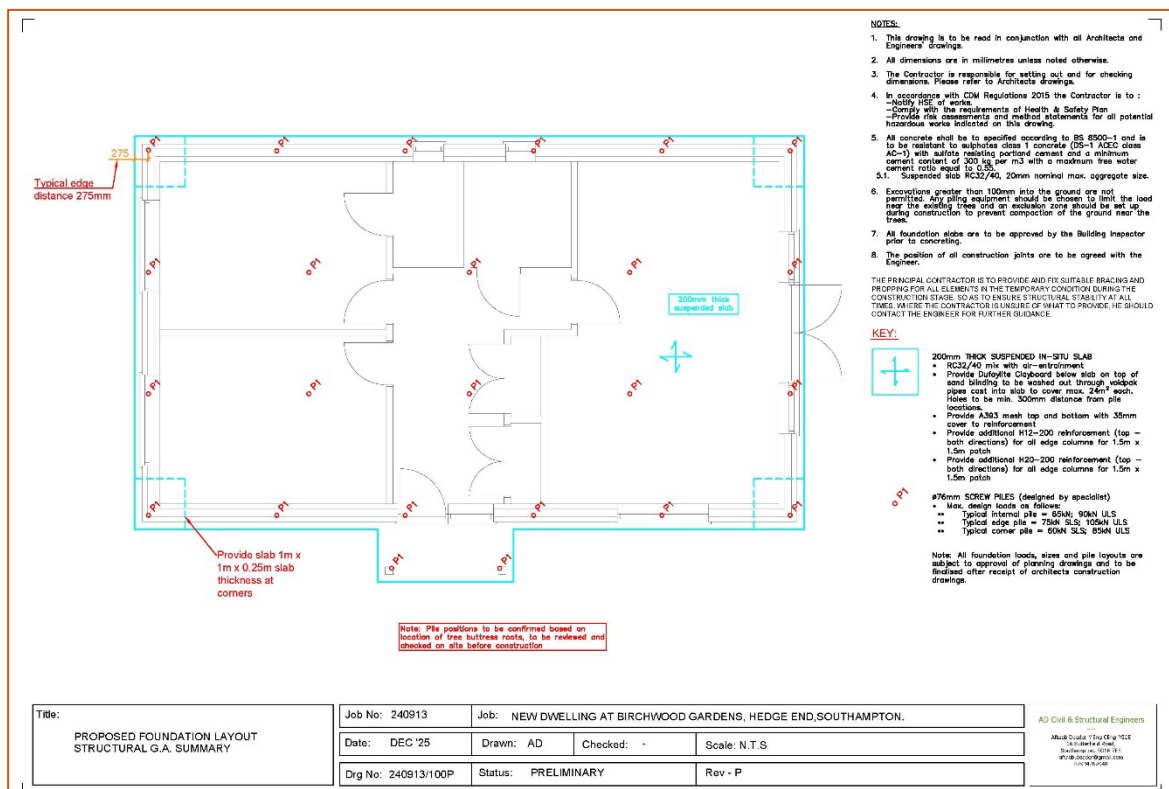
- 4.5 **Proposed new dwelling:** The footprint of the proposed new dwelling encroaches into the root protection areas of the adjacent oaks (T002 and T003). However, less than 20% of their overall RPAs is likely to be affected so, if the works are done with care, the structure can be installed using a low impact foundation design (as supported by BS5837:2012 - clause 7.5.3) to minimise harm. In this case, it is proposed to use a mini pile system such as the one proposed by the project structural engineer (AD Civil and Structural Engineers) in Image 5 below and illustrated (to a readable scale) on the tree protection plan WTP1. The use of this type of suspended slab formation minimises excavation using small diameter mini piles (as opposed to excavation for normal strip or trench fill foundations). To further avoid physical damage to roots it is proposed to undertake any ground preparation works in the RPAs by following BS5837:2012 recommendations (hand digging clauses 7.2.1- 7.2.4). Installation of the piles will need to be carried out using specialist equipment (for instance a shallow piling rig with a remote power unit which has less weight on the ground at the point of piling) and/or working from a platform/piling mat protecting the ground to minimise impact on the RPAs.

**Image 5:** The proposed foundation layout provided by the project structural engineer (AD Civil and Structural Engineers)

- 4.6 An air gap beneath the suspended structure will be required to allow for exchange of air to the soil with a suitable rainfall capture system. The flow of rainwater and the routing of the rainfall under the proposed structure will need to maintain the free flow of air and water, to feed the roots. In summary, the suspended slab must include:
