## **Tree Survey & Arboricultural Impact Assessment**

**16 Keble Road, Chandlers Ford**

**August 2019**

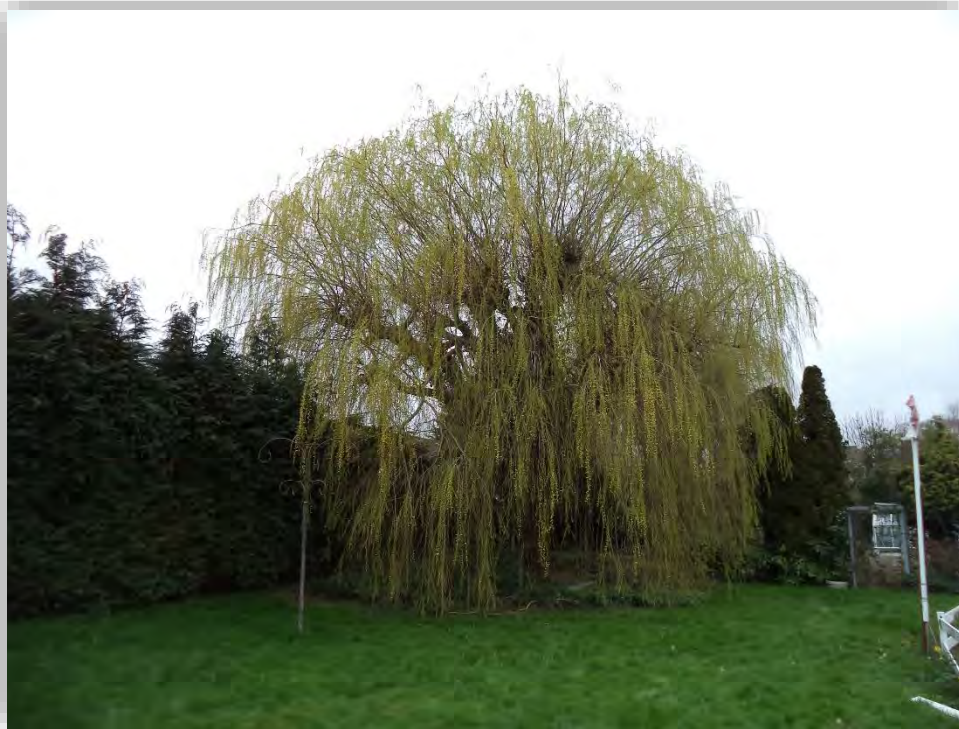
| Tree No. | Species | Height (m) | Stem Diameter (mm) | Average Crown Spread NESW (m) | Existing Branches | Life Stage | Observations Recommendations Management | Contribution in years | Category | RPA radius (m) |
|---|---|---|---|---|---|---|---|---|---|---|
| <b>T3</b> | Willow | 13.0 | 700 | 9.0 | 3.0 | Mature | Previously pollarded, Ivy covered stem – recently cleared to 2m, stem sub divides at 3 and 4m<br><b>Re-pollard up to 50cm below previous pruning points</b> | 20+ | B1 | 8.4 |

Photo 1 (above): The Willow (T3) situated centrally within the site

The proposed development will require the repollarding of T3 and T4. Repollarding will reduce the size of these trees, so they can be safely retained, adjacent to the newly proposed dwellings (unit 1 and 2) without being over-bearing or creating too much shade. It is worth noting that some of the existing pollard points are in poor condition, and if left untouched the trees are likely to start shedding limbs. For this reason, trees that have been pollarded, need to be re-pollarded on a regular cycle, generally 3 or 5 years. If the regrowth is left longer large pruning wounds result, which will not occlude, and cavities form at the pollard point, which creates a structural weakness. This has already occurred on both trees, so the recommendation is to cut each back up to 50 cm beyond the existing pollard points, to start the process again.

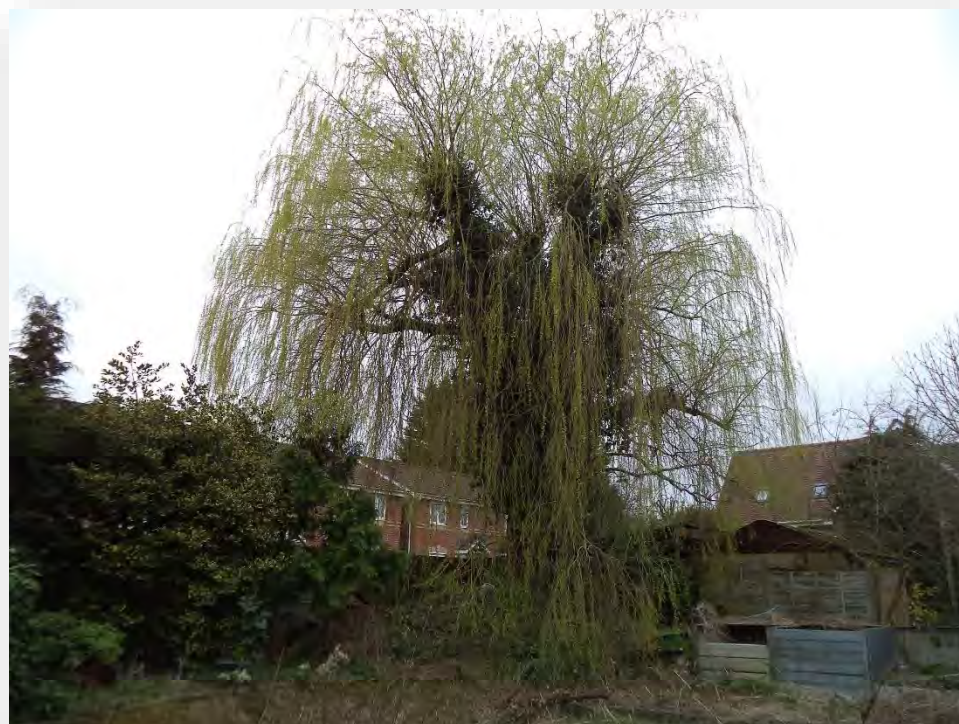
| Tree No. | Species | Height (m) | Stem Diameter (mm) | Average Crown Spread NESW (m) | Existing Branches | Life Stage | Observations Recommendations Management | Contribution in years | Category | RPA radius (m) |
|---|---|---|---|---|---|---|---|---|---|---|
| <b>T4</b> | Willow | 14.0 | 800 | 8.0 | 3.0 | Mature | Previously pollarded, Ivy covered stem – recently cleared to 2m, stem sub divides at 2 and 3m, causing damage to adjacent wall<br><b>Re-pollard up to 50cm below previous pruning points</b> | 20+ | B1 | 9.6 |

Photo 2: The Willow (T4) located in south western corner

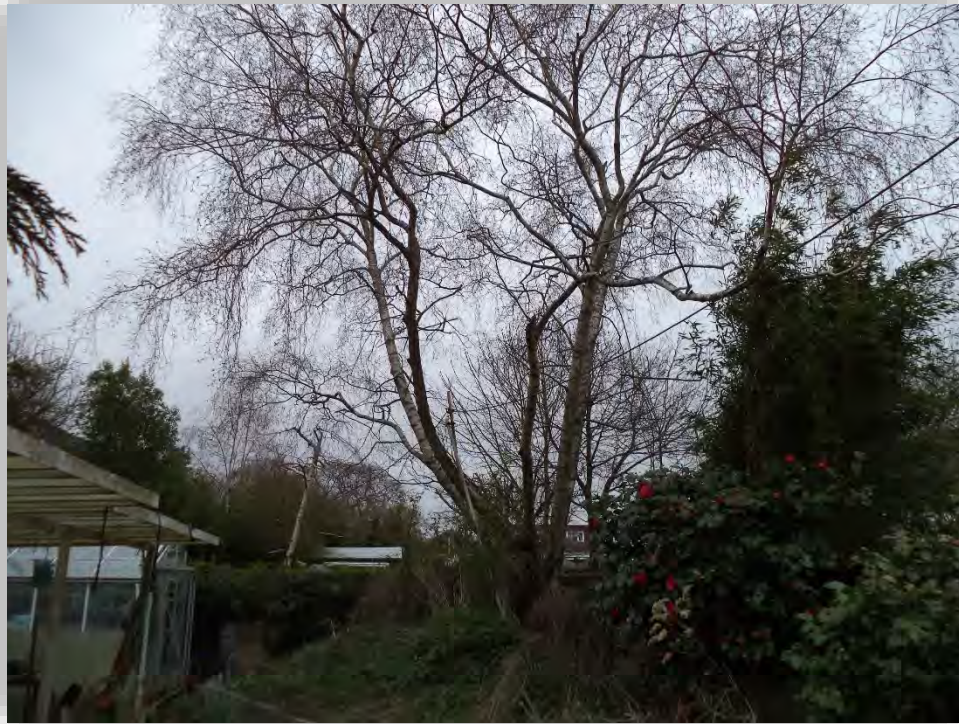
| Tree No. | Species | Height (m) | Stem Diameter (mm) | Average Crown Spread NESW (m) | Existing Branches | Life Stage | Observations Recommendations Management | Contribution in years | Category | RPA radius (m) |
|---|---|---|---|---|---|---|---|---|---|---|
| <b>T5</b> | Birch | 11.0 | 650 | 9.0 | 3.0 | Middle | Off-site tree, poor form, sub divides into 3 stems at 2m<br><b>Crown raise overhanging branches to 5m to facilitate construction of garage</b> | 20+ | C1 | 7.8 |

Photo 3 (above): Poor quality Birch tree in neighbours garden (T5)

The overhanging branches of T5 will need to be crown raised to a height of approximately 5 metres to facilitate the construction of the garage associated with unit 1.

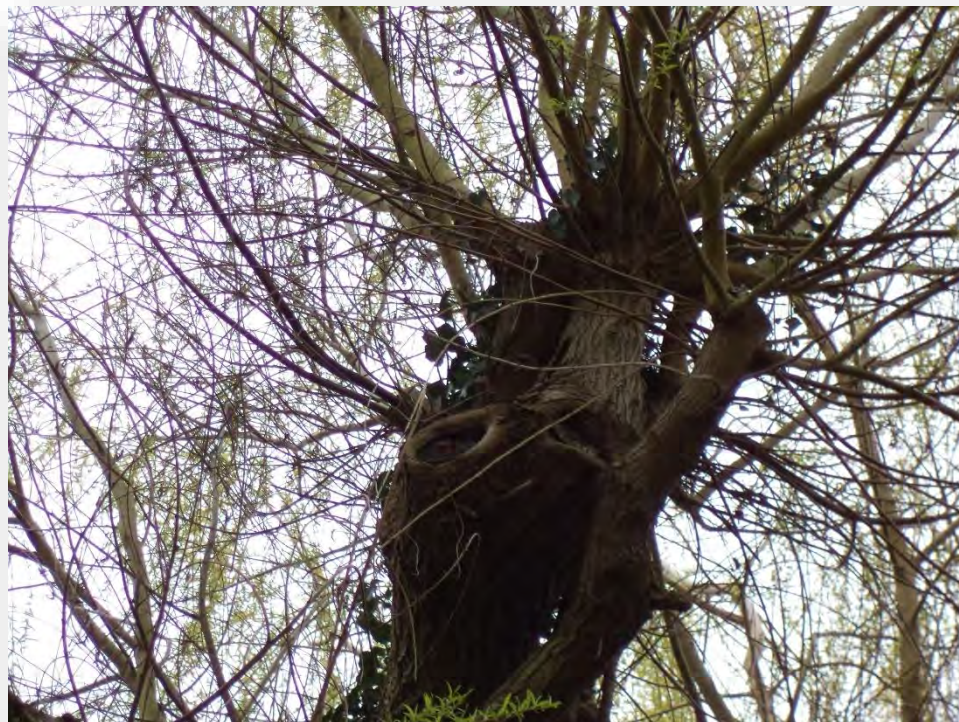
Photo 4: An example of old pruning wounds and pollard point on Willow (T3)
