**HORTON HEATH**

**FLOOD RISK ASSESSMENT AND WATER  
MANAGEMENT STRATEGY**

**FLOOD RISK ASSESSMENT AND WATER MANAGEMENT STRATEGY  
ON BEHALF OF EASTLEIGH BOROUGH COUNCIL**

December 2020

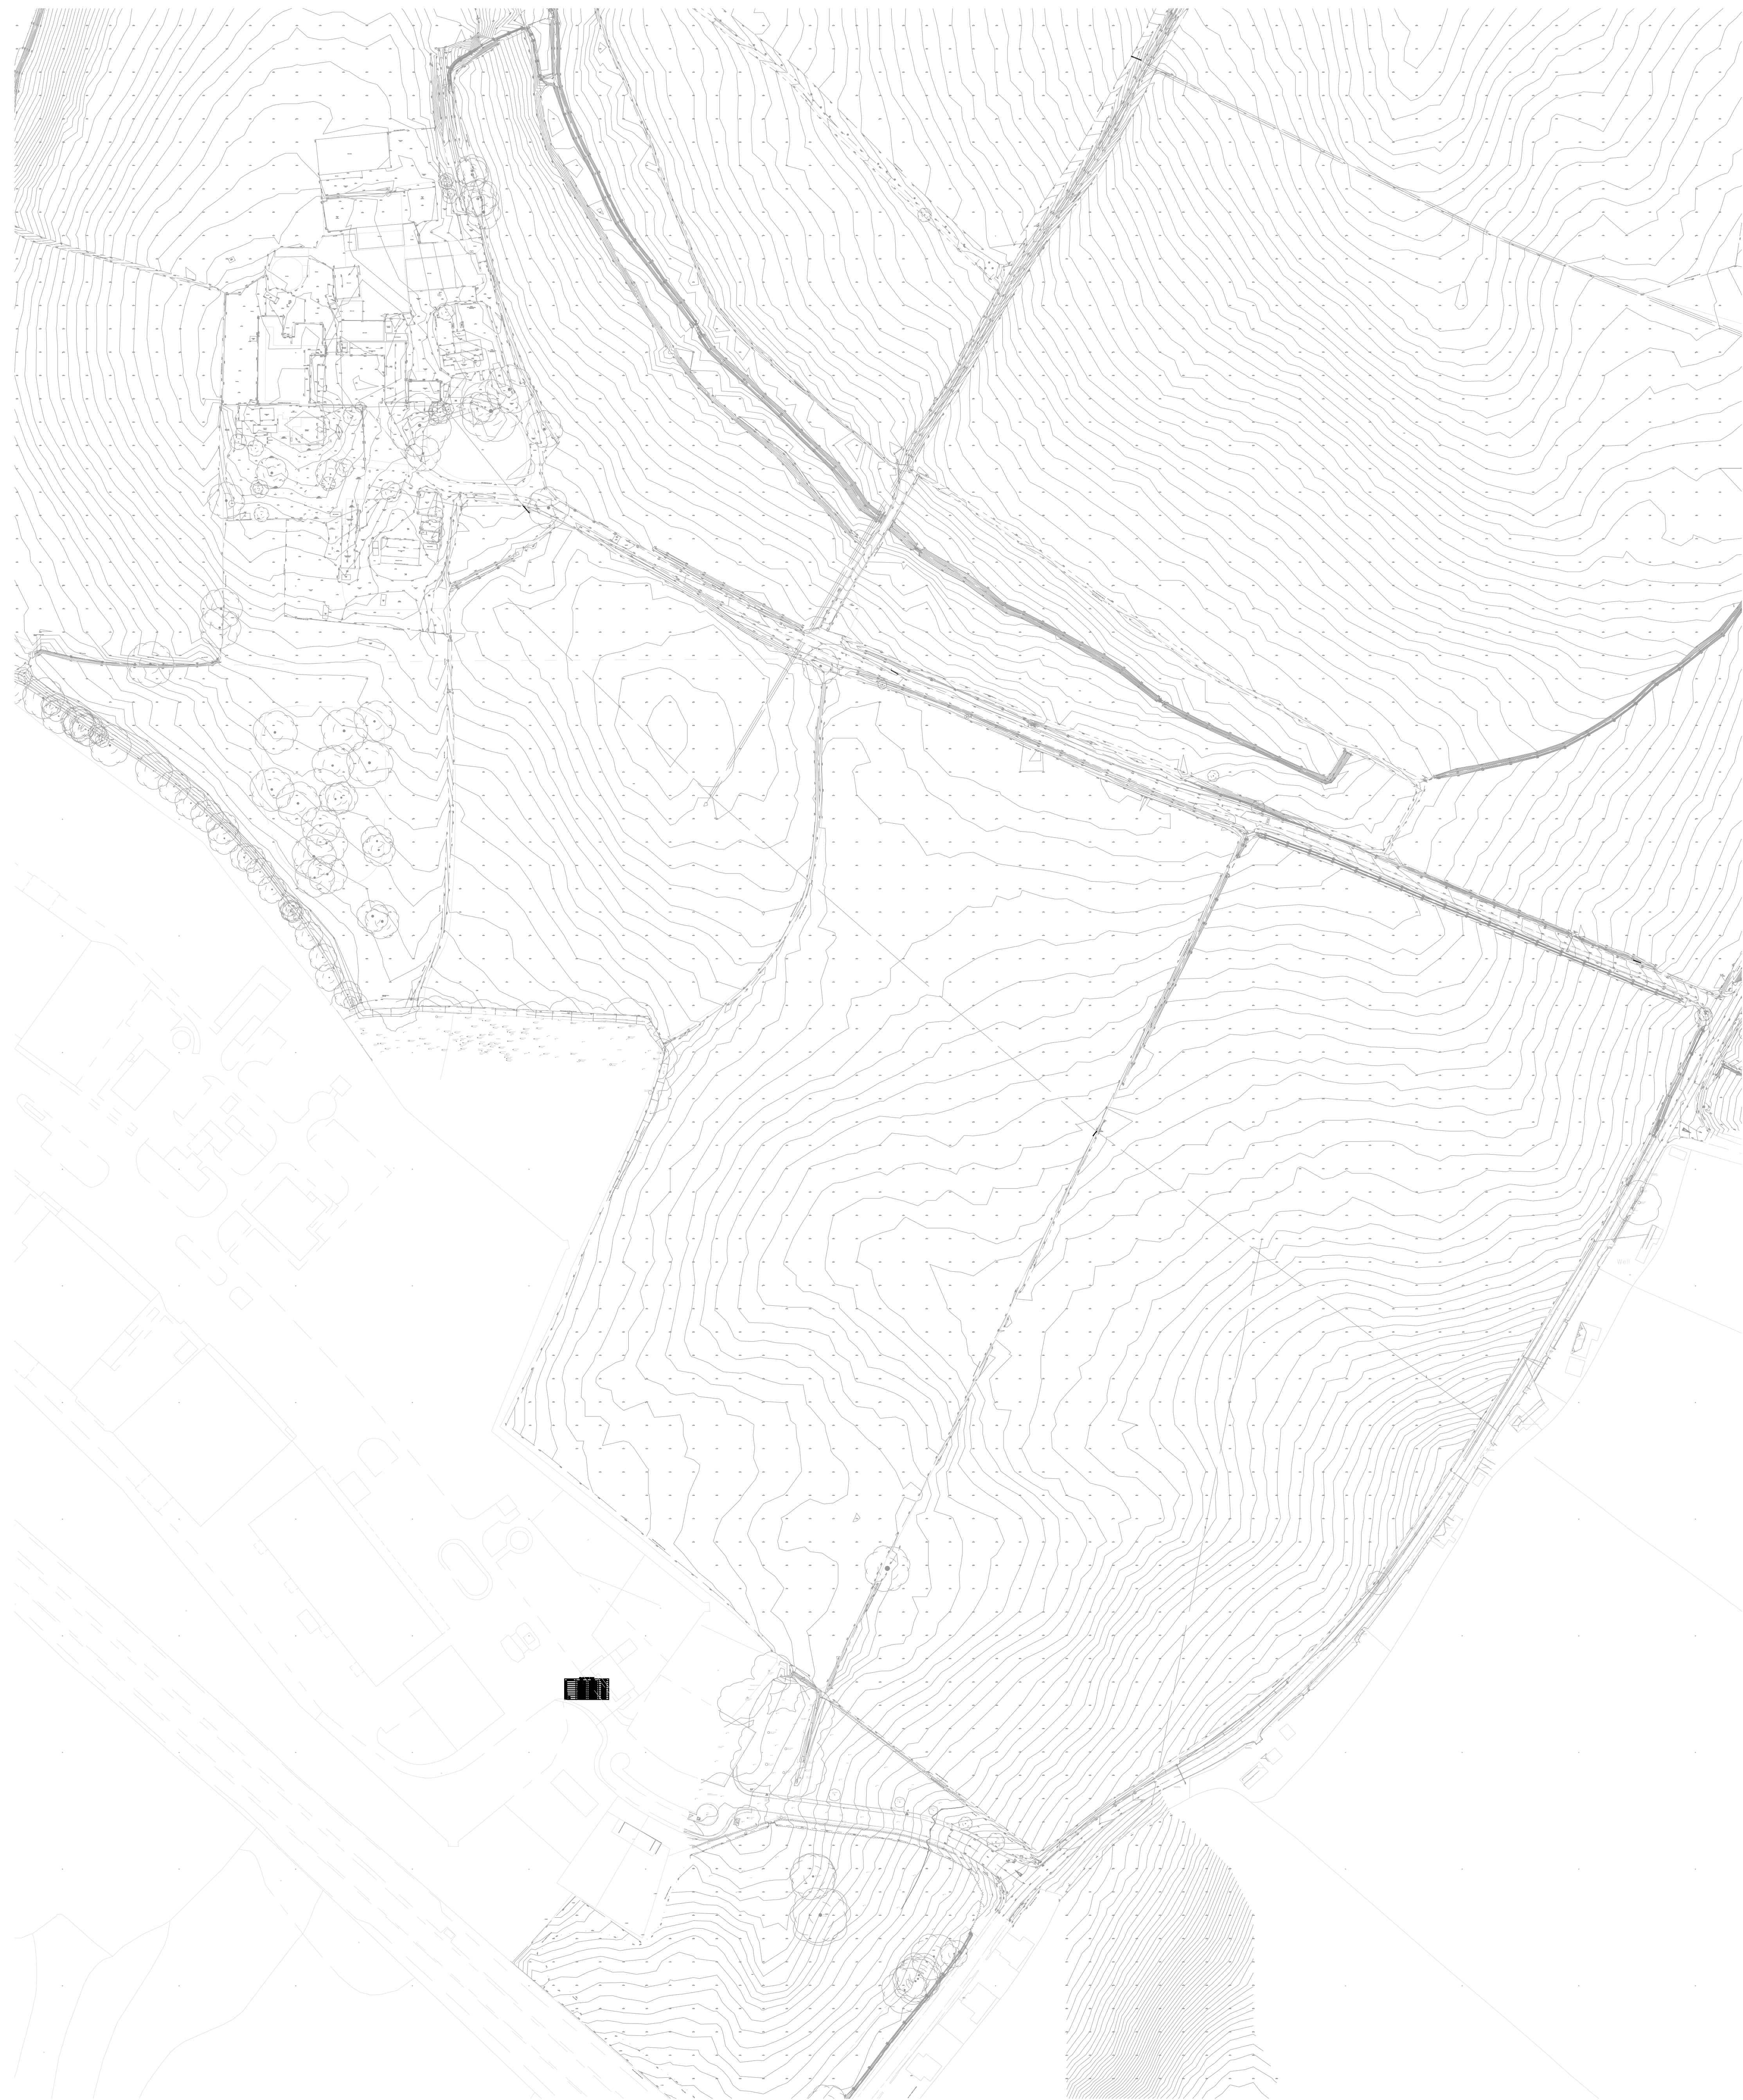
### **Topographical Survey**

2.2.1 A topographical survey of the site was undertaken by Reuby and Stagg in May 2019. Levels generally fall from the southeast towards north and west of the site, and range from approximately 29.66m Above Ordnance Datum (AOD) in the southeast to approximately 19.8m AOD in the north. The topographical survey is presented in **Appendix C**.

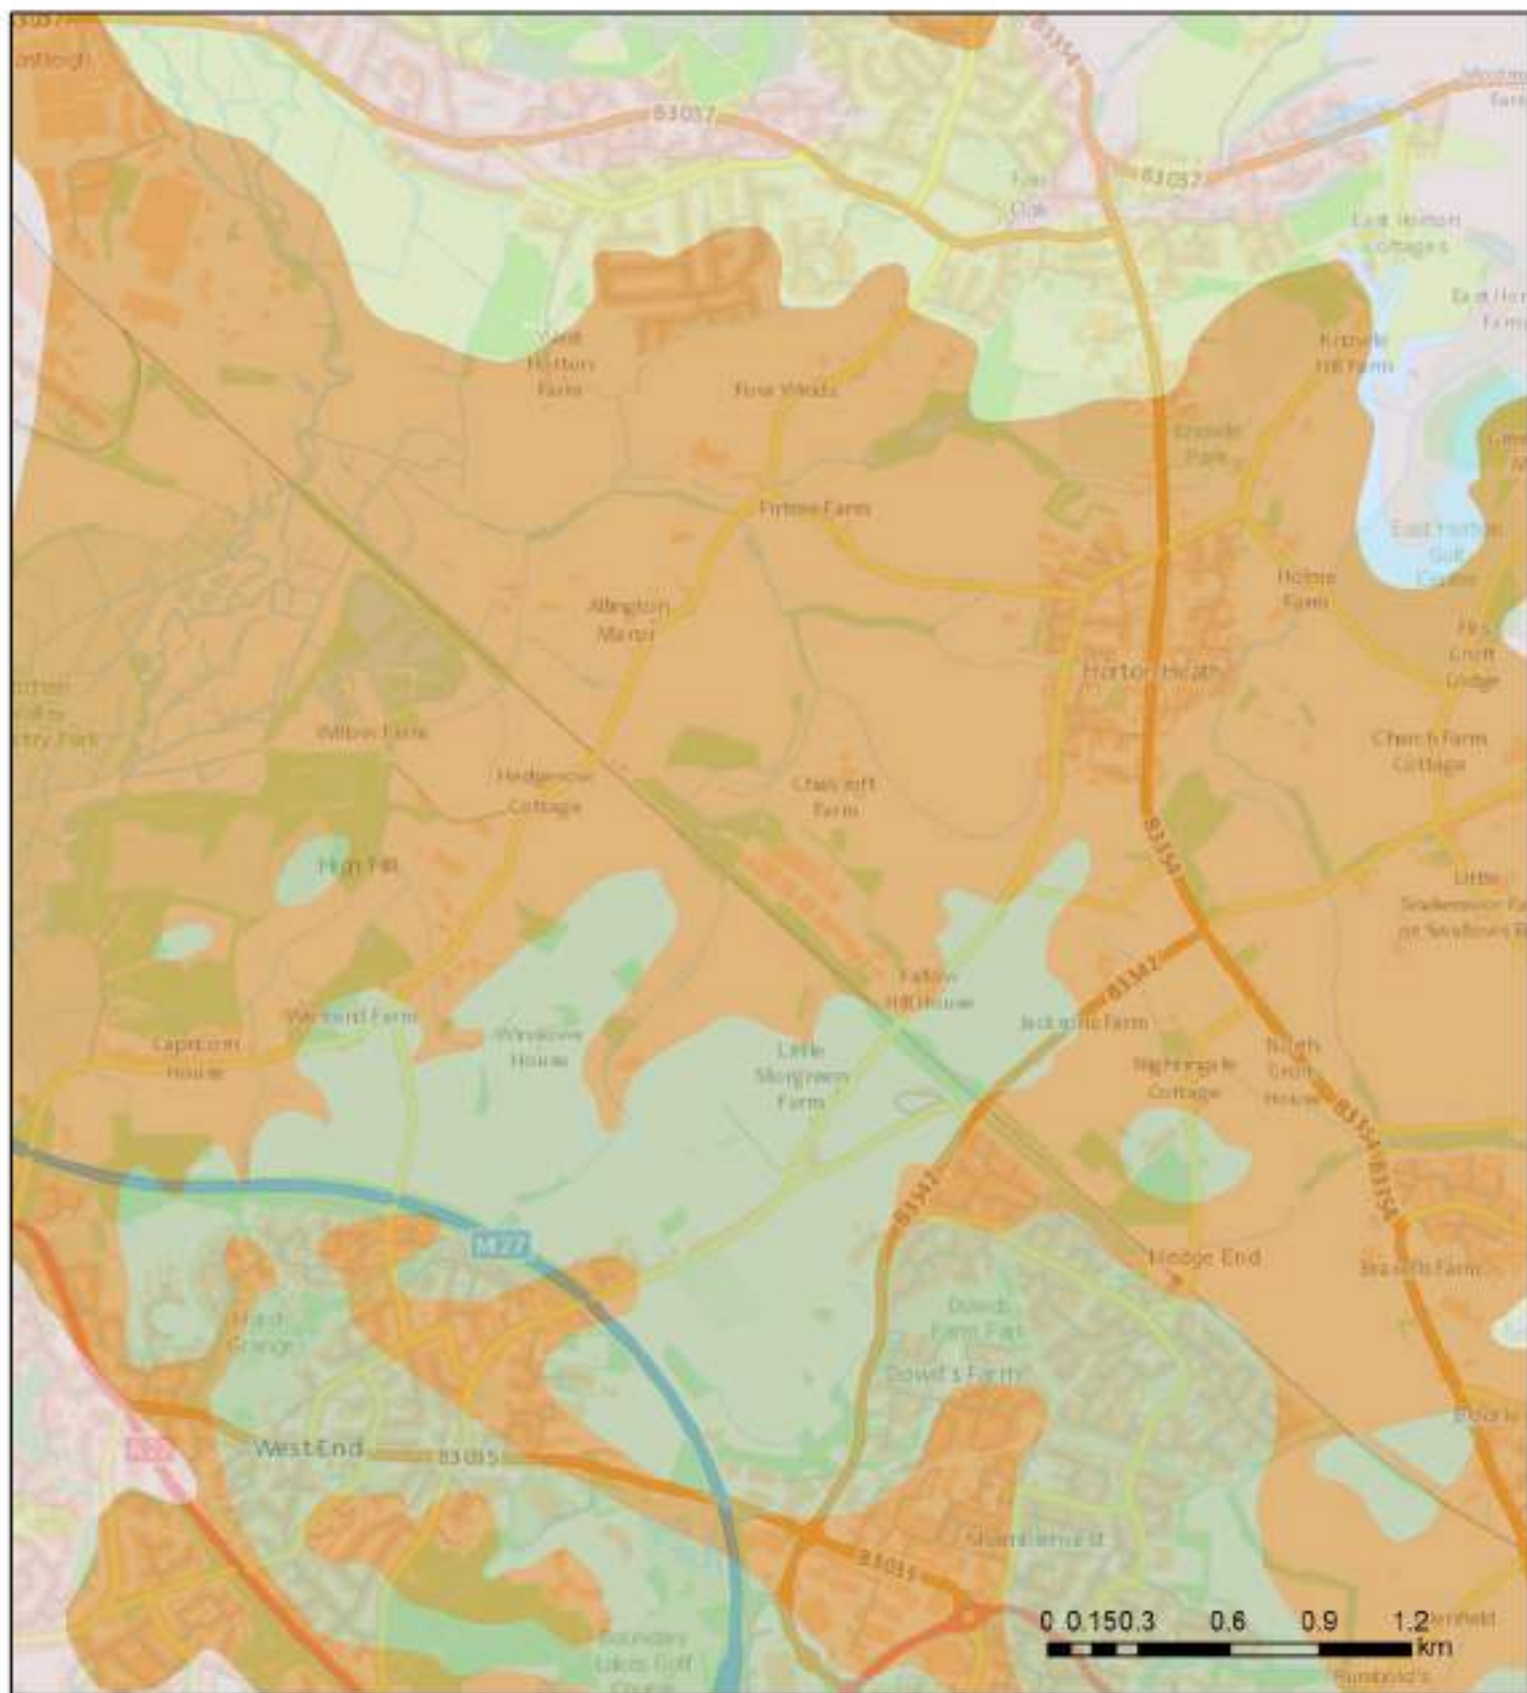
## Bedrock Geology

2.3.1 British Geological Survey (BGS) online maps (accessed July 2020) indicate that the bedrock geology of the majority of the site comprises Wittering Formation (sand, silt and clay). There is a smaller area to the east of the site which comprises Earnley Sand Formation (sand, silt and clay). The maps show the presence of superficial deposits comprising Alluvium (clay, silt, sand and gravel) associated with the watercourse to the north of the site. BGS mapping is shown in **Appendix D**.

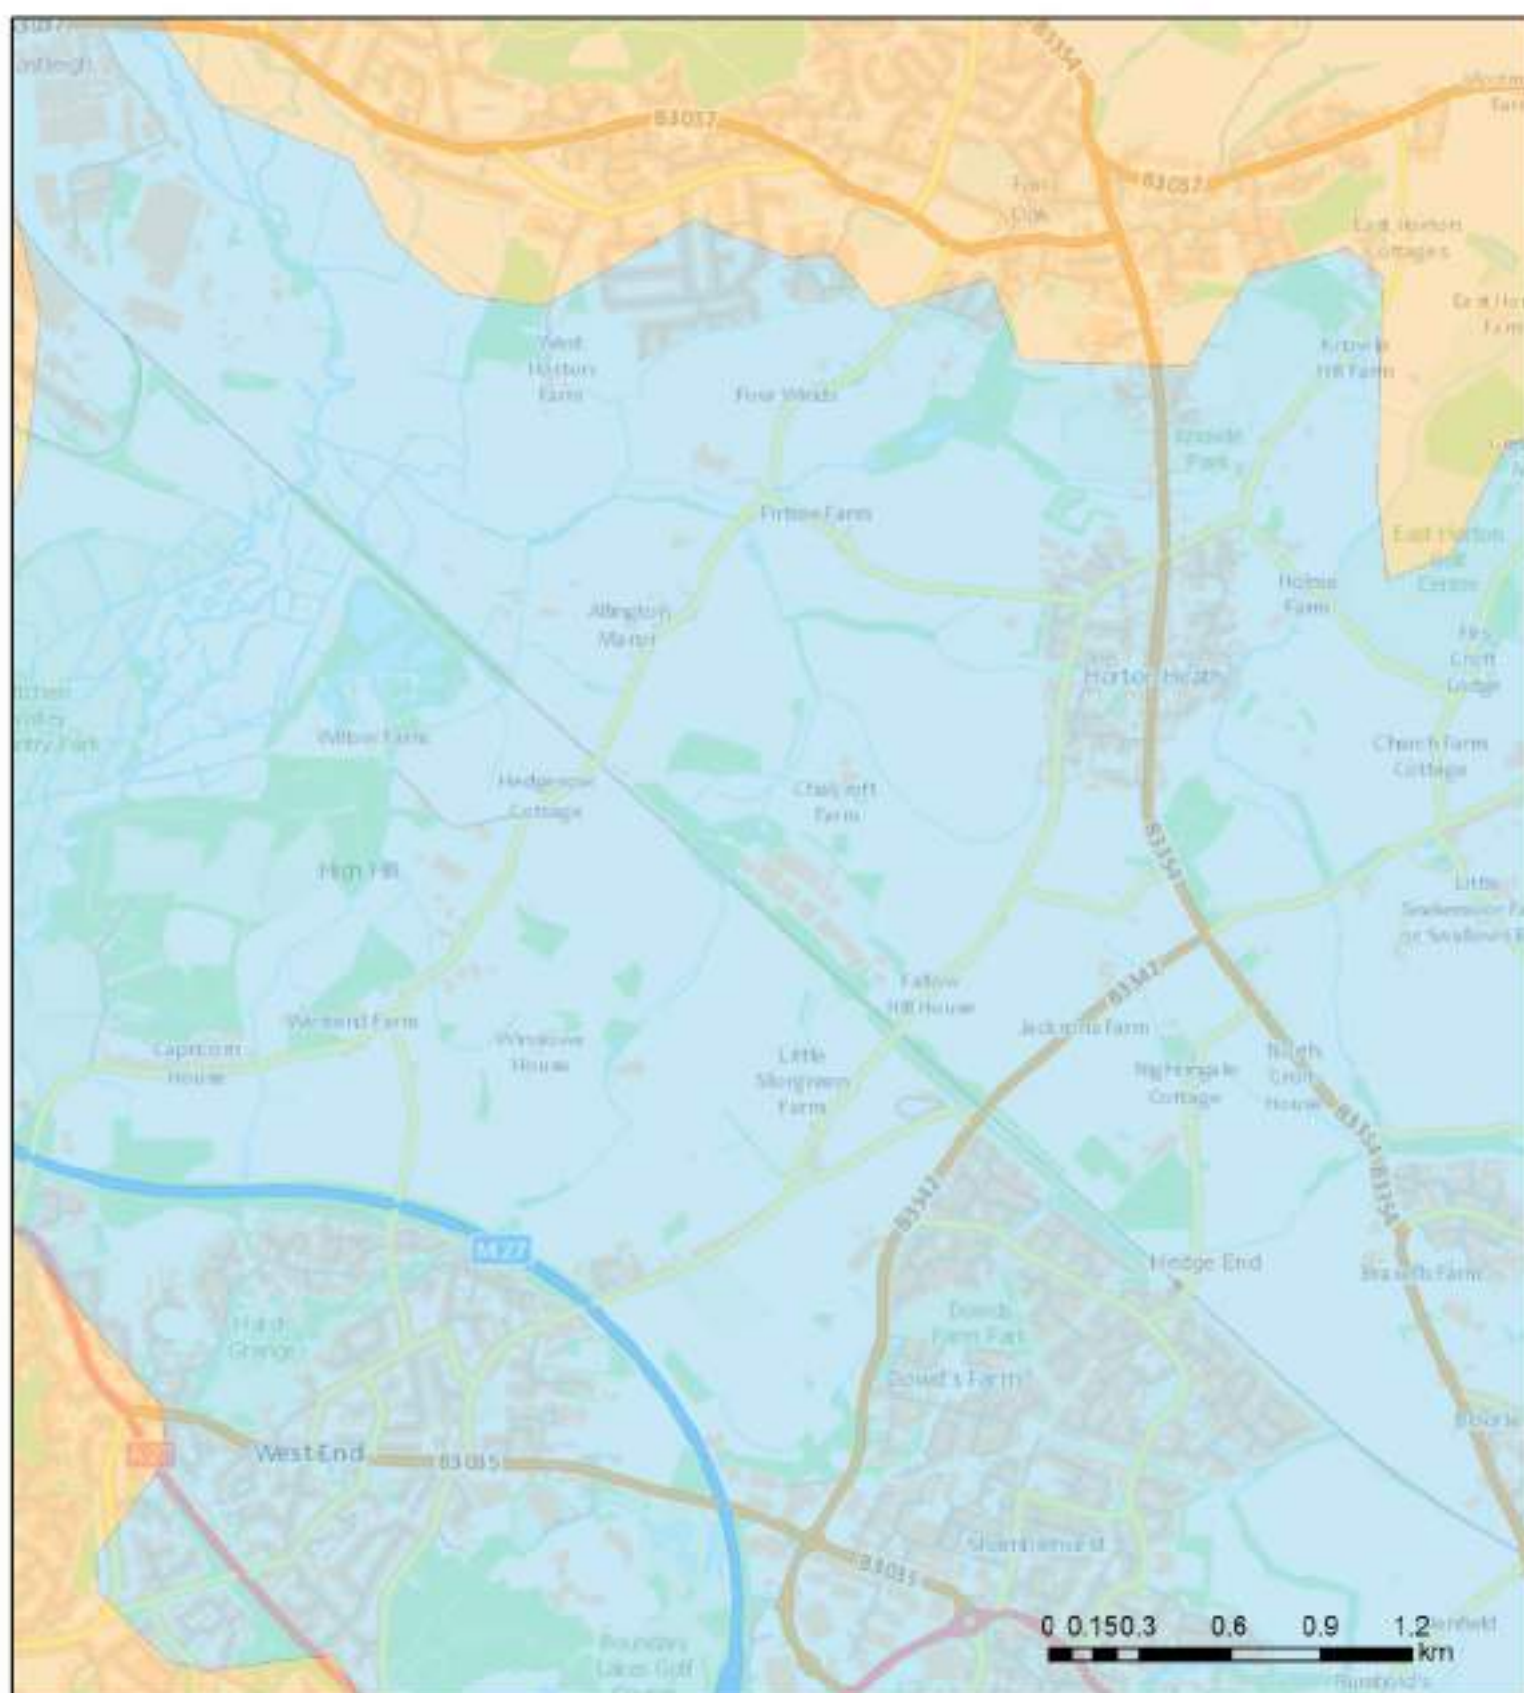
# Hydrogeology

2.3.4 BGS hydrogeology mapping shows that the site is located within the Bracklesham Group and Barton Group, described as a moderately productive aquifer.
