Our ref: GE18741/KOD01/200204

**RE: Boorley B6 Desiccation Assessment – Desiccation Report**

Project Title: Boorley B6 Linden - Desiccation  
Assessment  
Location : Winchester Road, Southampton  
Project No. : GE18741  
Client : Linden Homes South

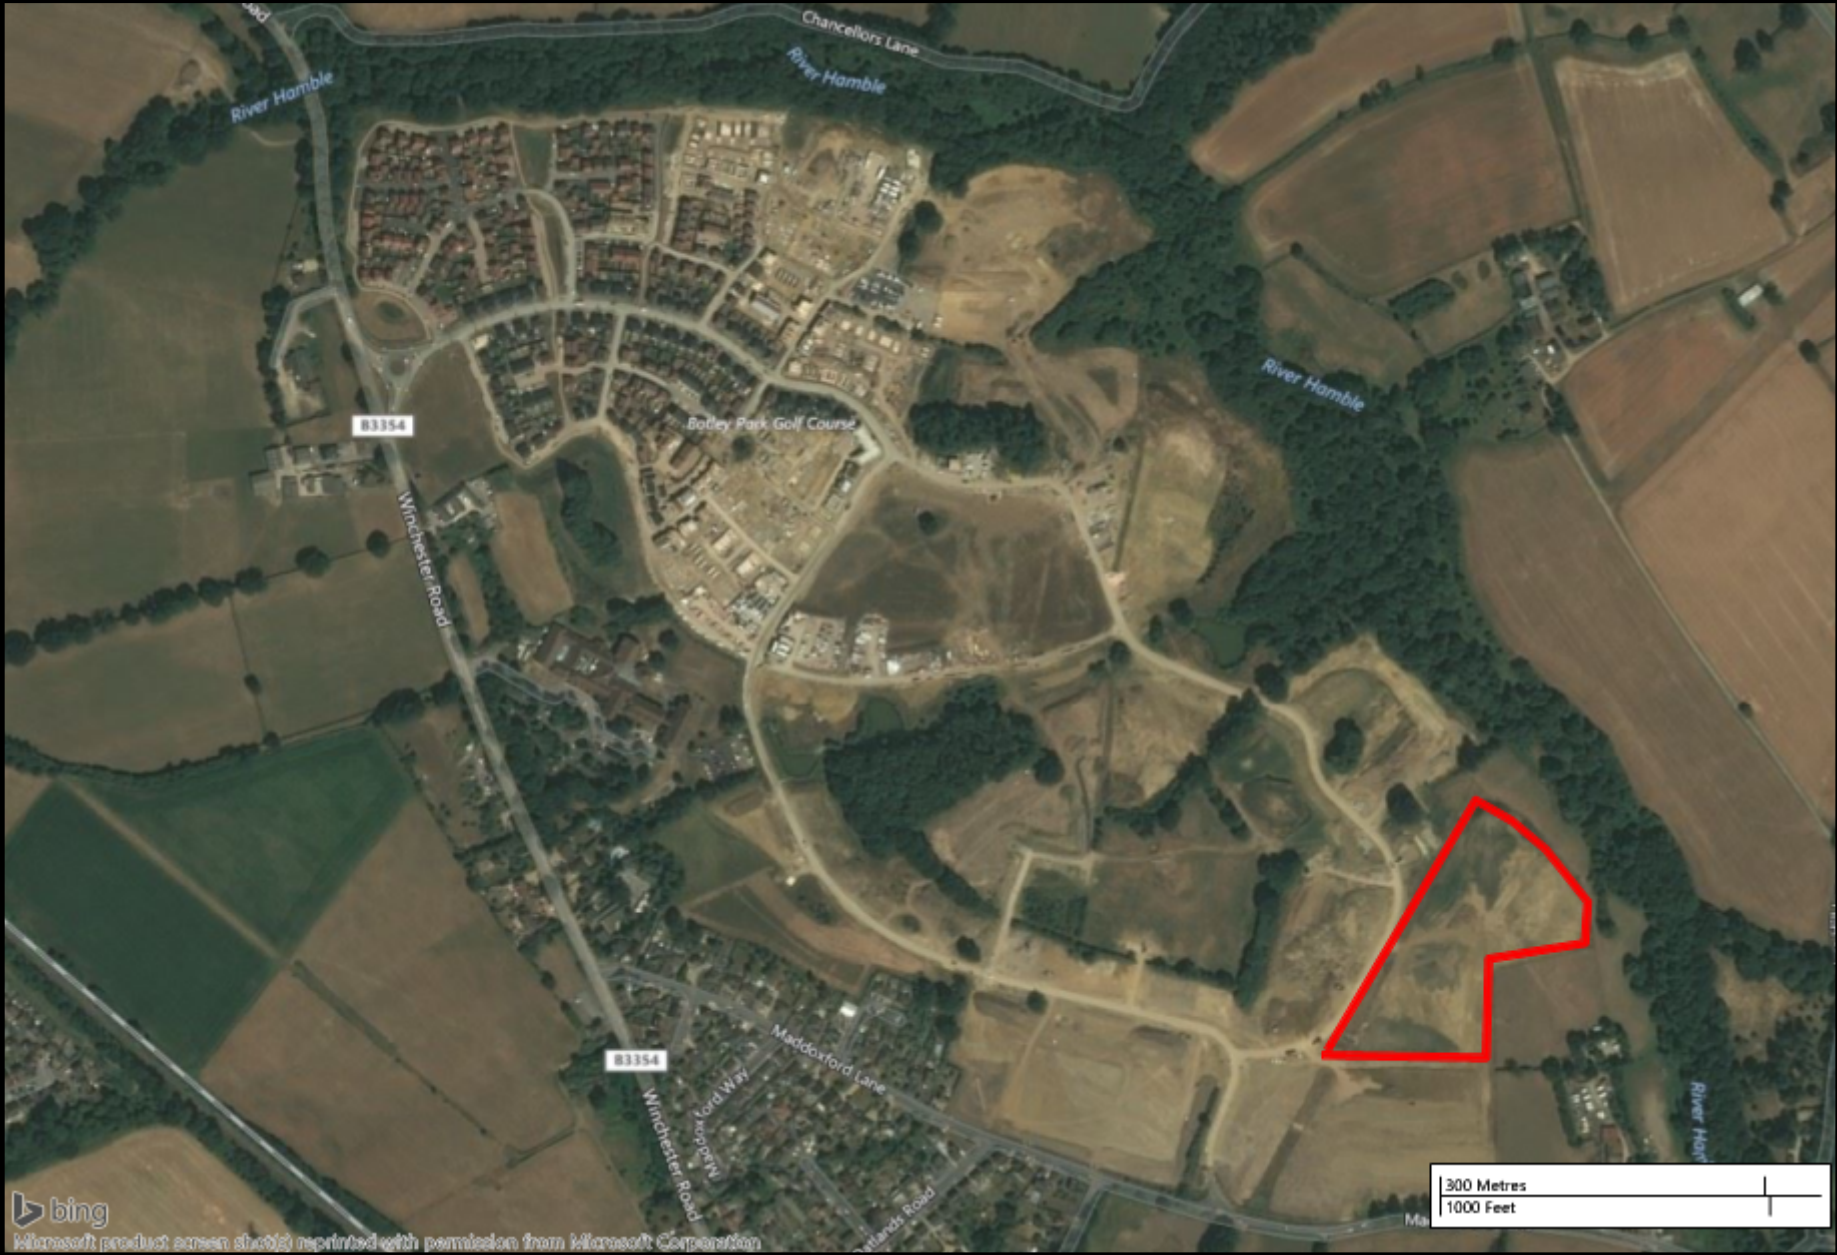
Title : Figure 2 - Exploratory Hole Location Plan  
Scale: 1:800  
Engineer: GR

Figure 2 presented the locations of the exploratory holes constructed between the 6<sup>th</sup> and 7<sup>th</sup> January 2020.

The numbering on the trial pits was not sequential due to works on site being targeted to provide a coverage of the area within the investigation timescales allowed. As such the following boreholes were constructed: WS1-WS8, WS10 and WS13-WS14.
