# Technical Note

**Site:** Boorley Green Phase B5

**Ref:** GE18071

**Client:** Linden Homes

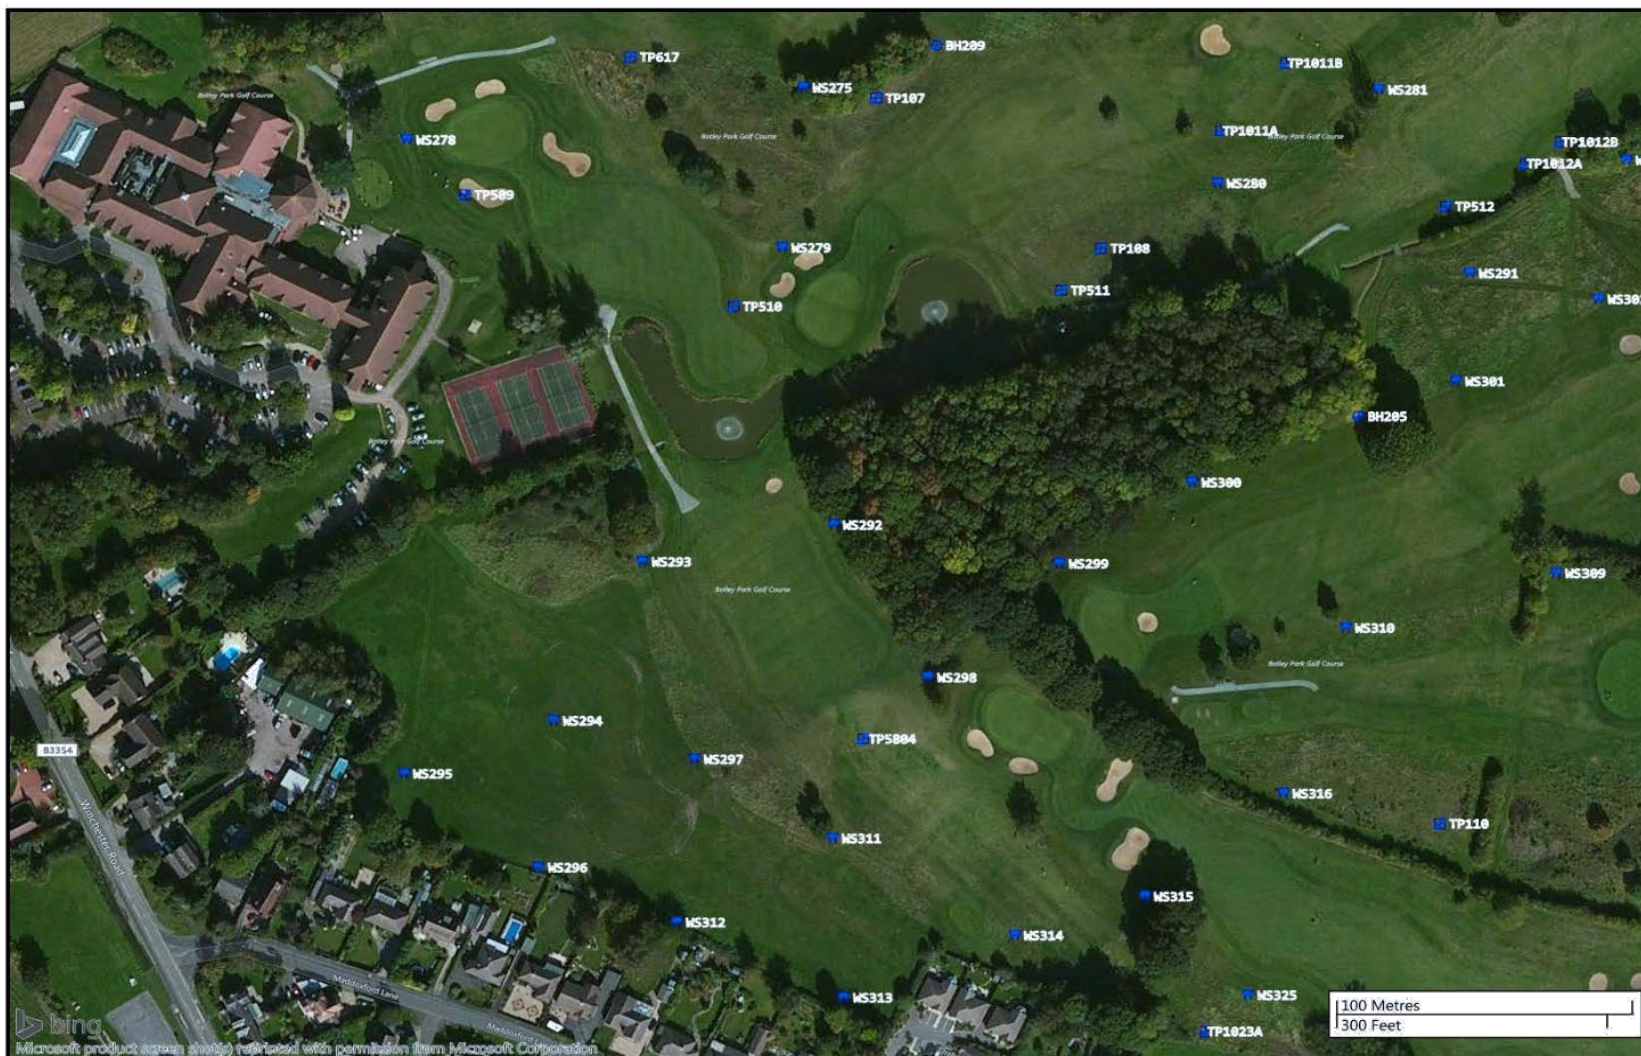
A review of pre-existing ground investigation records was undertaken to clarify the encountered ground conditions during the site's former use as a golf course. The relevant exploratory hole logs for positions within the B5 development parcel (WS292-294, WS297-WS298 and TP5084) and two deeper boreholes (BH205 and BH209) near to parcel B5 are enclosed together with a plan as Figure 1 showing the location of these exploratory holes.

The ground conditions encountered within or in close proximity to parcel B5 comprised Topsoil 0.3-0.7m thick overlying firm to stiff becoming stiff, or stiff silty clay. The clay strata would have been considered suitable, in general, for conventional foundations with foundation depth likely to be governed by tree influence. Based on the results of laboratory testing, a high volume change potential would be applicable for foundation design, thereby requiring a minimum founding depth of 1.0m bgl (Linden standard minimum foundation construction depth is typically 1.2m so deeper than the minimum for volume change potential). Heave protection and deepening to account for tree influence would be applicable.

| <b>Project:</b> | Boorley Green - Parcel B5 | | | <b>Title</b> | Previous Ground Investigation Plan | |

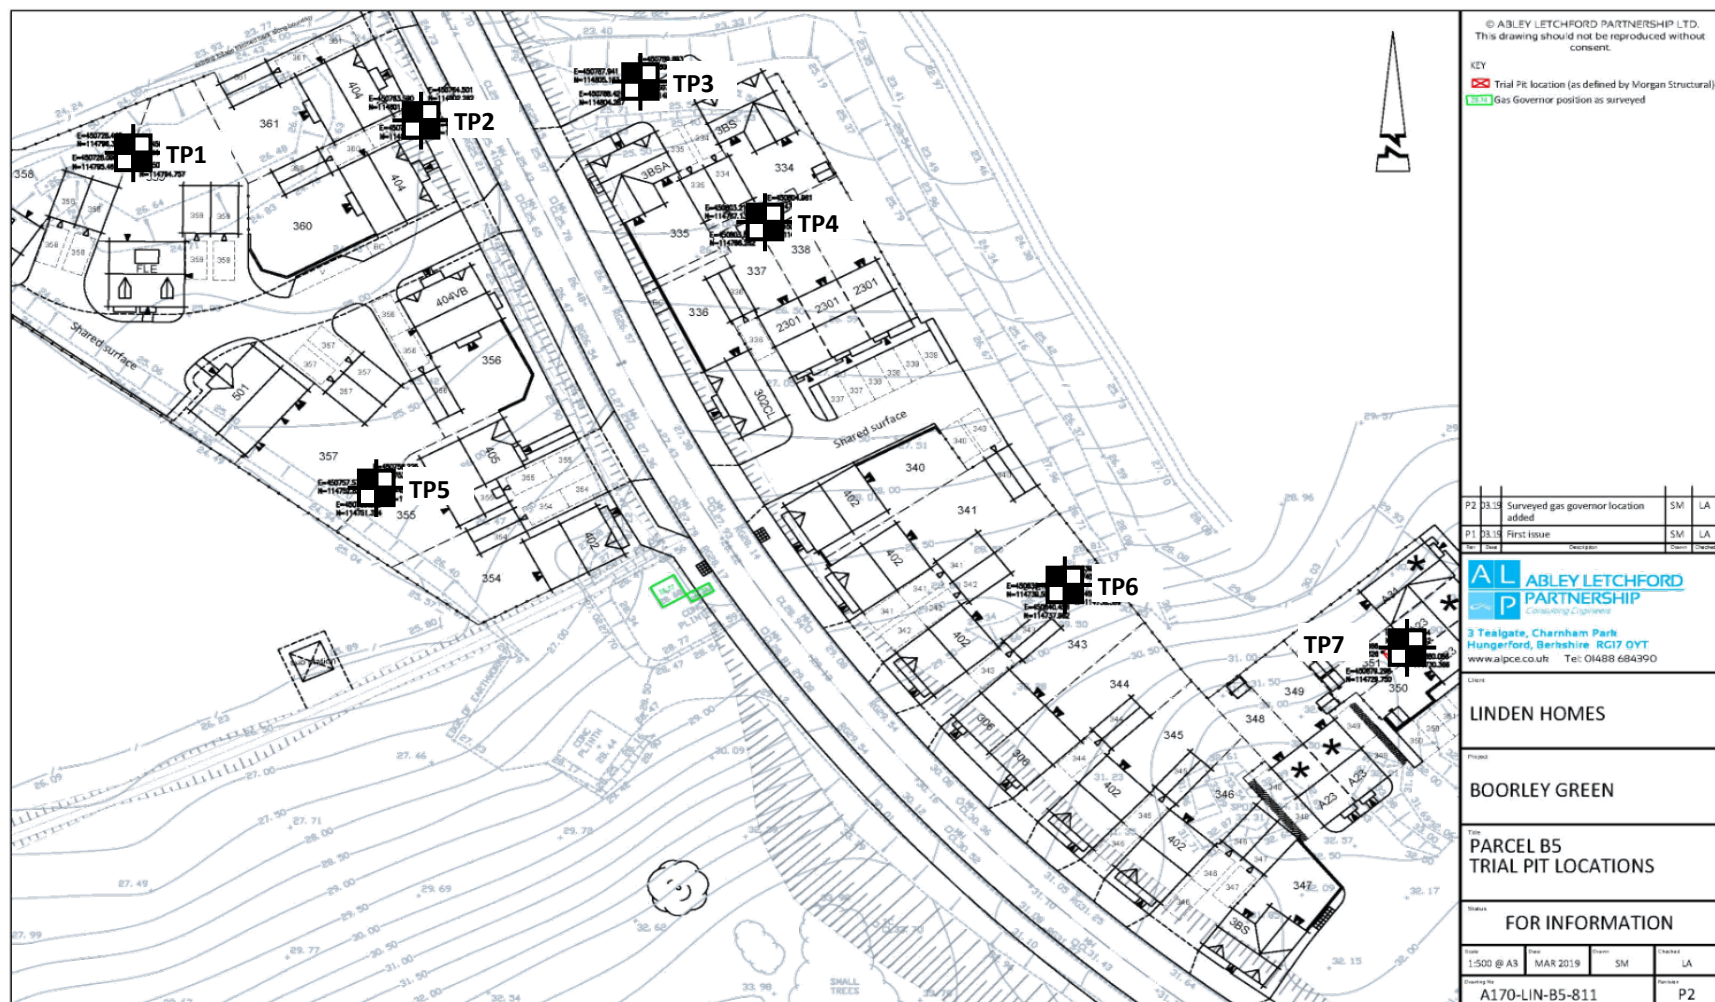
In addition to the water ingress via land drain in TP6, groundwater ingress was also observed in TP7 at 2.0m bgl as a seepage and running sand. Groundwater was also encountered during drilling of WS293 during the previous investigation, with groundwater ingress at 2.0m bgl. WS293 was located approximately mid-point between the locations of TP1, TP2 and TP5 (approximately Plot 356 based on the development layout plan provided).

In the portion of the site where trial pits TP6 and TP7 were located (approximately Plots 340-352), it is considered that conventional foundations would be suitable and could be constructed to terminate in undisturbed, natural stiff clay soils at depths of c. 1.5m bgl.

In the portion of the site downslope of the stockpiles, i.e. Plots 334-339 and 354-361, covered by trial pits TP1 and TP3-TP5, it is considered that the depth of Made Ground encountered, presence of lower strength clay soils and tree influence at TP1 (and likely for TP2) would require conventional foundations to extend to depths in excess of 2.5m bgl. Whilst technical approval for deep strip foundations could be dependent on which Building Control organisation is engaged for this site, it is considered that there could be constructability issues such as overdig and side collapse in the clay Made Ground, coupled with possible increased foundation width, generation of excessive spoil volumes and a substantial increase in concrete costs due to increase in volume of concrete required.

| <b>Project:</b> | Boorley Green - Parcel B5 | | | <b>Title</b> | Trial Pit locations on proposed layout | | |

In conclusion, it is considered that conventional foundations may be suitable for the portion of the site around and upslope of the stockpiles (approximately Plots 340-352), subject to clarification for Plots 340-342 following stockpile removal. A piled foundation solution is recommended for the remainder of the site, i.e. Plots 334-339 and 354-361).
