Title - Preliminary Bat Roost Assessment Report

Site address - 27 Orchard Avenue, Bishopstoke, Eastleigh SO50 8HN

Proposal - Remove tiles on side elevations and side dormers and reclad and alterations to bathroom window on first floor side elevation

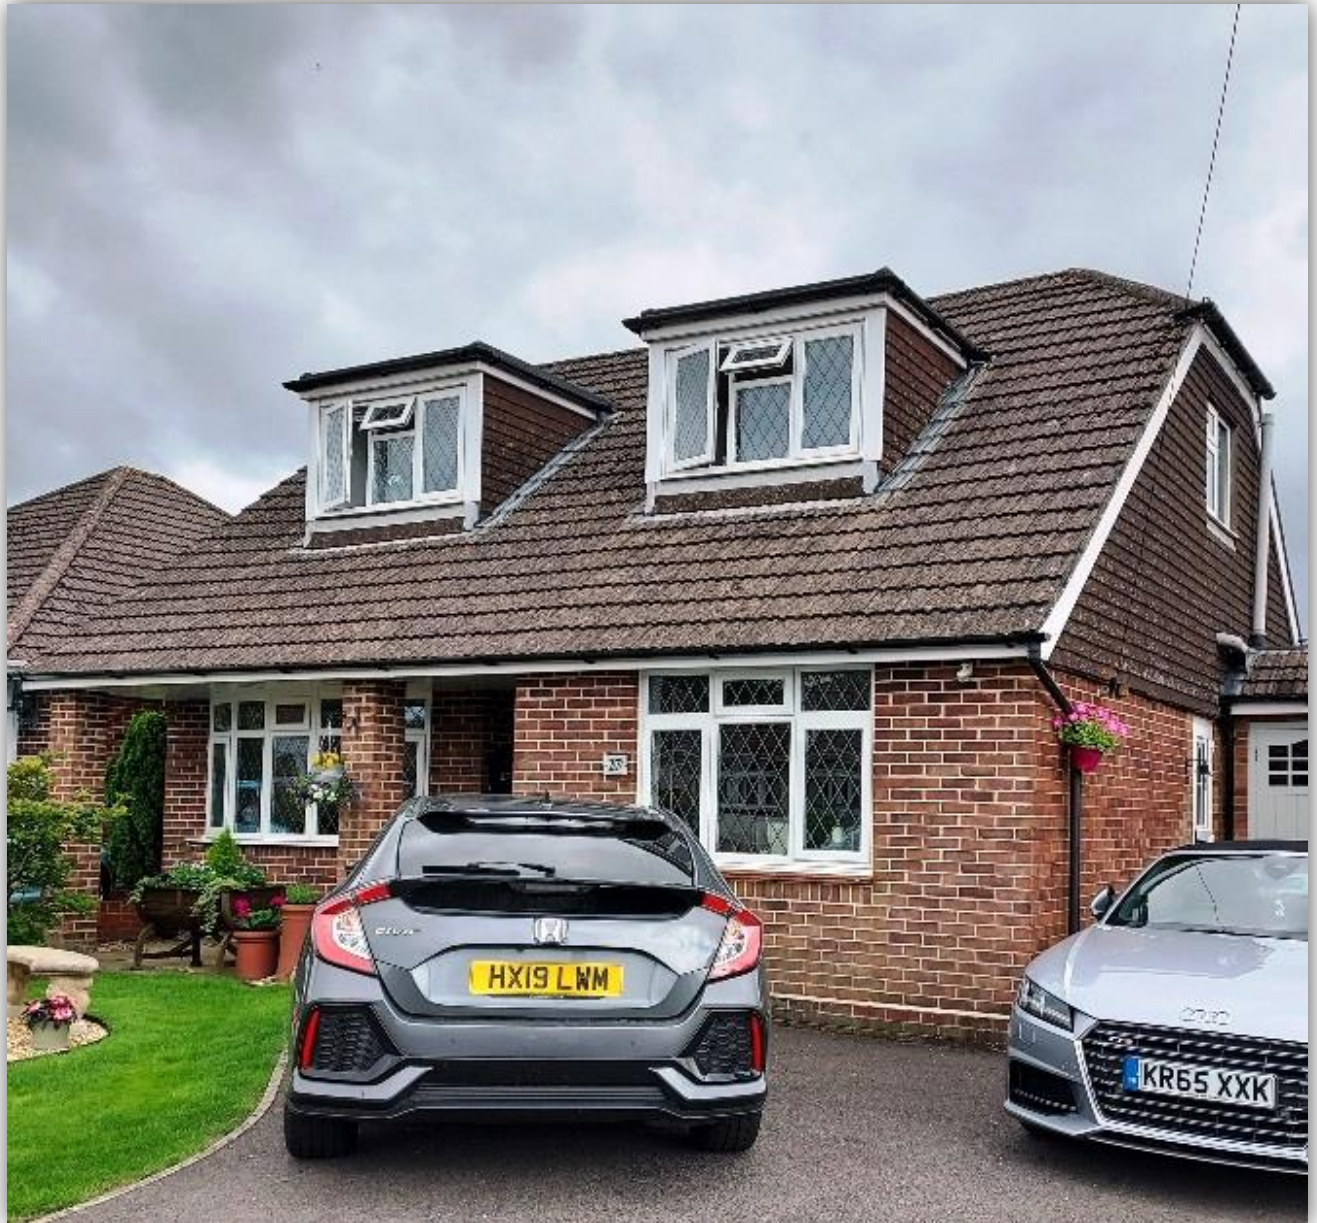
Dormer windows above the front elevation, side (west) elevation and hanging tiles.

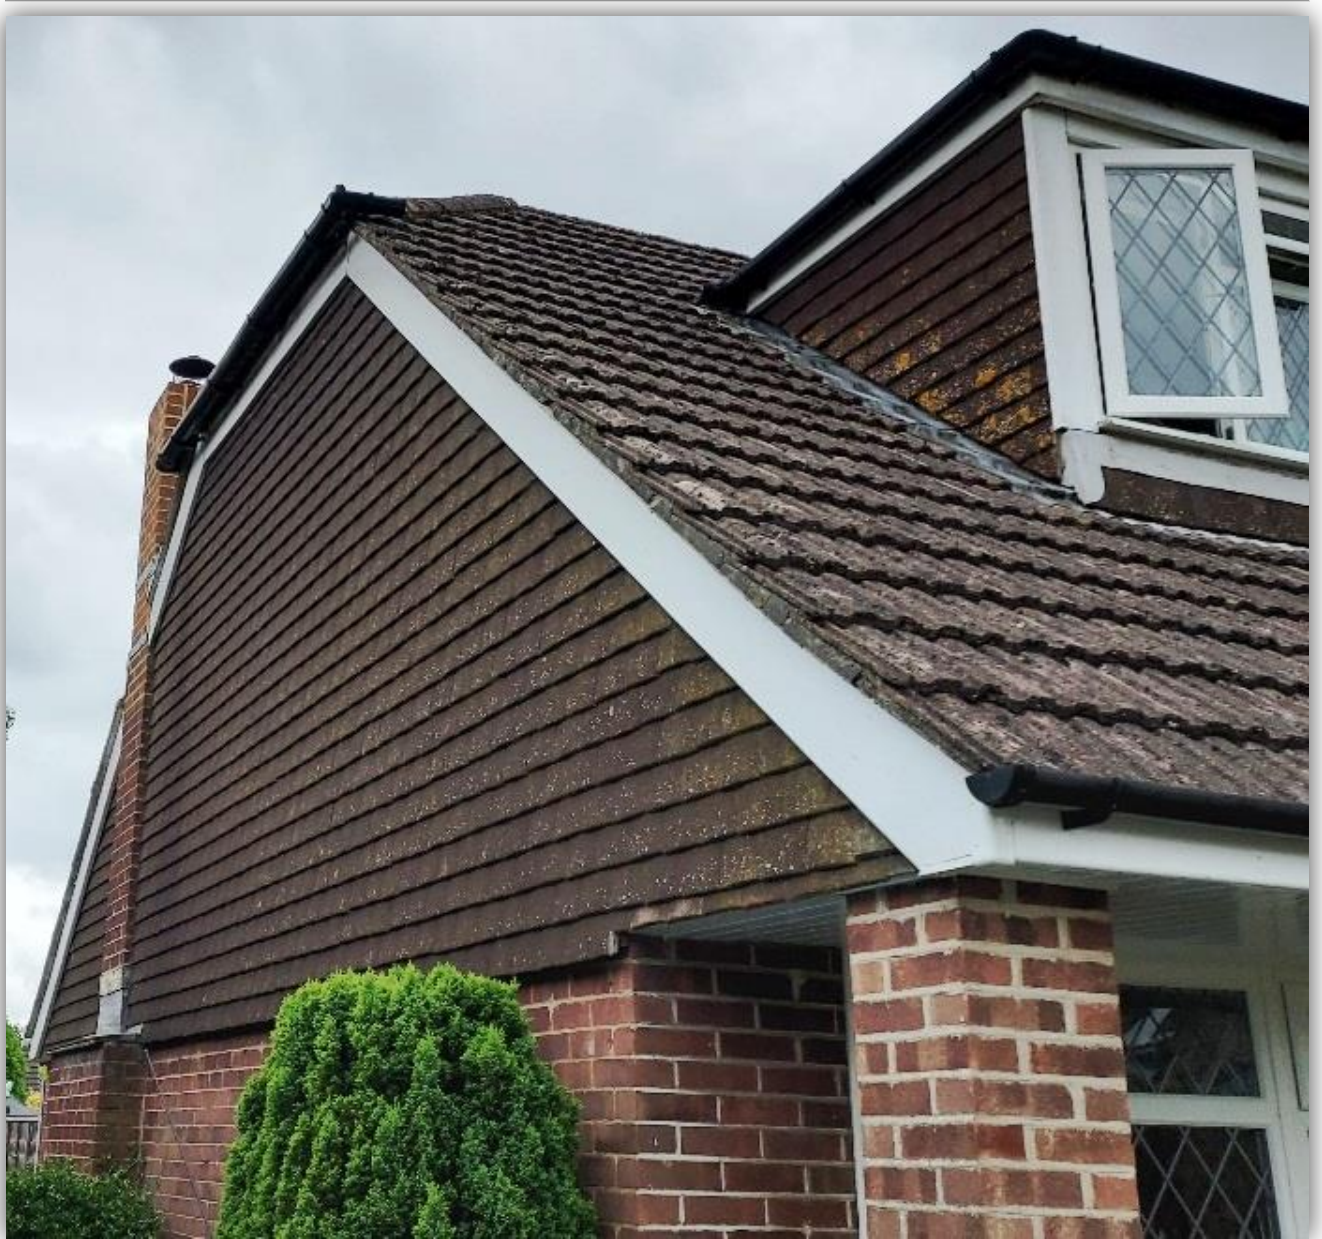
Side (east) elevation and hanging tiles.
