**REPORT ON  
GROUND INVESTIGATION  
AT  
LEIGH ROAD, EASTLEIGH**

| <b>Report Title:</b> | Report on Ground Investigation at Leigh Road, Eastleigh |
| <b>Report Number:</b> | AG3386-22-AO16 |
| <b>Date:</b> | March 2022 |

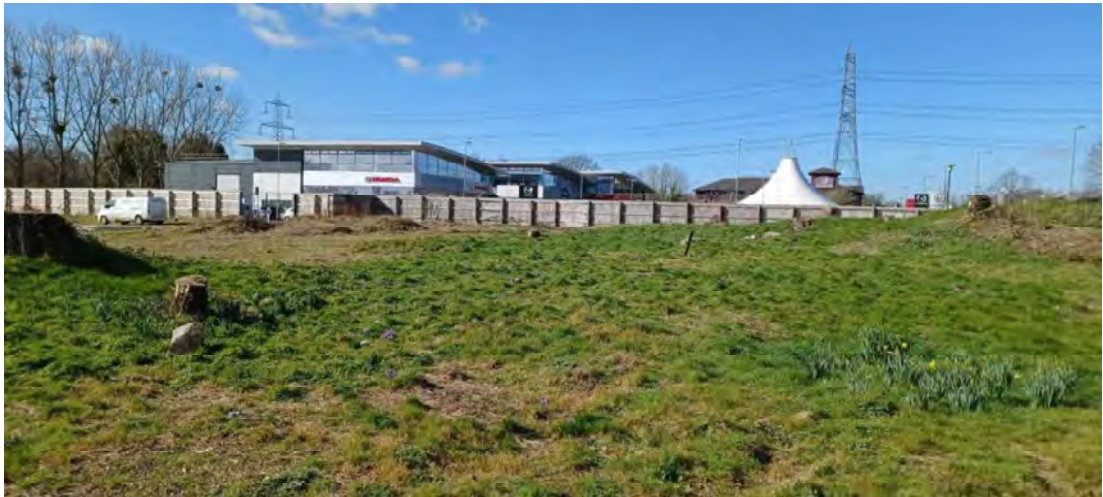
Northern half of hoarded part of the site, looking west

The main (hoarded) part of the site was accessible from Villeneuve St George's Way and Kornwestheim Way. The northern half was grassed with some weeds and daffodils. There were several grass-covered mounds, possibly of soil, and evidence of trees having been felled with remnant stumps, sawn tree trunks and chippings. Localised areas were waterlogged following recent heavy rainfall. Sporadic piles of bricks, some on pallets, some remnant parts of walls and some loose, concrete rubble, asphalt, wood and cones were present. The bricks and concrete may have been placed/fly-tipped on site or may represent a small former building. A former borehole installation was noted, with the pipe partially pulled out of the ground. The southern half of this area had a gravel surface with a narrow grassed boarder around the perimeter. Some bricks and Heras fence panels were noted, together with a sewer manhole cover in the far south. There was standing water in slightly depressed areas.

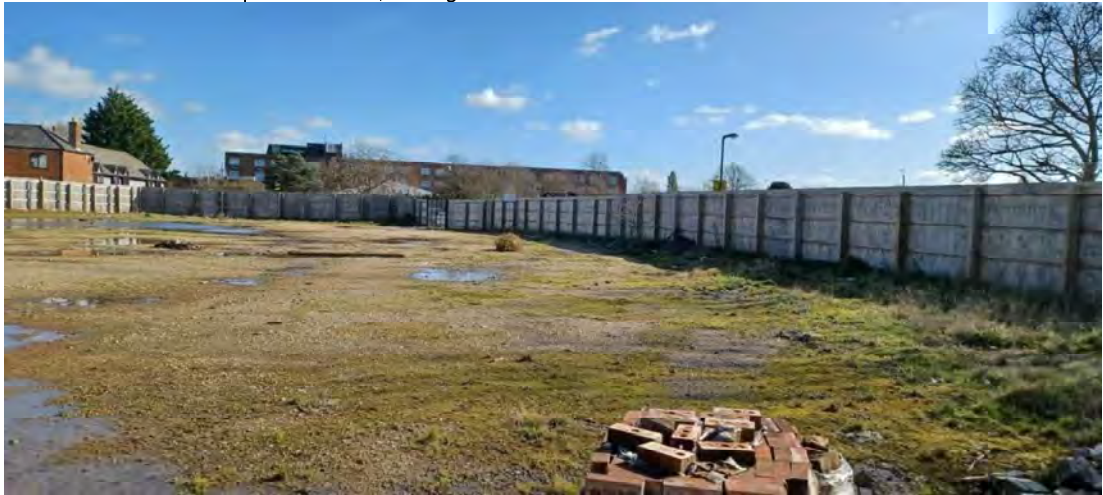
Southern half of hoarded part of the site, looking east

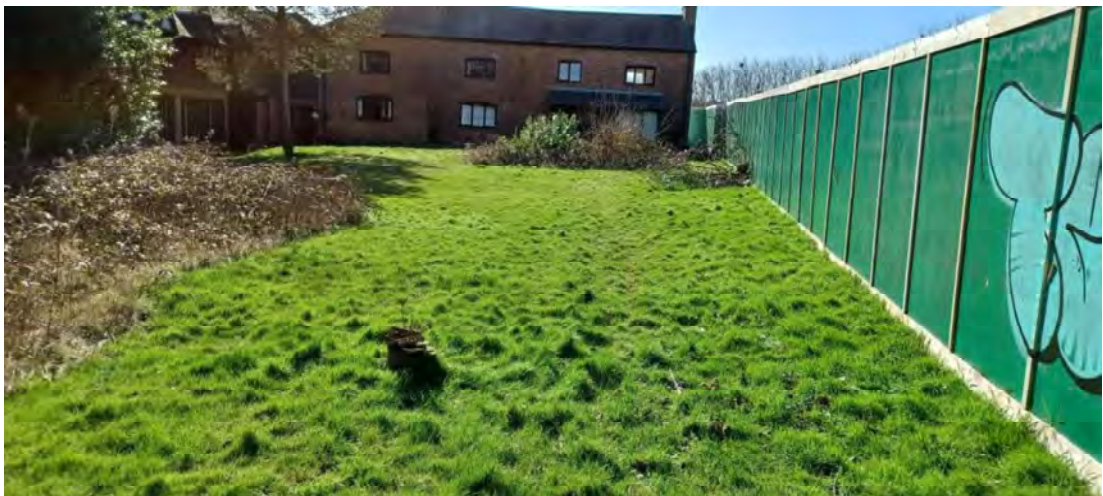
Landscaped area in the northeast, with Fleming Court Business Centre (outside of site boundary) beyond, looking south

There were mature trees in landscaped areas in the far south of the site and a small tree stump and bushes were noted in the landscaped area in the northeast. Further mature trees were present adjacent to the north of the site, together with an electricity substation.

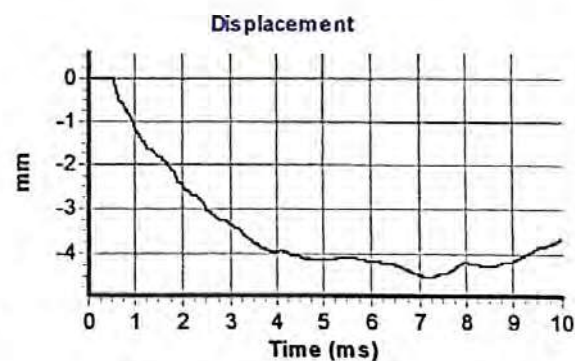
Hammer Mass  $m$  (kg): 63.6  
Falling Height  $h$  (mm): 760  
SPT String Length  $L$  (m): 16.0

Area of Rod  $A$  (mm<sup>2</sup>): 1083  
Theoretical Energy  $E_{theor}$  (J): 473  
Measured Energy  $E_{meas}$  (J): 371
