# Remediation Strategy

Woodside Avenue,  
Eastleigh,  
SO50 4ZR

A REPORT PREPARED FOR AND ON BEHALF OF:  
OXW CATALINA (LOGISTICS XXIV) LIMITED

Issue Date: 25 May 2022  
Revision No:  
Revision Date:

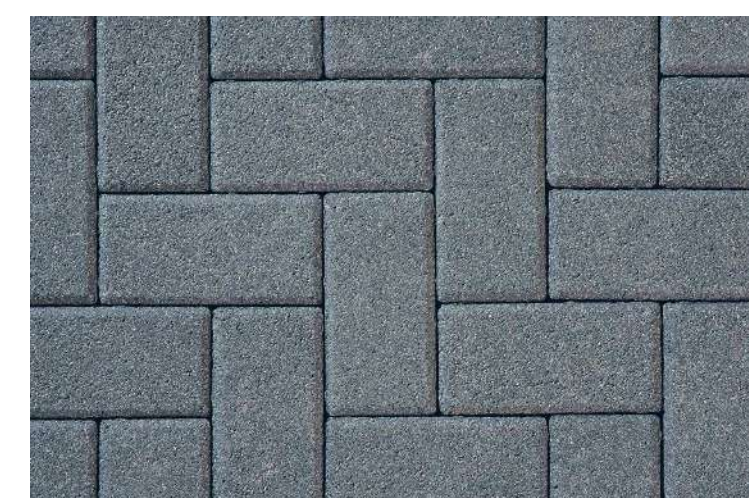
**Pedestrian footpaths**  
Concrete block paving to pedestrian footpaths within site boundary  
Colour: Charcoal

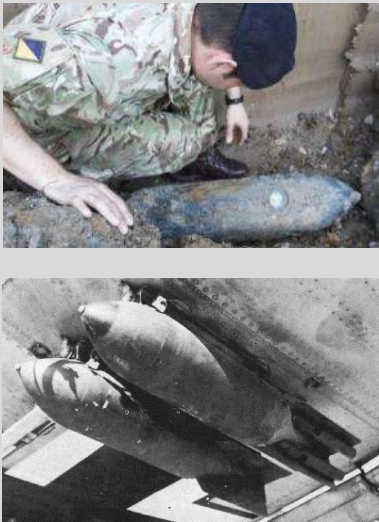
SC 50

**Bomb Weight:** 40-54kg (110-119lb)  
**Explosive Weight:** 25kg (55lb)  
**Filling:** TNT, Amatol or Trialen  
**Charge/Weight Ratio:** 46%  
**Fuse Type:** Electrical impact fuse or mechanical delayed action fuse  
**Body Dimensions:** 1,100mm length x 200mm diameter  
**Appearance:** Bomb body and tail painted grey/green with a yellow stripe on the tail unit. Steel construction.  
**Variants:** 8 x variants. Additional fittings: Kopfring nose for limited penetration and Stabbo nose for dive-bombing.

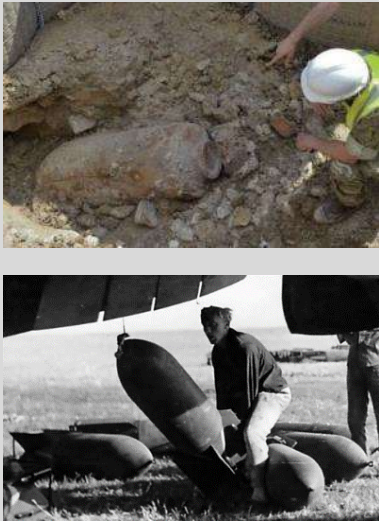
SC 250

**Bomb Weight:** 245-256kg (540-564lb)  
**Explosive Weight:** 125-130kg (276-287lb)  
**Filling:** TNT, Amatol and Trialen mix  
**Charge/Weight Ratio:** 44%  
**Fuse Type:** 1 or 2 electrical impact fuse(s) or mechanical delayed action fuse(s)  
**Body Dimensions:** 1,173mm length x 368mm diameter  
**Appearance:** Bomb body and tail painted grey/green with a yellow stripe on the tail unit. Steel construction.  
**Variants:** 8 x variants. Kopfring nose for limited penetration. Stabbo nose for dive-bombing.

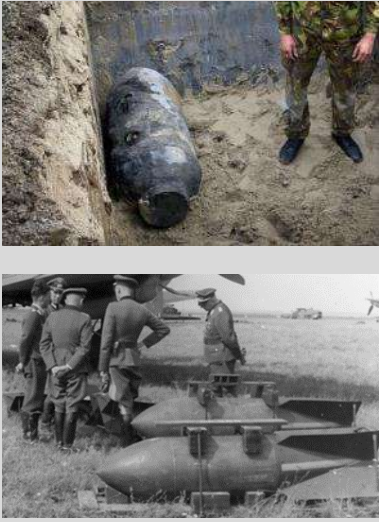
SC 500

**Bomb Weight:** 480-520kg (1,058-1,146lb)  
**Explosive Weight:** 220kg (485lb)  
**Filling:** TNT, Amatol and Trialen mix  
**Charge/Weight Ratio:** 44%  
**Fuse Type:** 2 electrical impact fuses or mechanical delayed action fuses  
**Body Dimensions:** 1,423mm length x 470mm diameter  
**Appearance:** Bomb body and tail painted grey/green or buff with a yellow stripe on the tail unit. Steel construction.  
**Variants:** 3 x variants. Kopfring nose for limited penetration.

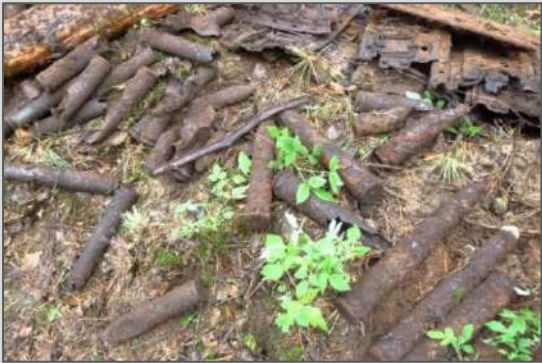
Bottom Right: Colour identification of Hispano rounds

Bottom Left: Colour identification of Oerlikon rounds
