**Title** - Bat Survey Report

**Site address** - 27 Orchard Avenue, Bishopstoke, Eastleigh SO50 8HN

**Proposal** - Remove tiles on side elevations and side dormers and reclad and alterations to bathroom window on first floor side elevation

Title - Preliminary Bat Roost Assessment Report

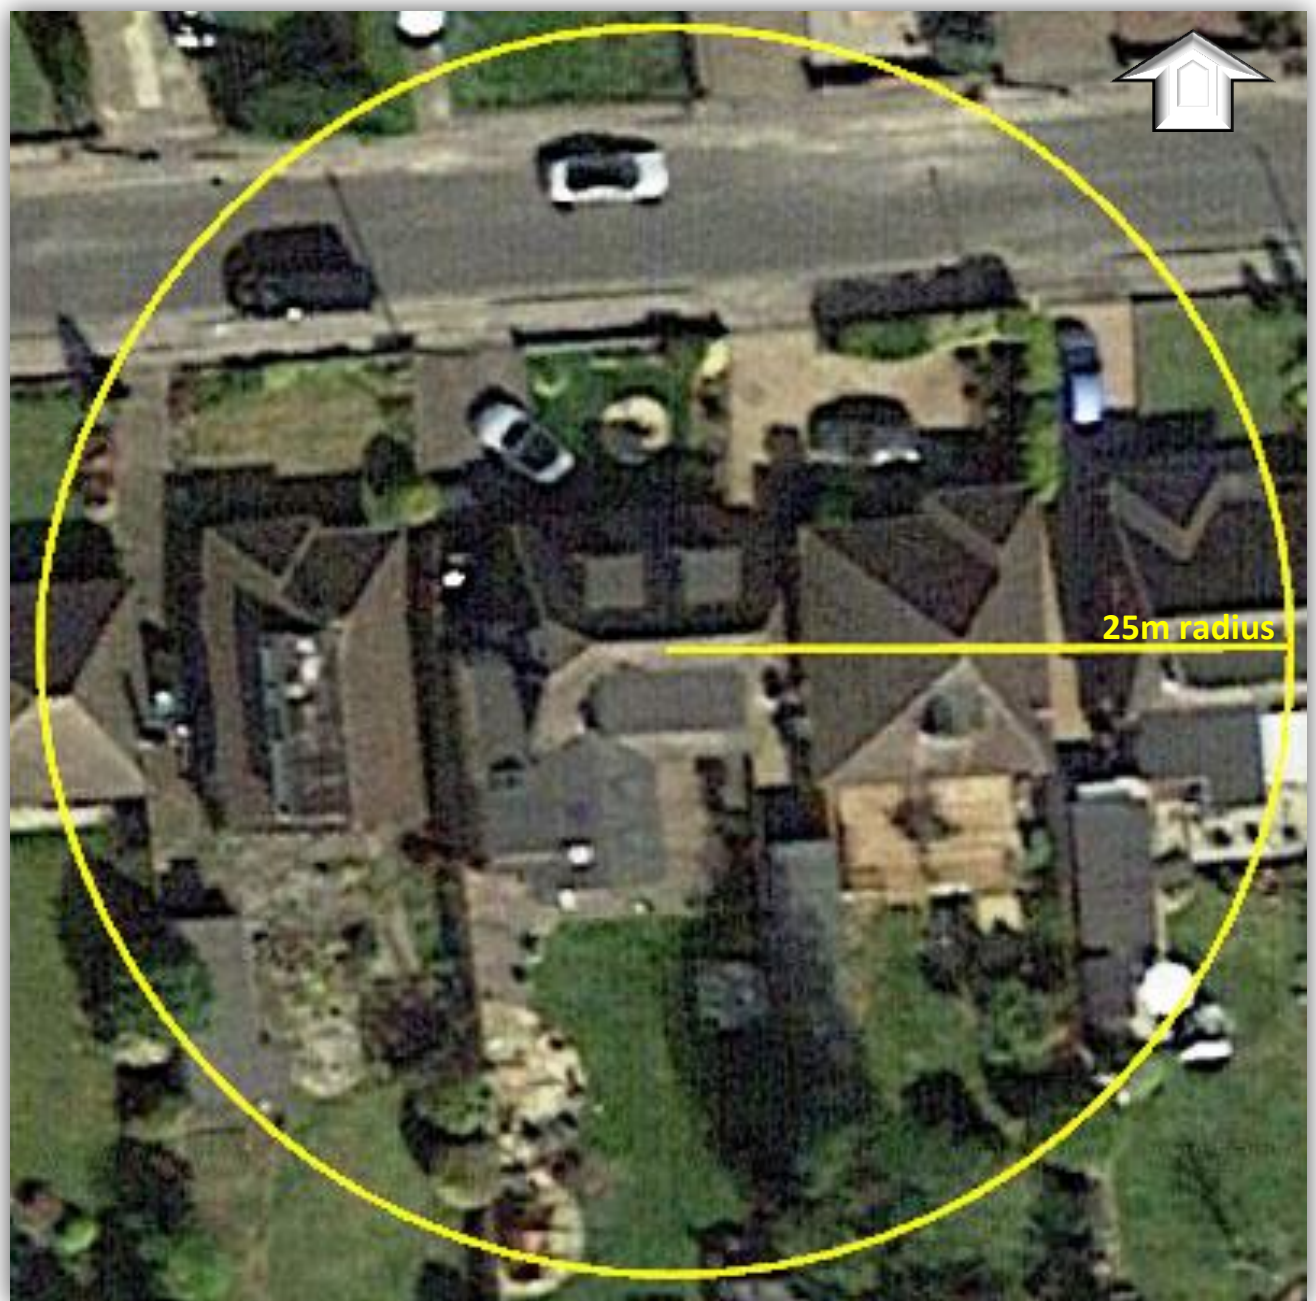
- 2.3 Bats forage for insects above grassland, hedges/hedgerows, trees and waterways (foraging habitats). Having been on site, and viewed Google Earth; negligible habitats for foraging bats are within 25m of the dwelling. Bats will not forage close to the dwelling.

Aerial photograph (courtesy of Google) showing negligible foraging habitats for bats.
