**PEMBERS HILL FARM, MORTIMERS LANE, FAIR  
OAK, HAMPSHIRE**

**ECOLOGICAL IMPACT ASSESSMENT**

**Final Document**

July 2022

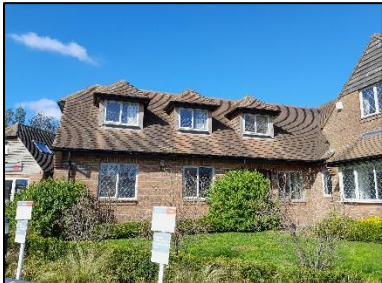
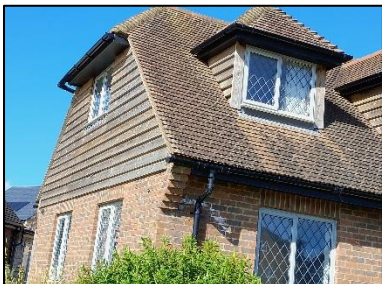
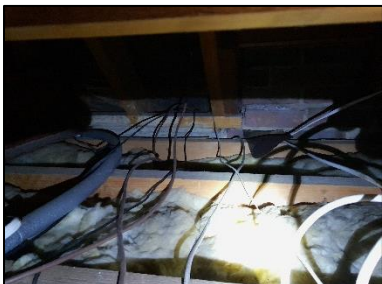
| Surveyed Feature | Figure | Building Description | Description of Potential Bat Roost Features | Evidence of Bat Roost Activity and Location | Assessment of Suitability for Roosting Bats |
|---|---|---|---|---|---|
| Plot 1 | <p><b>Figure 1:</b> Plot 1</p> <p><b>Figure 2:</b> Wooden cladding on the western gable end</p> <p><b>Figure 3:</b> Loft void lv1</p> | <p>Plot 1 is a two-storey red brick, L shaped, residential building that is unoccupied (<b>Figure 1</b>). The roof is multi pitched, with hipped and pitched sections, with clay tiles and dormer windows. There is wooden cladding on the gable ends on the south-western elevation (<b>Figure 2</b>). There is a wooden soffit in good condition on all elevations. There is a redbrick chimney present on the south-east elevation.</p> <p>There is a loft void (lv1) that extends east to west and is the length of the building (<b>Figure 3</b>). Lv1 is approximately one metre high and half a metre wide. There is a wooden framework including wooden joists, beams, rafters and purlins. This void is where the water tanks are stored along with associated pipework (<b>Figure 4</b>). In addition, there is an abundance of wires along the floor of lv1. Due to the size of the hatch, it was not possible to enter and inspect the whole void. The liner is bitumen felt and it is in good condition with no rips or tears. No day light can be seen in the parts of the void that were accessed.</p> <p>There is eaves storage (lv2) on the northern elevation of the building (<b>Figure 5</b>). Lv2 is</p> | Occasional lifted tiles and gaps under wooden cladding that provides a small number of crevice opportunities for a roosting bat. No gaps found in the loft voids however as lv1 could not be fully inspected access cannot be ruled out. | No evidence of roosting bats was recorded during the survey. | Low suitability |

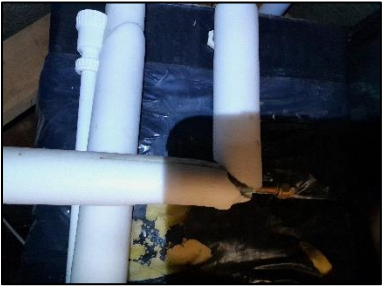
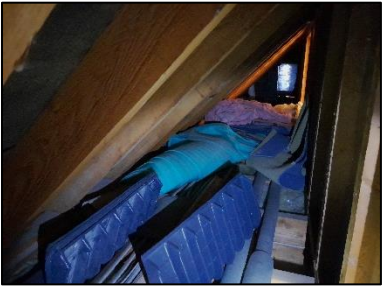
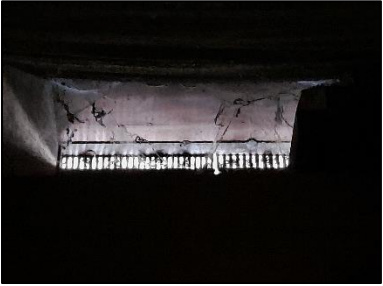
| Surveyed Feature | Figure | Building Description | Description of Potential Bat Roost Features | Evidence of Bat Roost Activity and Location | Assessment of Suitability for Roosting Bats |
|---|---|---|---|---|---|
| | <p>Figure 4: Water tank filling the space within the loft void lv1</p> <p>Figure 5: Loft void lv2</p> <p>Figure 6: Metal grid at the eaves of the building</p> | <p>approximately half a metre high by half a metre wide by eleven metres long. There is a wooden framework including wooden rafters, joists, and beams. There is a bitumen felt liner which is in good condition with no damage. Day light is present at the eaves where there is a metal grid preventing access (Figure 6).</p> <p>Both voids appear to be well sealed.</p> | | | |

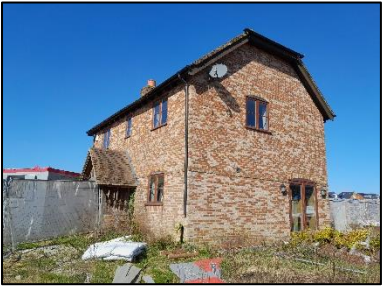
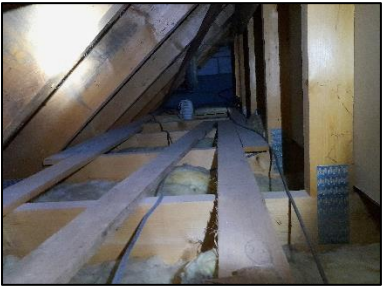
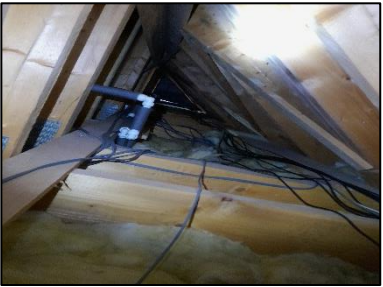
| Surveyed Feature | Figure | Building Description | Description of Potential Bat Roost Features | Evidence of Bat Roost Activity and Location | Assessment of Suitability for Roosting Bats |
|---|---|---|---|---|---|
| Plot 234 | <p>Figure 7: Plot 234</p> <p>Figure 8: Loft void lv1</p> <p>Figure 9: Loft void lv2</p> | <p>Plot 234 is an unoccupied two storey residential building (<b>Figure 7</b>). It is constructed of red brick outer layer and a break block inner layer. The roof has clay tiles and is hipped with sky lights allowing daylight into the converted loft. There is a wooden soffit on gable ends only which is in good condition. The other elevations do not have the soffit boxing but do have the wooden supports for the roof. External lights are present on the northern elevation. The led flashing present on the building is in good condition. A red brick chimney is present on the western elevation. The porch at the front door is constructed of wood and red brick with a pitch clay tile roof.</p> <p>The loft conversion has used up most of the loft space and is very well sealed. At the eaves there are storage areas, the dimensions for which are approximately half a metre wide by half a metre high by the length of the building. One on the southern and one on the northern elevation. The southern elevation is referred to as lv1 (<b>Figure 8</b>). Lv1 has a wooden structure including rafters, joists, purlins and purlin prop. The void had both Foil and fibre glass</p> | <p>There are occasional lifted tiles that provide a crevice opportunity for roosting bats. While daylight can be seen at the eaves of the building there is no obvious gap.</p> | <p>No evidence of roosting bats was recorded during the survey.</p> | <p>Low suitability</p> |

| Surveyed Feature | Figure | Building Description | Description of Potential Bat Roost Features | Evidence of Bat Roost Activity and Location | Assessment of Suitability for Roosting Bats |
|---|---|---|---|---|---|
| | | <p>insulation. Some of the piping for the building is stored here.</p> <p>Loft void (lv2) is located on the northern elevation and is the same size and construction as lv1 (<b>Figure 9</b>).</p> <p>In both voids the liner is in good condition and there are no rips.</p> | | | |

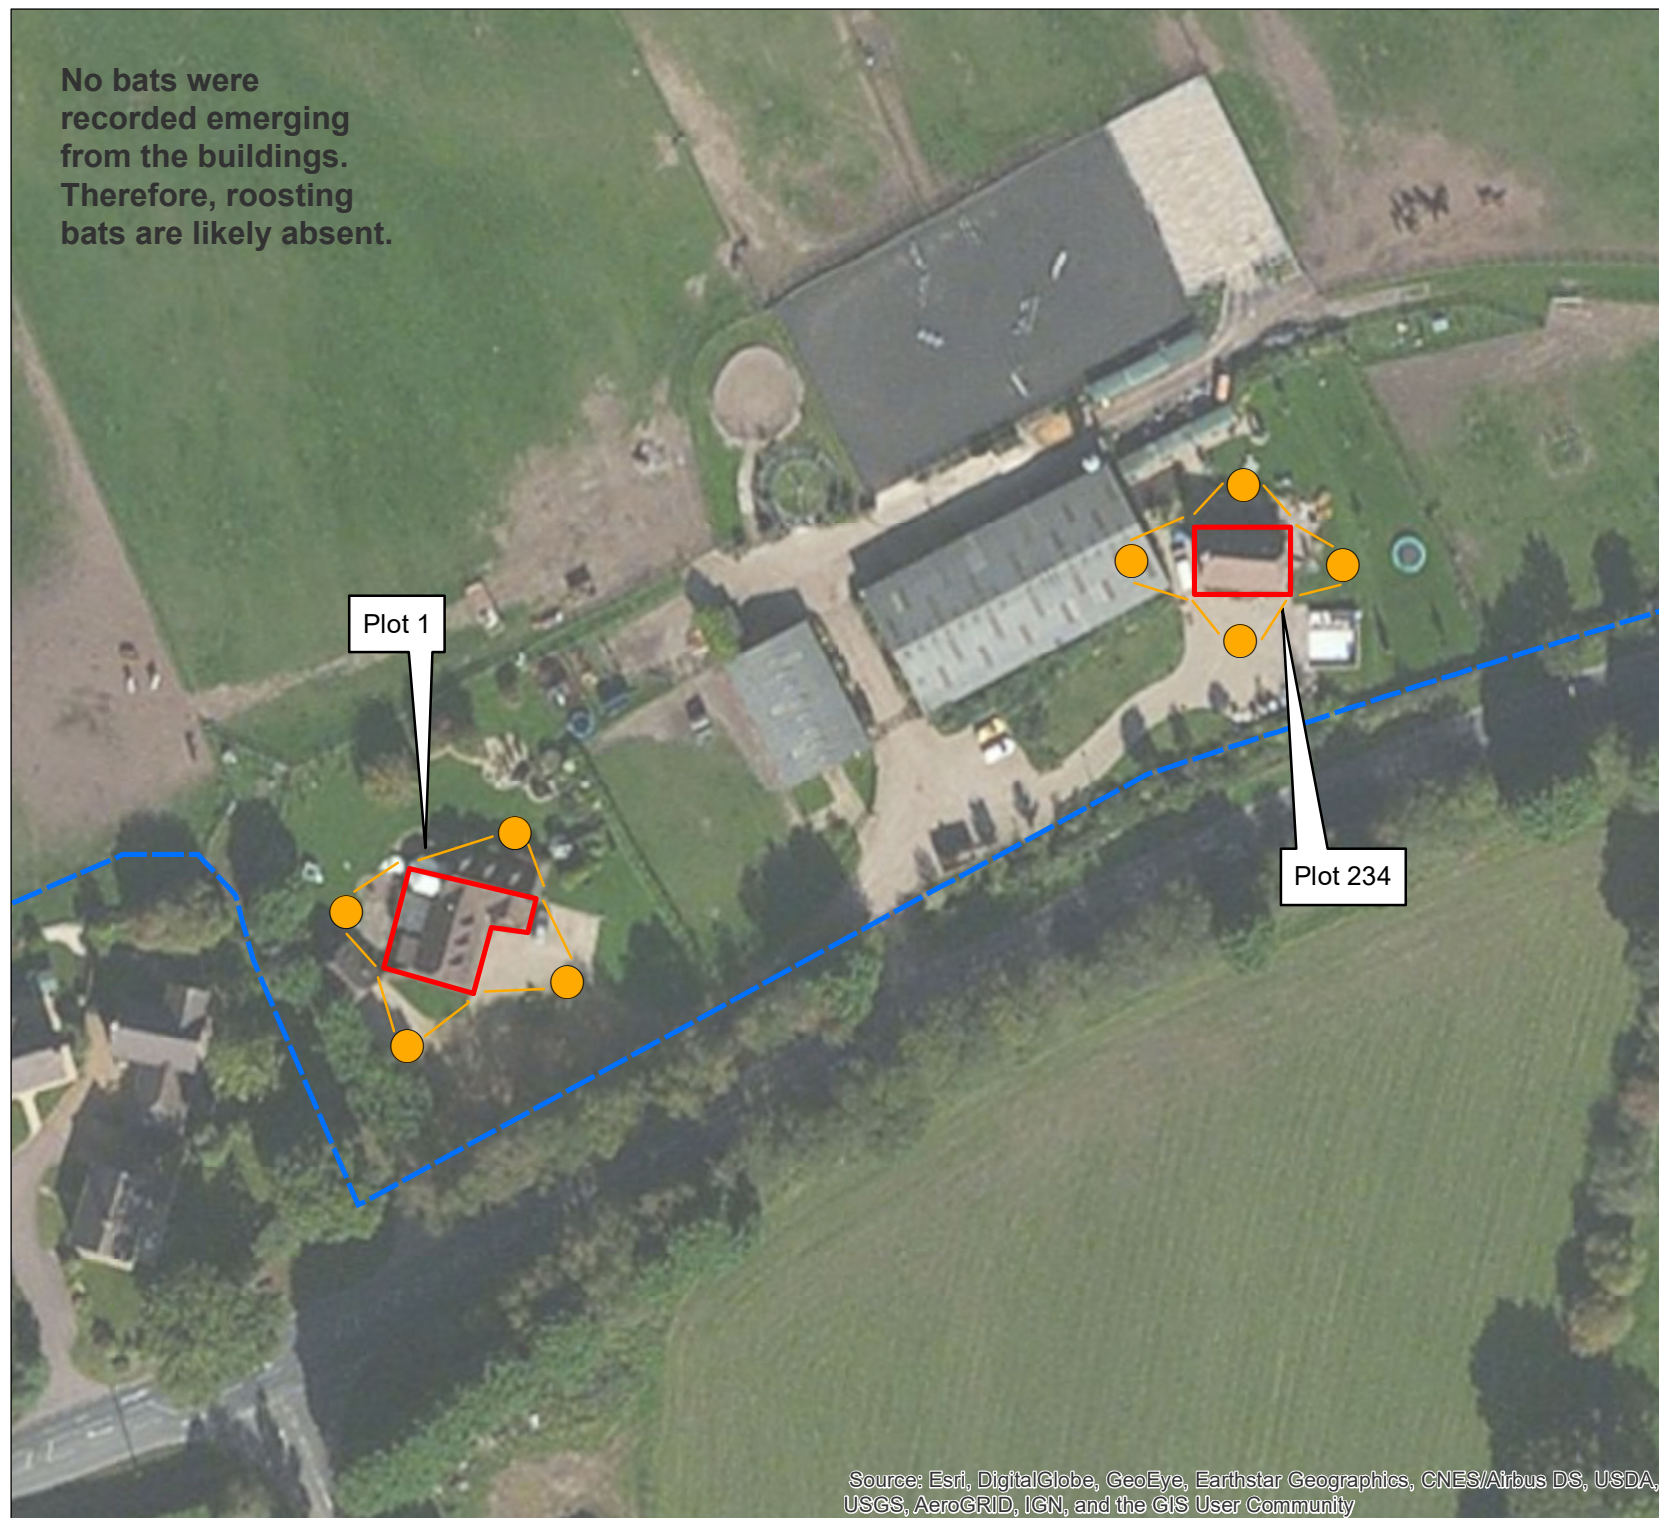
Surveyor Locations

No bats were recorded emerging from the surveyed buildings.
