# **Geo-Environmental Desk Study Report**

Lidl, Stoneham Lane, Eastleigh

**Client:** Lidl Great Britain Ltd  
**Project:** Lidl, Stoneham Lane, Eastleigh  
**Title:** Geo-Environmental Desk Study Report  
**Report Ref:** 21-1500-P-R1-B  
**Status:** Revision B  
**Date:** 16<sup>th</sup> August 2022

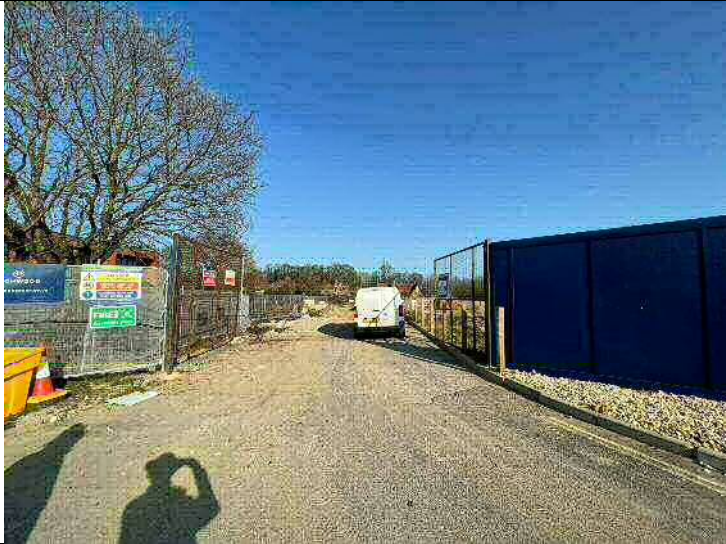
The site is bounded by wooden hoarding with access via a lockable steel gate in the north-western corner.

Photograph 1 – A view of the site entrance in the north-west corner.

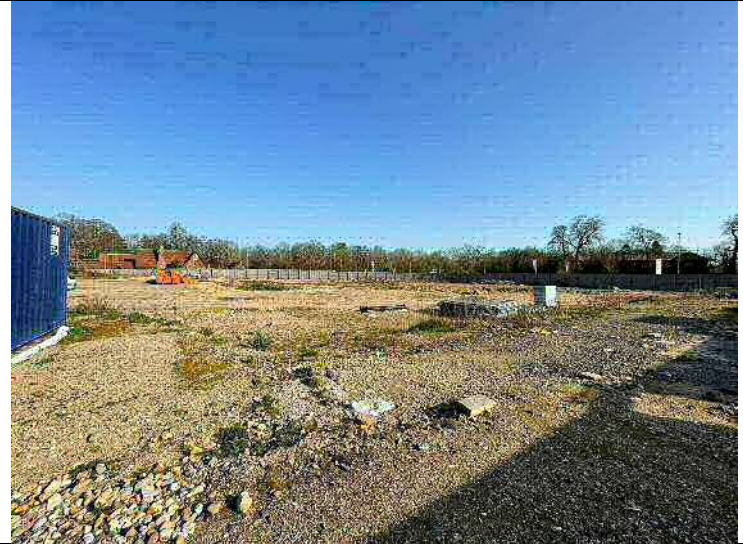
Photograph 2 – A view south across the site.

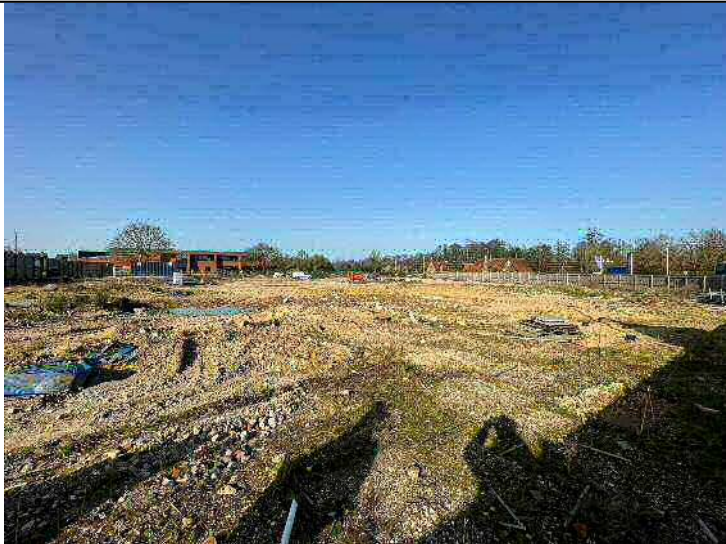
Photograph 3 – A view across the site from the south.

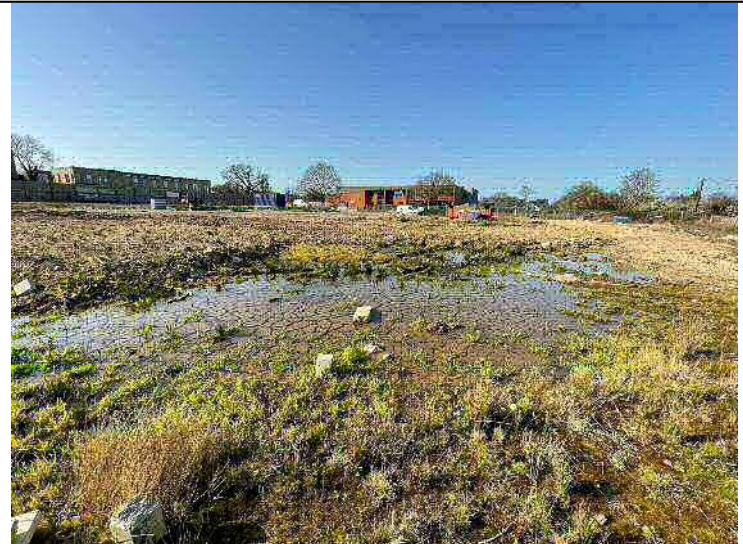
A significant amount of surface debris is present with small stockpiles of waste construction materials and a stockpile of soil in the north of the site. It would appear that a significant volume of granular Made Ground has been imported and compacted across the site surface to create a compound and set-down areas. Some localised, surface ponding is present within the south of the site.

The site walkover highlighted Made Ground on site throughout, associated with its use as a site compound for adjacent construction work. There was noted to be a small bund of Made Ground to the south-east corner of the site, which appeared to be in place to mitigate surface water migration offsite, towards Stoneham Lane. There was some surface water still present above the bund, and the ground surface would suggest previous water levels have been higher.

Photograph 4 – A view of the ponding in the south of the site.

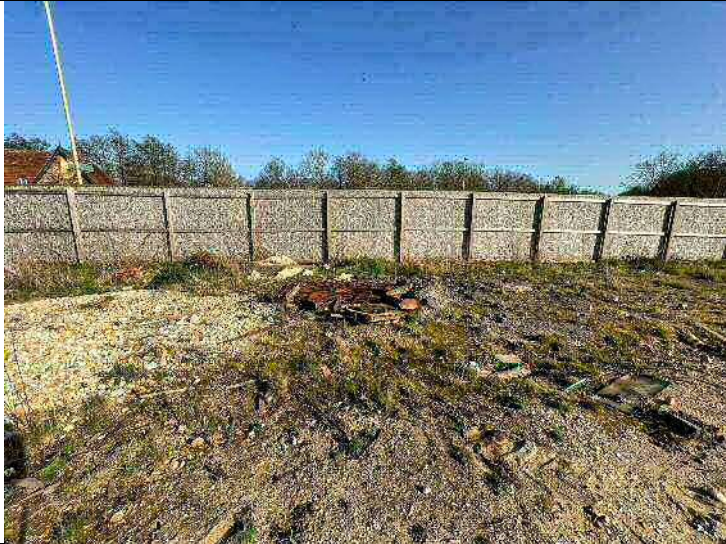
There are some small areas of concrete hardstanding and apparent evidence of burning of material on site.

If any material has been burned on site, then the points at which this occurred could present potential sources of contamination, which may include metals.

Photograph 5 – A view of the burnt waste materials on-site.

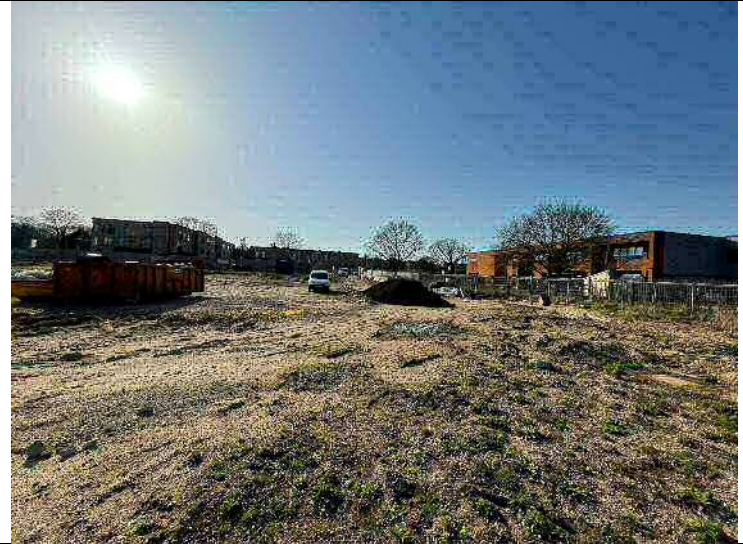
It was noted during the site walkover that there was a stockpile of off-site earth/compost to the north of the site, which was tended to at the time by a third party.

It was noted during the site walkover that there was a stockpile of imported soil in the north of the site. This is of unknown origin, and as such it is unknown what contaminants this may potentially contain.

Photograph 6 – A view of the stockpile in the northern area of the site.

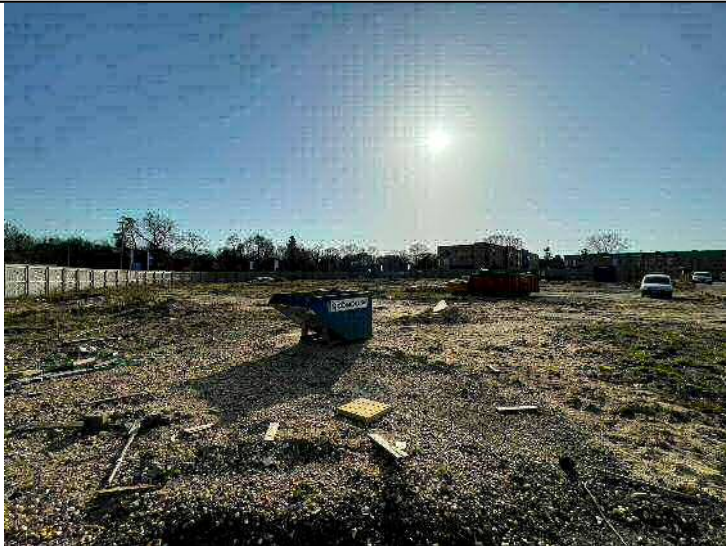
There is vegetation overgrowth to the north-east corner of the site, however it is noted this is primarily bracken and there is no significant tree growth on site. There is also an electrical junction box in this corner of the site.

Photograph 7 – A view across the site from the north-east corner.

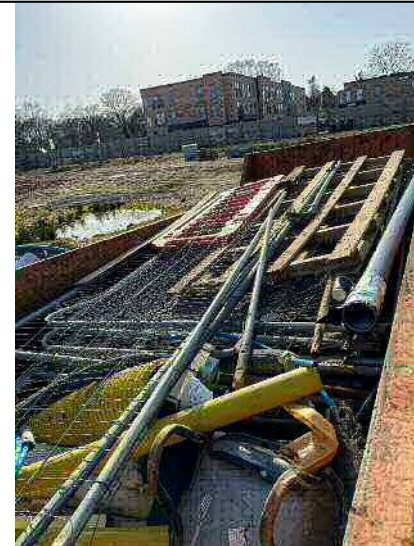
There are also some containers, including a large skip, containing site waste. There are also some piles of site waste, which primarily includes rusted metalwork.

Photograph 8 – A view of the waste skip located centrally on site.
