Lidl Great Britain Limited

# Geo-Environmental Investigation Report

Lidl, Stoneham Lane, Eastleigh

16<sup>th</sup> August 2022

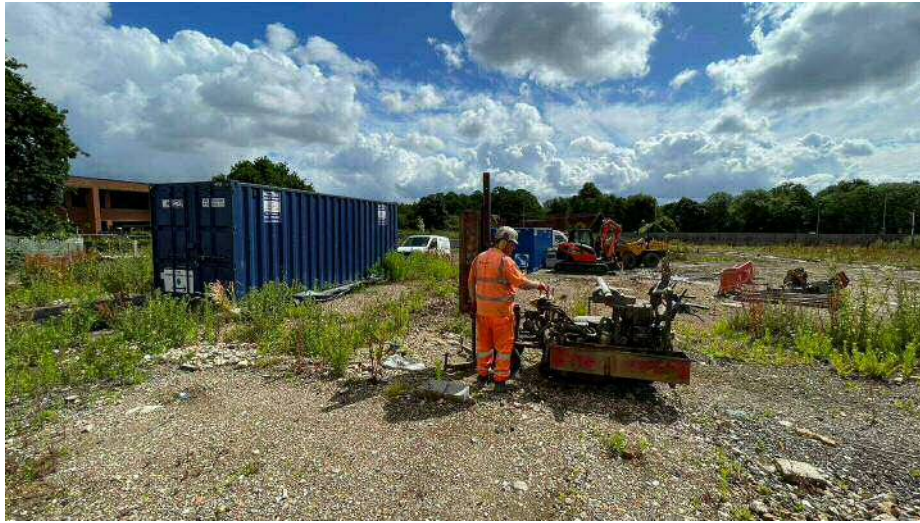
Photograph 1 – An example of the rig on position.

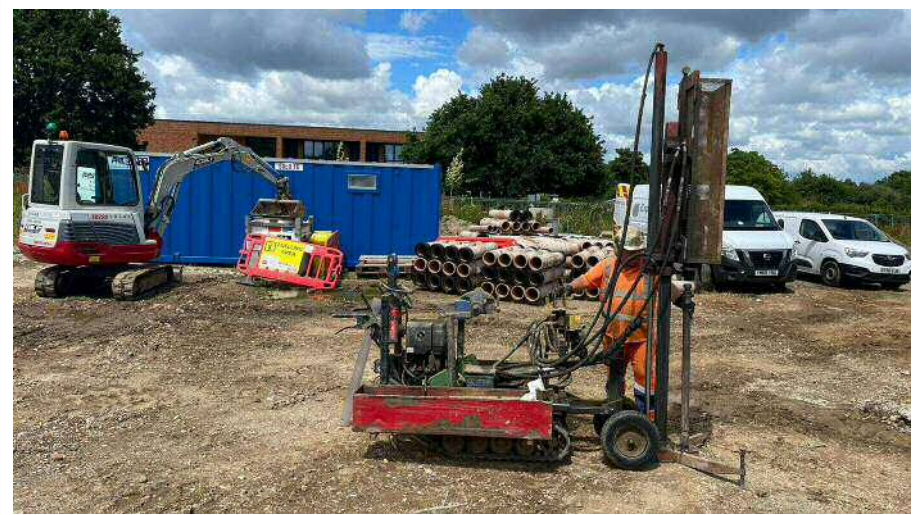
Photograph 2 – A view of some of the plant and materials being stored on site during the supplementary investigation.

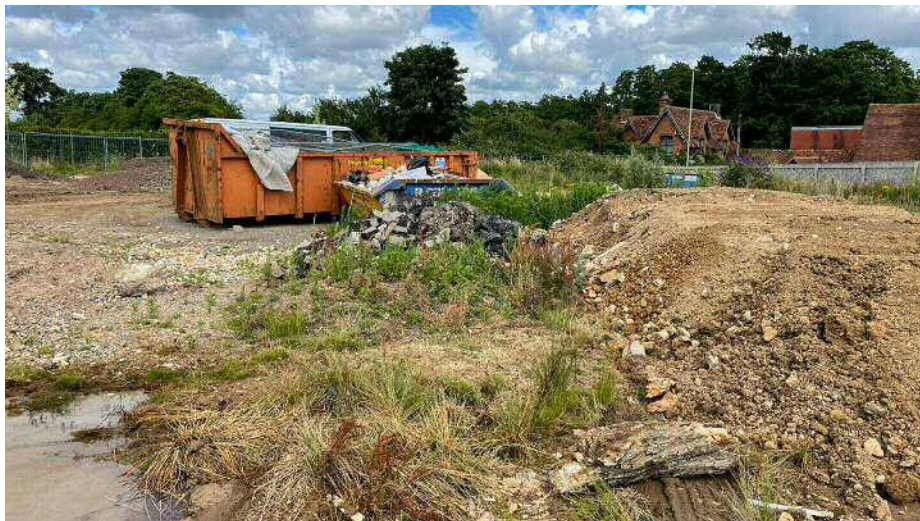
Photograph 3 – A view of the excavated materials from off-site works being stockpiled on site during the supplementary investigation.

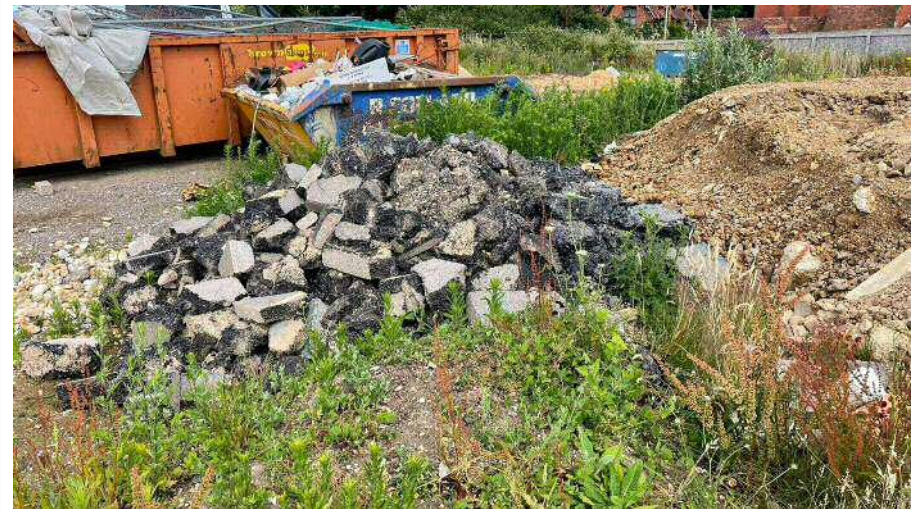
Photograph 4 – A view of the excavated materials from off-site works being stockpiled on site during the supplementary investigation.
