**REMEDIATION STRATEGY  
AND VERIFICATION PLAN  
FOR A SITE  
AT  
FORMER EASTLEIGH POLICE  
STATION, LEIGH ROAD,  
EASTLEIGH, HAMPSHIRE**

| <b>Report Title:</b> | Remediation Strategy and Verification Plan for site at Former Eastleigh Police Station, Leigh Road, Eastleigh, Hampshire SO50 9DG |
| <b>Report Number:</b> | AG2854B-19-AK05 |
| <b>Date:</b> | March 2022 |

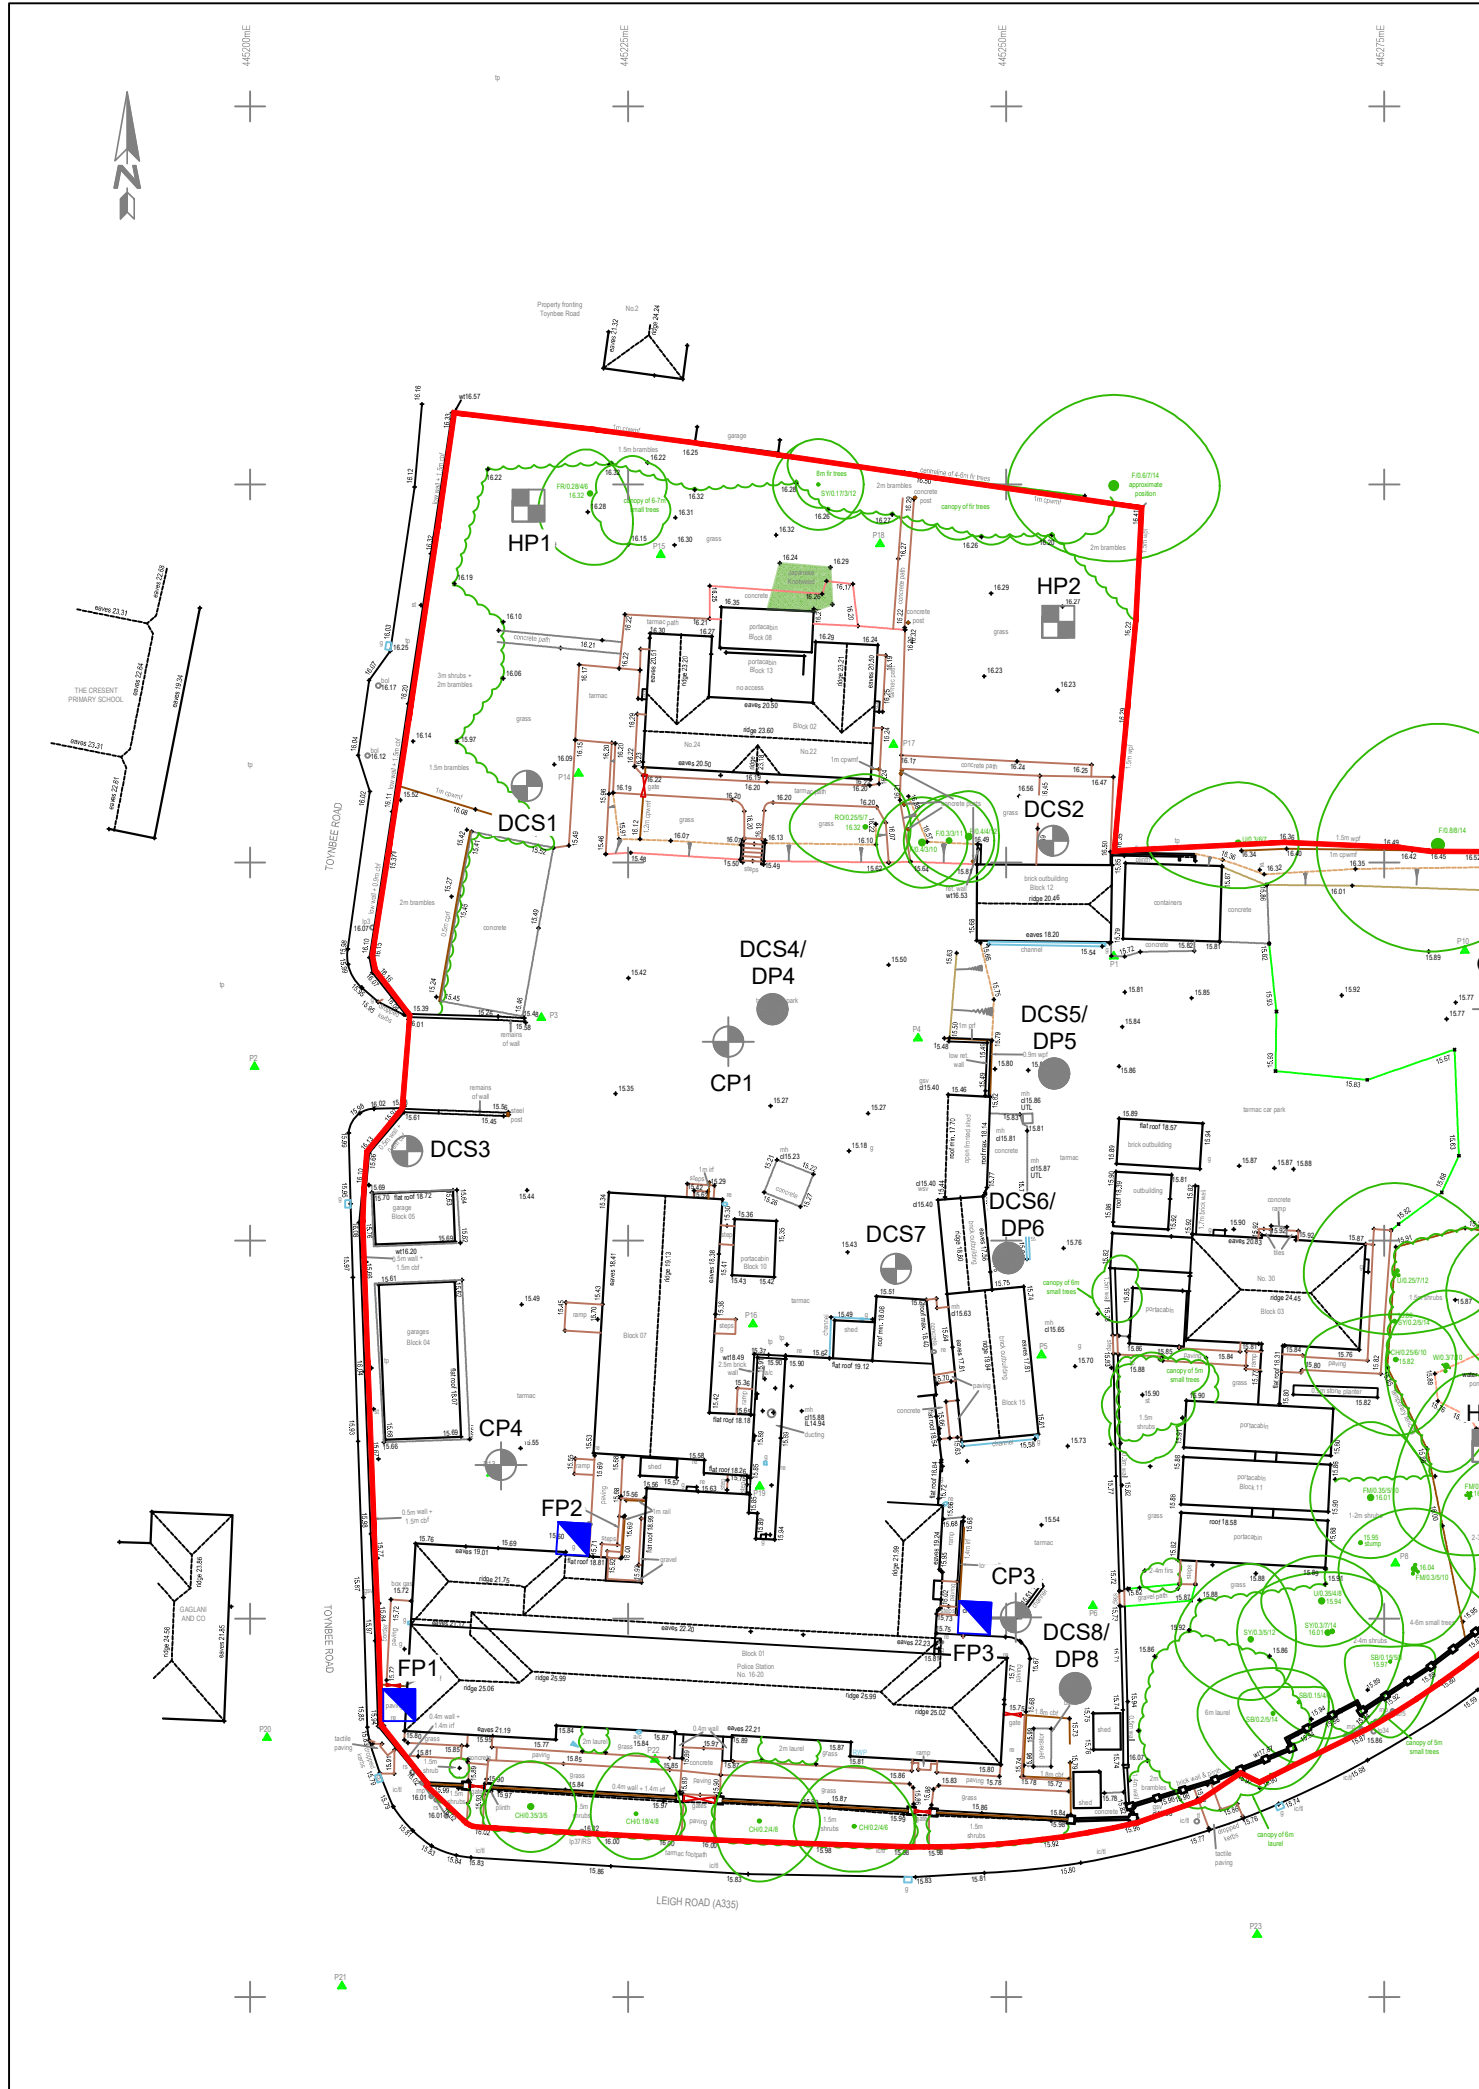
Based on the findings of the previous site investigations, the following remedial works and subsequent validation is considered necessary. A copy of the Exploratory Hole Location Plan showing the sampling locations of previous investigations, Dwg No. AG2854B-19-02, is included in Appendix A for reference.
