**Methodist Church Site, School Road,  
Lowford, SO31 8BU**

**Bat Survey Report**

Report Number: 0254

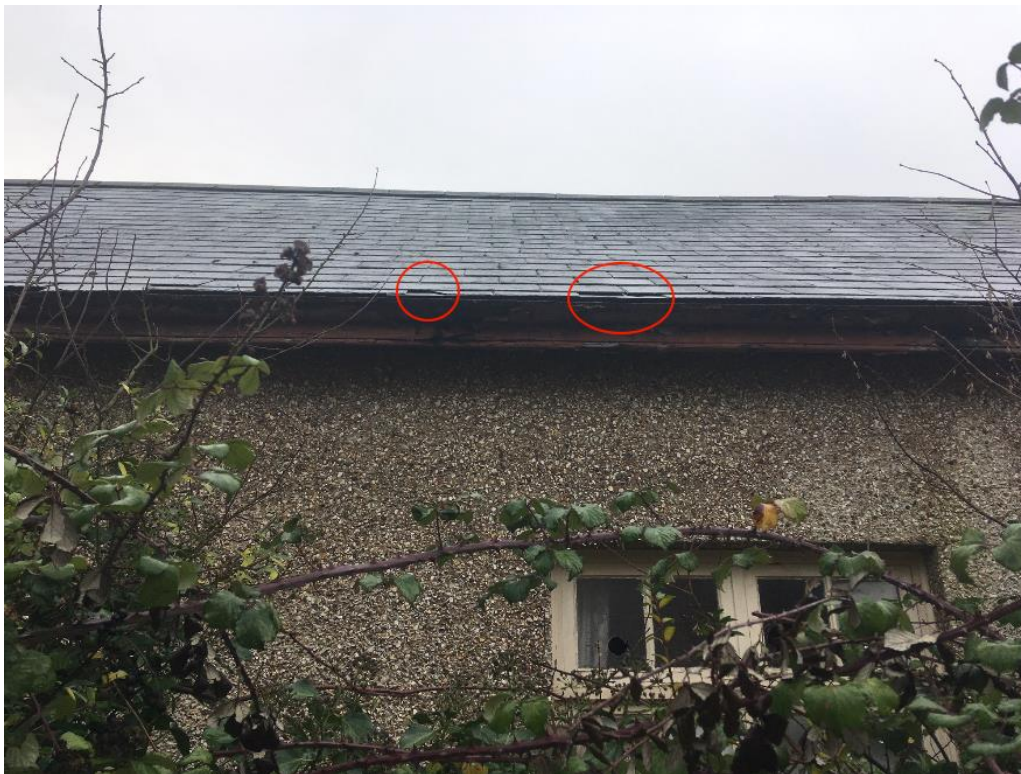
- 4.3 The building has bat roosting potential. There are gaps under the slate tiles (**figure 3**), under the soffits (**figure 4**) and where rafters protrude through the external walls (**figure 5**). The roof has no lining under the slate tiles. Bats may also roost in cavity walls. There also smashed windows where bats could gain access to the building.

**Figure 3:** Slate tile roof with potential gaps for bats.

- 4.4 The lack of a lining under the slate roof tiles allows greater access for bats to access the attic and the building in general. Although no direct evidence of bats was found, the building has features with bat roosting potential and if these areas cannot be avoided and have minimal levels of disturbance during construction then further surveys would be necessary to ascertain the bat roosting status and to determine if a European Protected Species licence is required to proceed with the proposals. The proposals include two new dormer windows and several conservation style rooflights, all of these will be where there are existing slate tiles with no bat access potential and therefore it is unlikely that there will be an impact on bats. There were no signs of bats in the attics so losing the attic to the development is considered to have a negligible impact on bats.

- 5.1 The proposal is to internally convert the church into flats.
- 5.2 The slates required to be removed for the dormer windows and the rooflights will be done so under ecological supervision after a tool box talk has been given. The toolbox talk must be carried out by a suitably qualified ecologist prior to any works on site to highlight locations with bat potential and the required working practices regarding these or near to them.

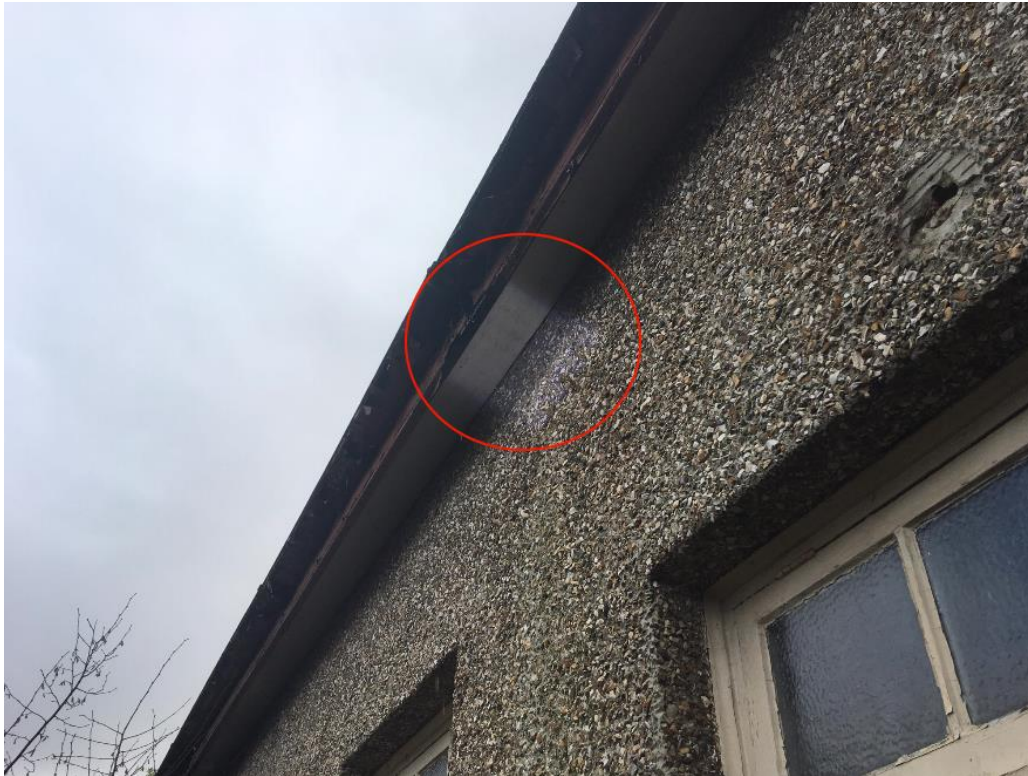
**Figure 4:** Gap where soffit meets the external wall; this was present around the building at different locations

- 5.4 Two new bat roosting crevice features will be incorporated into the proposals under the eaves facing south, see Appendix E.
- 5.5 The site will be monitored during construction to ensure bat features are installed correctly.

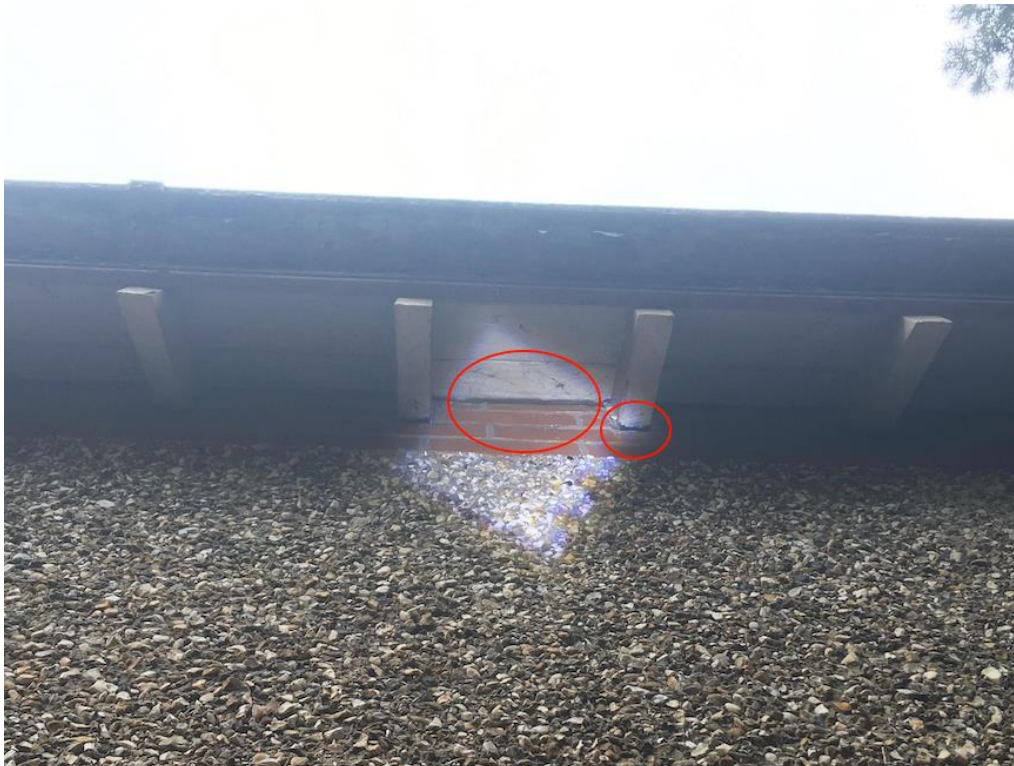
**Figure 5:** Gap under soffit, to left above, and where rafters protrude through the external wall, to the right above; these were present around the building at different points

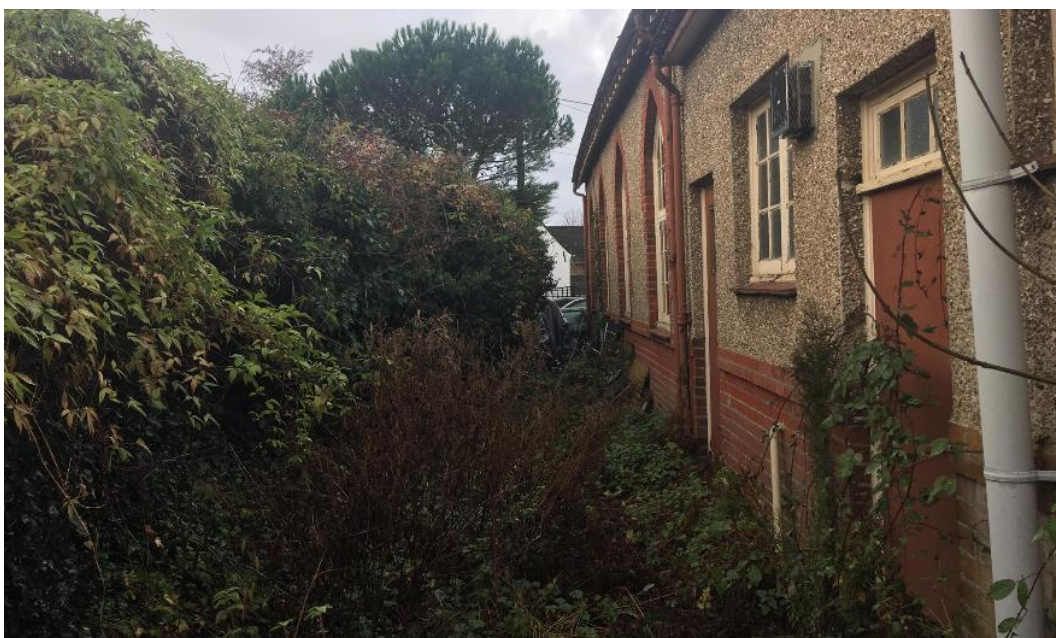
**Figure 6:** Southern aspect of building

- 4.5 The woodier species of trees and bushes adjacent to the building at the site boundary (**figure 6**) provide some low quality foraging habitat for bats. These should be retained and protected from any disturbance during building works and protected from external lighting post construction, however if this is not possible then new planting will need to be included as part of the scheme.

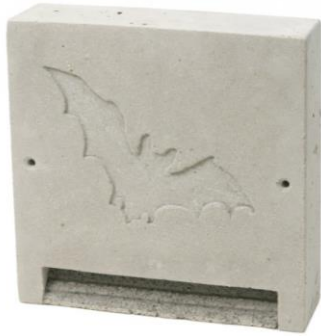
### 2x 1FE Bat Access panel

This maintenance free woodcrete Bat inlet panel is for installing on (or in) the surface of exterior walls.

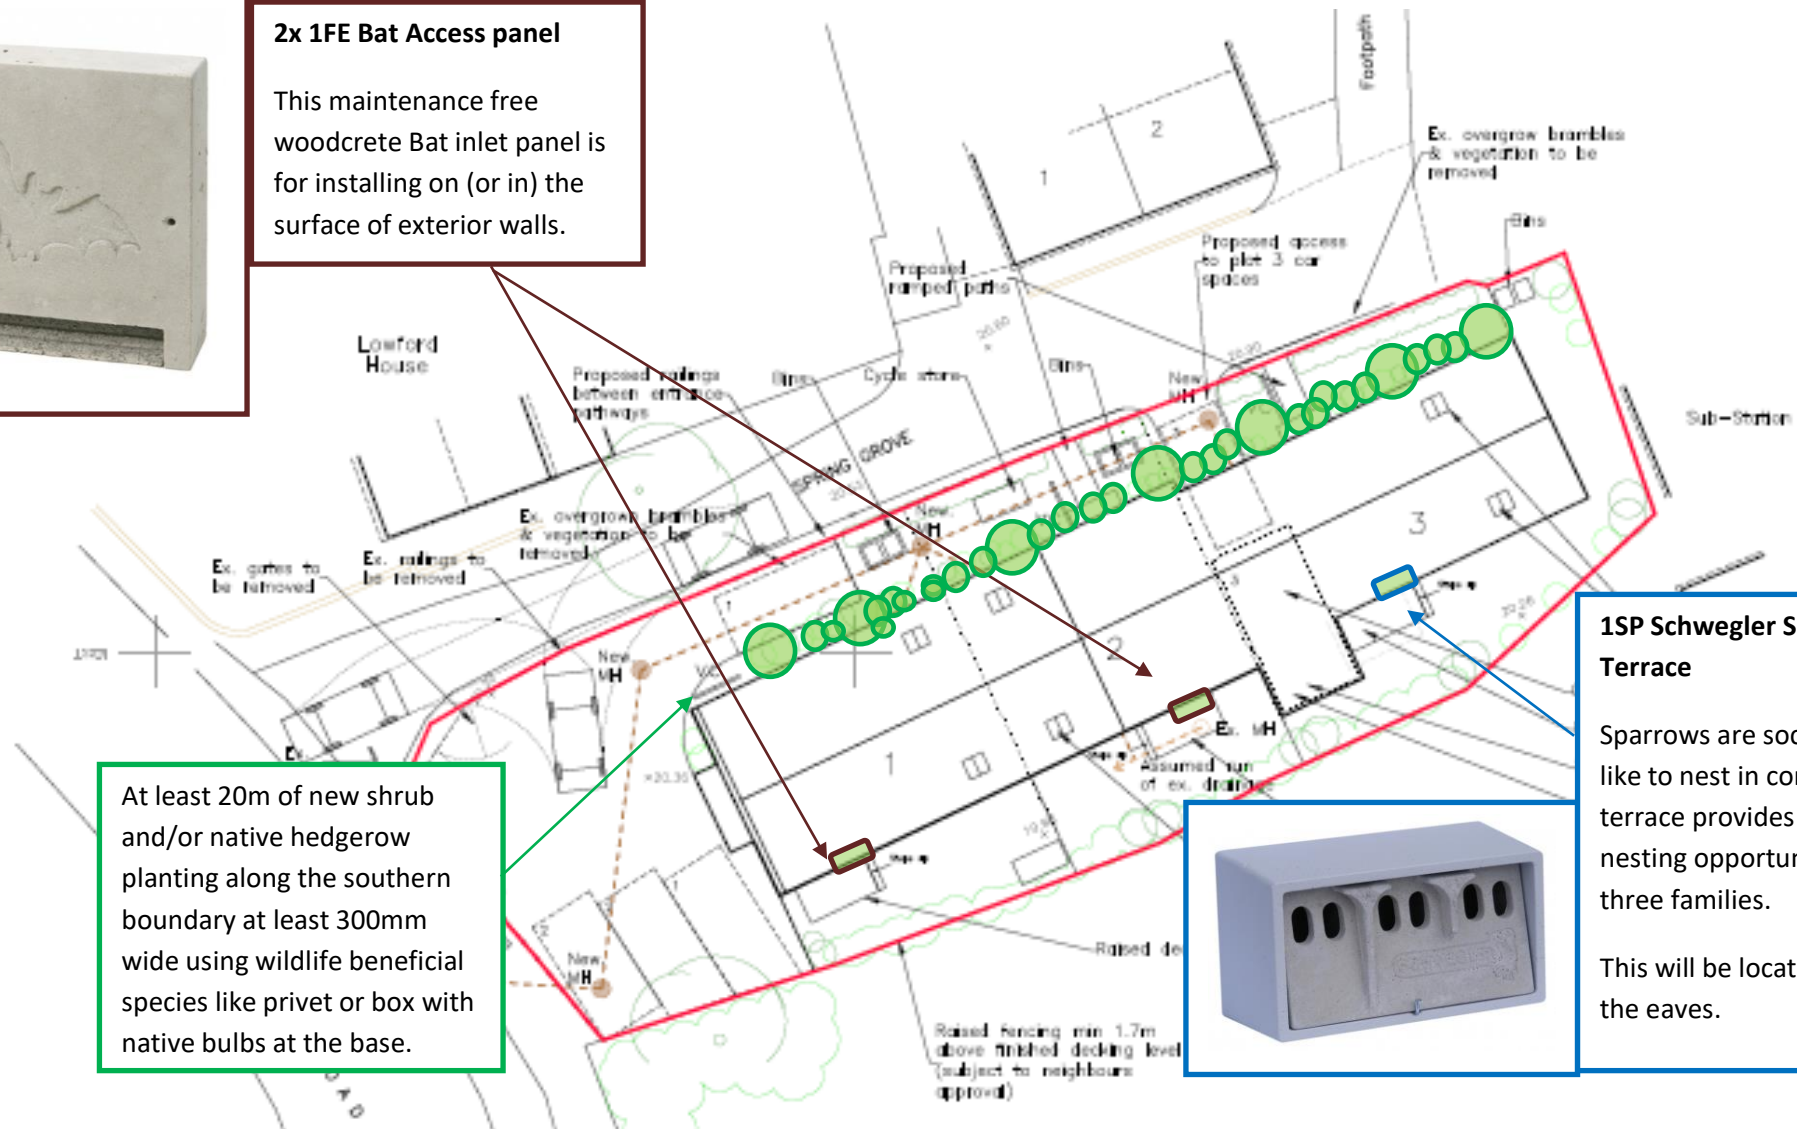
Sparrows are social birds and like to nest in company. This terrace provides ideal nesting opportunities for three families.

This will be located under the eaves.
