**DETAILED QUANTITATIVE GAS RISK ASSESSMENT**

**PARK FARM AREA, BOORLEY GARDENS**

**BELLWAY HOMES & MILLER HOMES**

| Reference: | GE20584/DQGRA/JUN22 |

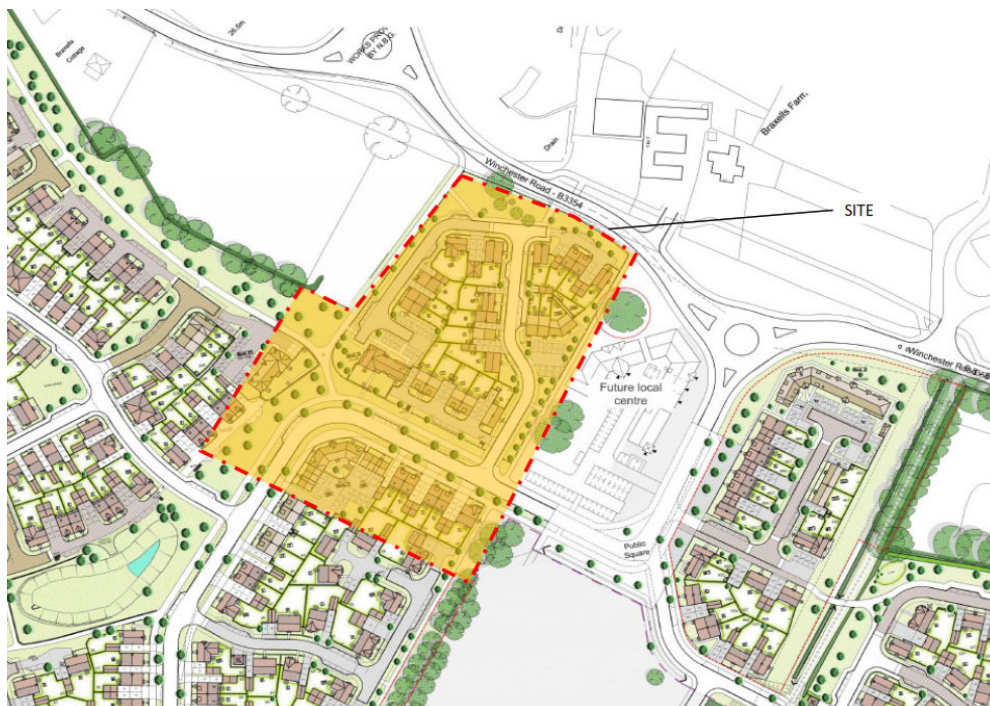
The development proposals for the Site comprise low rise residential with private gardens and associated infrastructure, including roads and public open space, as shown in Figure 3.

**Figure 3: Development proposals**
