Phase 1 Bat Surveys (PRA):

**94 Hiltingbury Road,**

**Chandlersford,**

Survey and report by: Vesper Conservation & Ecology Limited

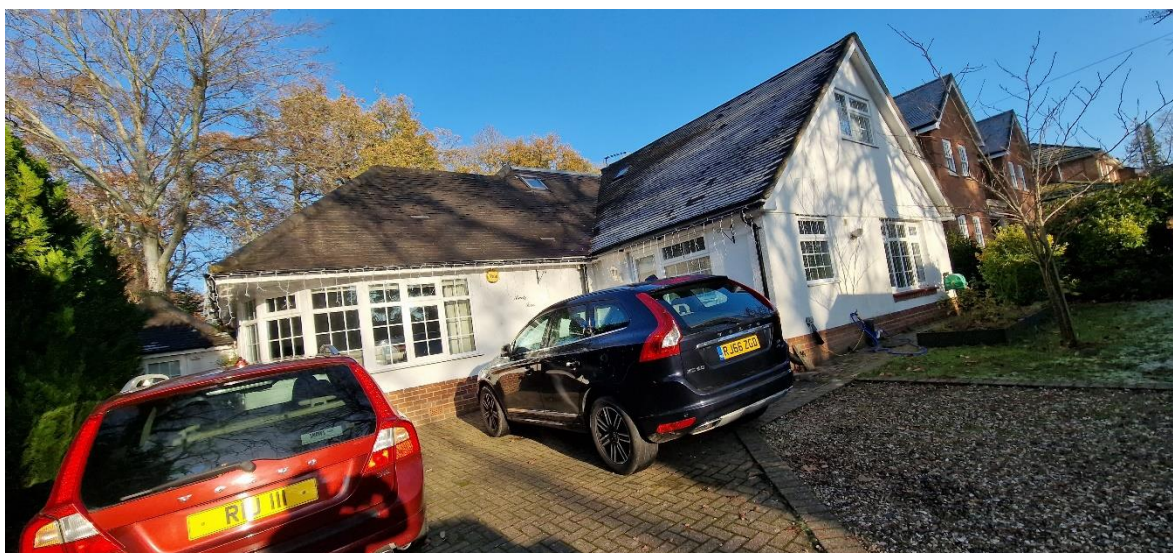
- 2.3 The building dates from about the 1940's and has had numerous extensions and has been reroofed about 7 years ago.
- 2.4 The roof material is tight fitting small machine-made clay tiles, there are no gaps or loose or missing tiles on any of the roof elevations.

**Picture 1:** The front elevation showing the dormer window

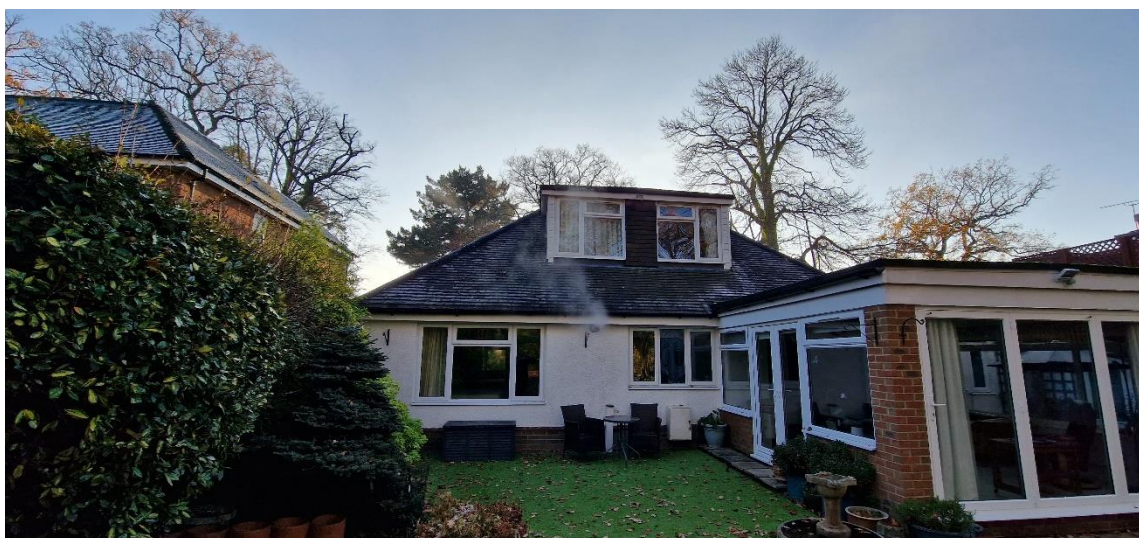
- 2.5 All the tile verges are intact with no obvious gaps or holes that would allow ingress into the building.
- 2.6 The rear elevation has one double dormer window the cheeks and eaves are covered in upvc cladding, there are some hanging tiles which are made from the same tiles as the roof, they are tight fitting with no gaps or holes that would allow ingress into the roof structure. The roof on the dormer window is felt covered flat roof.

**Picture 2:** Showing the rear elevation.

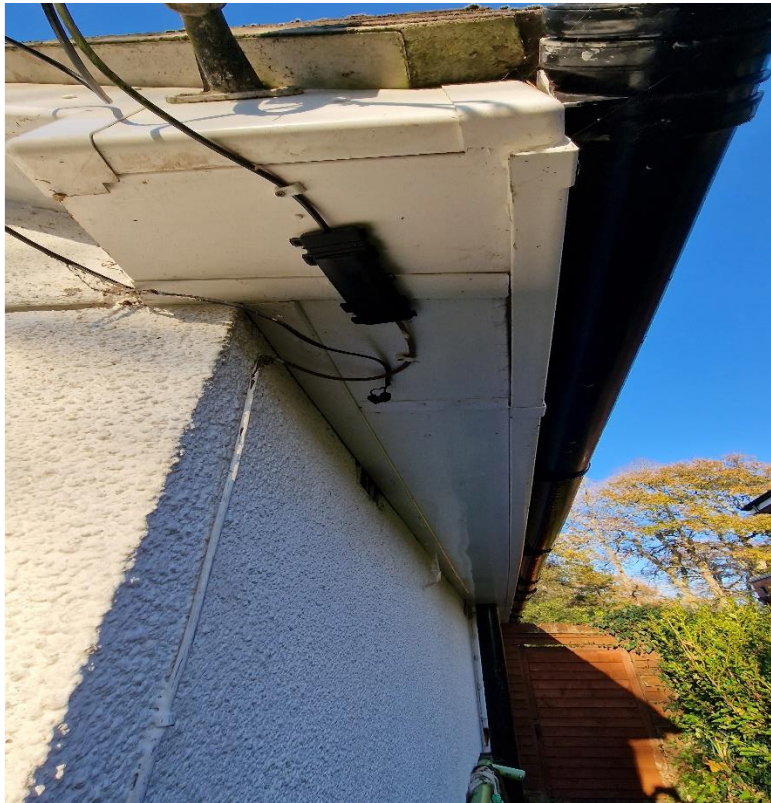
- 2.7 There are no gaps between the soffits and the walls and tiles, they have been replaced with UPVC and are tight fitting with no gaps.
- 2.8 The lead flashing around the building is in good order with no obvious gaps or holes that would allow ingress into the building.

**Picture 3:** Showing the UPVC soffits and eaves

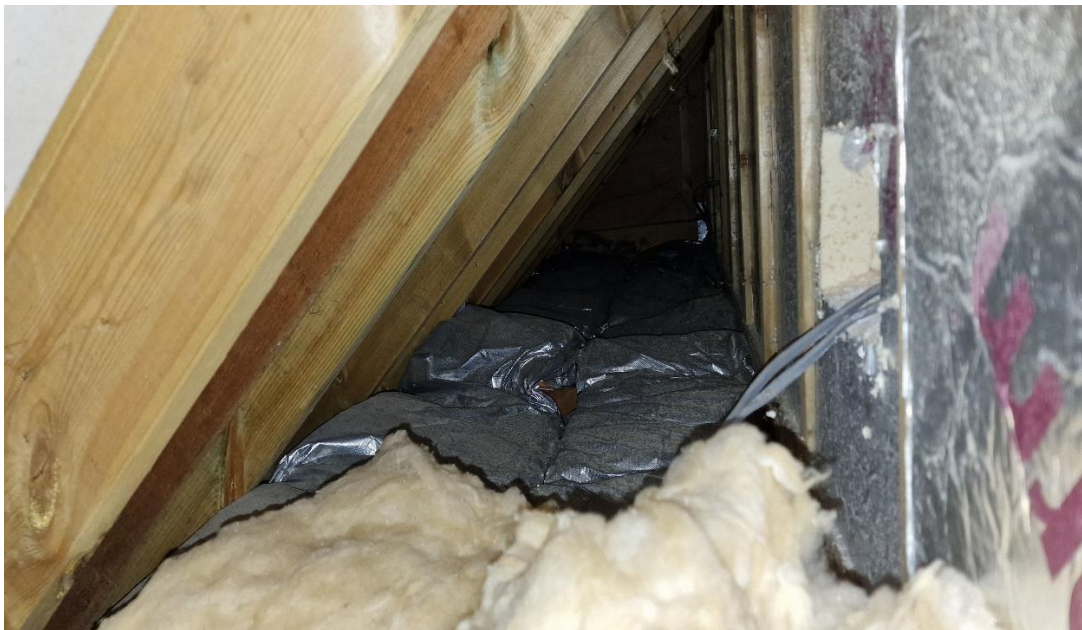
- 2.10 The building has small roof voids as there are rooms built into, the roof. There is a small void above each room, but this was not accessible, the other roof spaces were easy to access.

**Picture 4:** Showing the eaves spaces

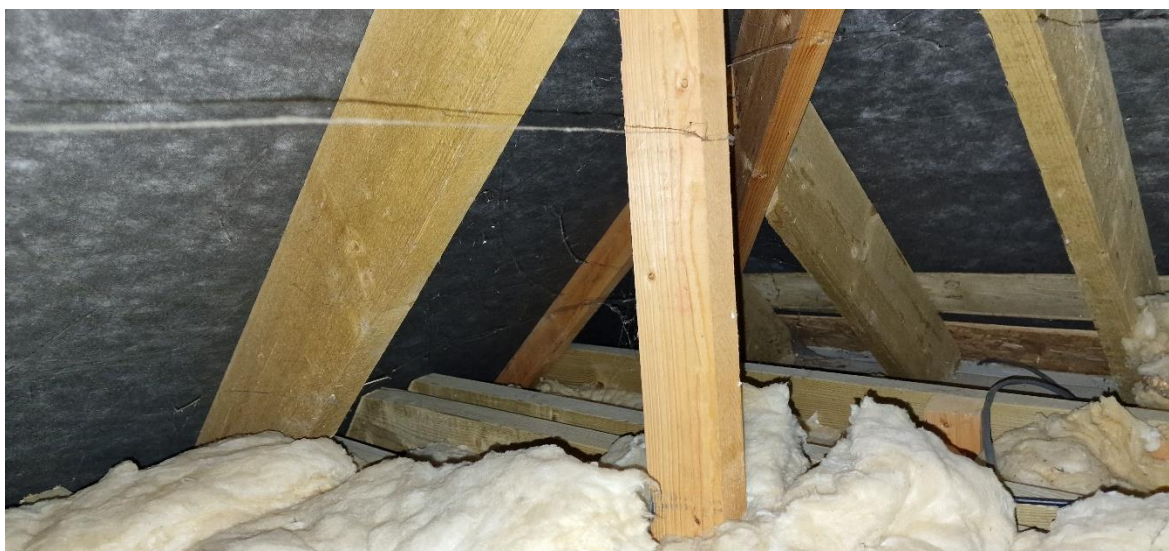
- 2.12 The tiles are backed with a woven breathable membrane which is intact and in good condition with no obvious gaps or tears that could allow ingress into the building.

**Picture 5:** Showing the roof spaces and the breather membrane

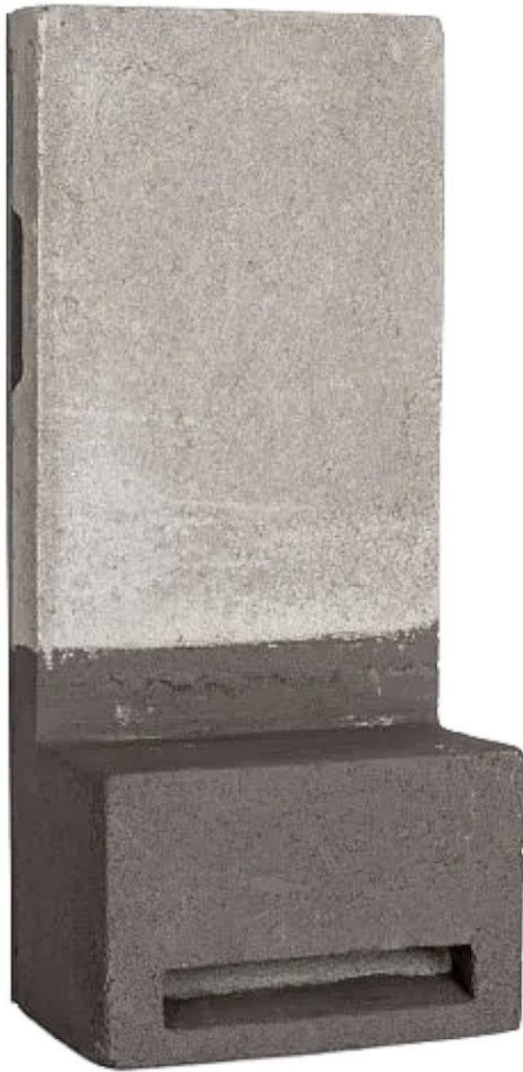
**Picture 7:** A PRO UK Build-in WoodStone Bat Box other types are available but an ecologist should be consulted about the choice.

| Recommendations | The incorporation of 2 inbuilt bat boxes (Figure 1 and Picture 7) into the new gable walls.<br><br>If bats are discovered during the work, then all <b>work must stop</b> and the advice of a suitable qualified person be sort.<br><br>. |
