## PRELIMINARY BAT ROOST ASSESSMENT

2 SHARON ROAD, WEST END, SOUTHAMPTON, SO30 3AS

FINAL REPORT

December 2022

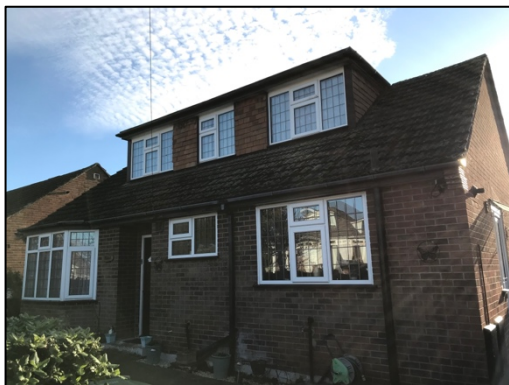
**Figure 1** – north-eastern elevation and dormer windows

The house comprises a single-storey brick-built bungalow which rises to a pitched and gable-end design roof clad with concrete interlocking roof and ridge tiles (Figure 1). The house is oriented northeast to southwest. A brick-built flat roof extension clad with roofing felt extends from the south-western elevation of the building (Figure 2). Two flat roof dormer windows extend from the north-eastern and south-western roof faces, the sides are clad with hanging concrete tiles and the face with uPVC boards. Lead flashing covers the joins between the dormer windows and main roof faces. The roof extends beyond the wall plate and the eaves are enclosed with uPVC fascia boards and under boards which adjoin to uPVC guttering. A bay window extends from the easternmost end of the north-eastern elevation (Figure 3). The windows and doors are set in uPVC frames that are tight fitting to the surrounding brickwork.

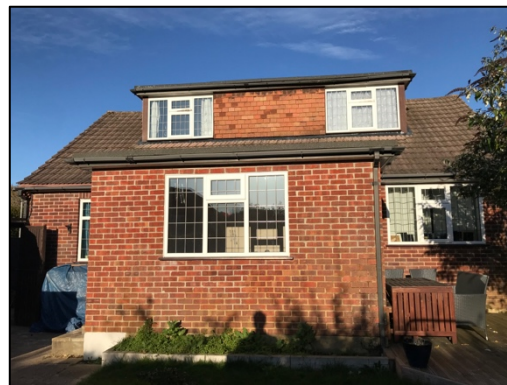
**Figure 2** – south-western elevation with extension and dormer windows

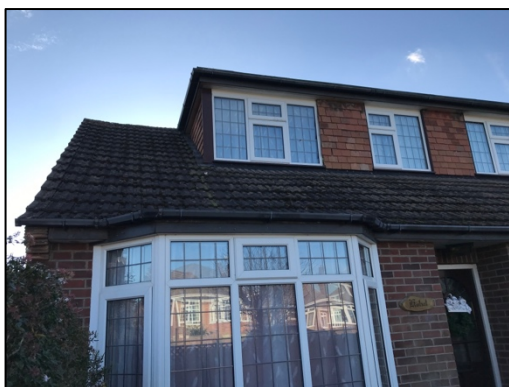
**Figure 3** – north-eastern elevation with bay window and dormer windows

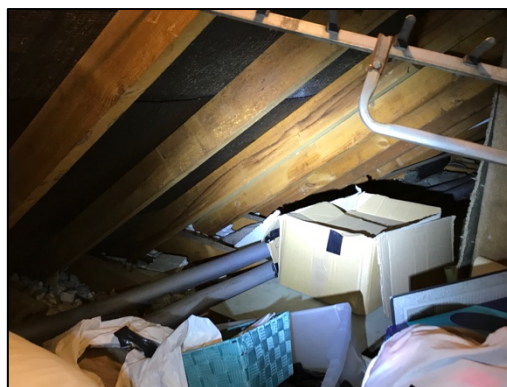
Internally, the house supports two distinct roof voids; both voids are at the side eaves which extend the full length of the building's north-eastern and south-western roof faces (Figure 7). Both voids support fibreglass insulation on the floor and heavy-duty bitumen lining on the roof (Figure 4). The voids are partially boarded and gaps in the eaves are infilled with fibreglass insulation. The spaces are used for storage and feature light cobwebbing throughout.

**Figure 4** – roof void with bitumen lining and stored items

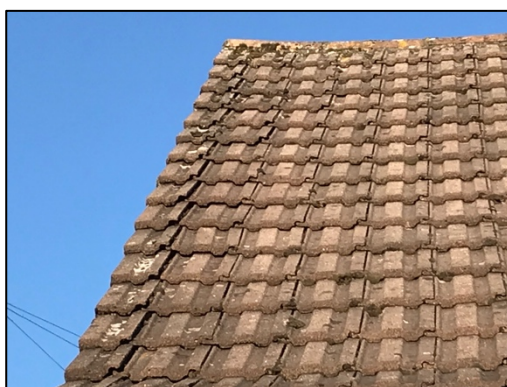
| <b>Suitability</b> | <b>Evidence</b> |
|---|---|
| <b>Exterior</b><br>The following suitable access/egress and roosting features were recorded externally during the survey:<br><ul style="list-style-type: none"> <li>- Lifted tiles on the south-western roof face (Figure 5).</li> <li>- Gaps under the hanging tiles on the dormer windows (Figure 6).</li> <li>- Slightly lifted sections of lead flashing.</li> </ul> | No evidence of activity was recorded externally during the survey. |

**Figure 5 – lifted interlocking concrete tiles**

In accordance with these guidelines, further survey effort will take the form of dusk emergence and dawn re-entry presence/absence surveys undertaken during the bat active season. The recommended minimum number of presence/absence surveys for a building with moderate roost suitability is two. Surveyors will be equipped with high-specification time expansion or full spectrum bat detectors with digital recording capability.

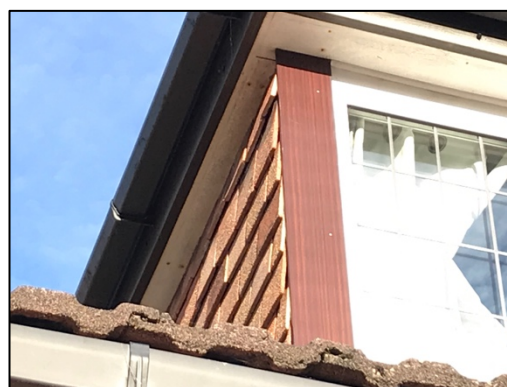
**Figure 6 – gaps under hanging tile on dormer windows**

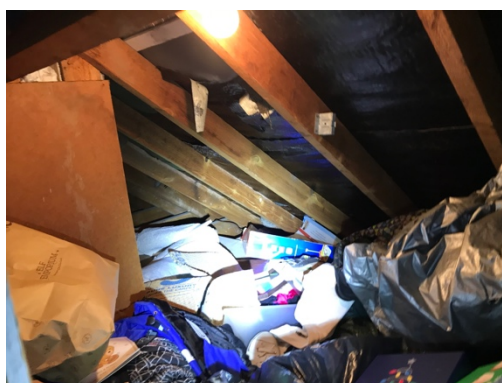
| <b>Suitability</b> | <b>Evidence</b> |
|---|---|
| <b>Interior</b><br>The following access/egress and roosting features were recorded internally during the survey:<br><ul style="list-style-type: none"> <li>- Tears in the bitumen lining causing hanging folds (Figure 7).</li> </ul> | No evidence of activity was recorded internally during the survey. |

**Figure 7 – tears in bitumen lining and hanging folds**
