Glen Lea House, Church Hill, Southampton  
Preliminary Bat Roost Assessment

EC1967-01

November 2022 Updated February 2023

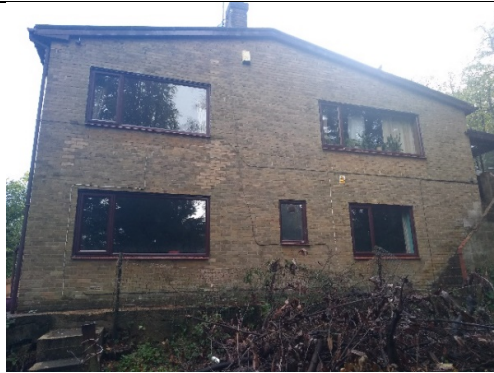
Photograph 1.  
B1, northwest elevation

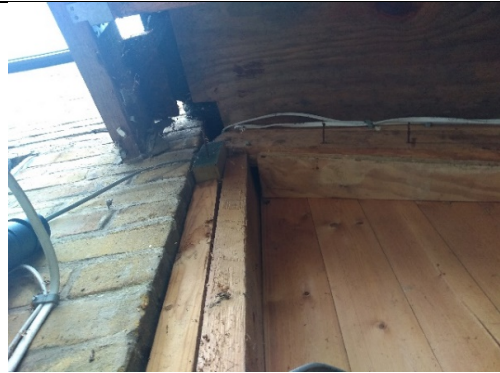
There was no direct evidence of bats but numerous access points in the main building were found. Roosting opportunities were found in between brick work, around the wooden soffit box, and gaps in the wooden porch.

Photograph 2.  
Gaps in the wooden porch on southeast elevation of B1

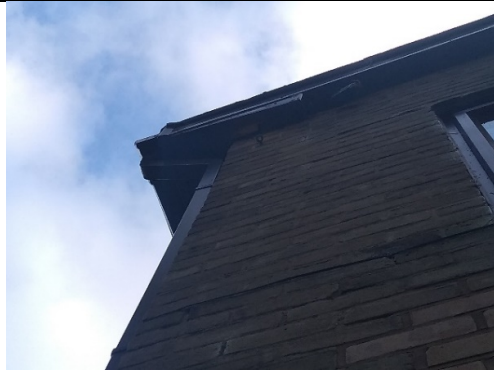
It is concluded that B1 has a moderate potential to support roosting bats as suitable roosting features have been identified. A key roosting feature identified was a wooden soffit box in the northwest corner and gaps in the brickwork and wooden porch area where a garage had been removed. A roof void is present. However, it is quite shallow and no obvious access points for bats were noted. The shed B2 has negligible potential for bat roosting.

Photograph 3.  
Wooden soffit box with gap northwest corner of B1

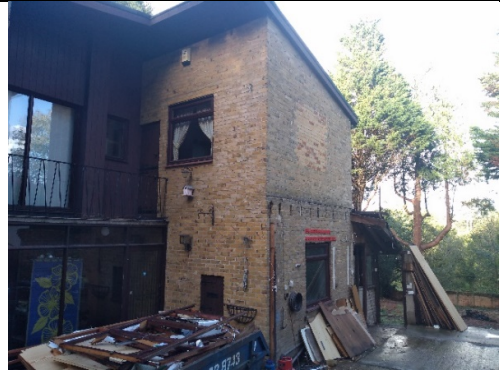
Building 1 (B1) was a residential building. Externally, it was made with brick and generally in good condition. However, where work had begun, there were some holes exposing the inner cavity wall and gaps in the brickwork had been created where the garage had been removed. There was a wooden soffit box which was generally in good condition, except for the northwest corner which was rotten and provided potential access for bats. Some gaps were present where a wooden porch joined the brick work of the building to the rear. The roof of the building was pitched; it did not have tiles but was covered with bitumen felt.

The cavity wall provides potential roosting spaces for bats, with access points at the holes resulting from garage removal, potentially with access to the walls via the gap in the wooden soffit. The roof void had low potential for roosting bats and no evidence of bats was found.

Photograph 4.  
Gaps in the brick work on southeast elevation of B1

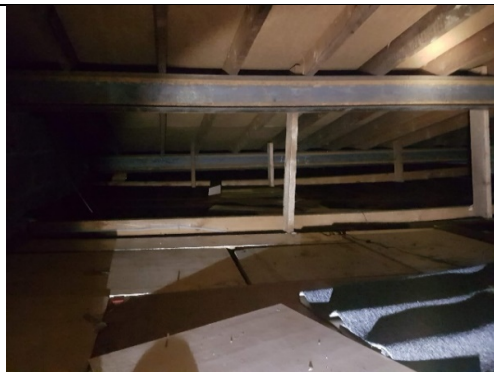
Internally, the loft of B1 was constructed from breezeblocks, which provided a cavity between inner and outer walls. The roof void was low in height and constructed from metal and wooden beams with sarking boards between the rafters. The internal roof space was in good condition and no features were noted which could provide potential access points for bats. However, mice and rat droppings were present, suggesting access could be gained where inaccessible to inspect.

Photograph 5.  
The roof space of B1

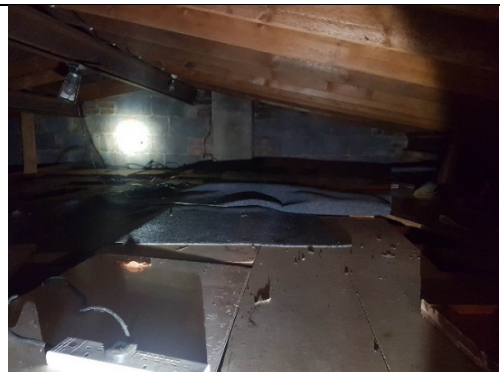
Photograph 6.  
The roof space of B1

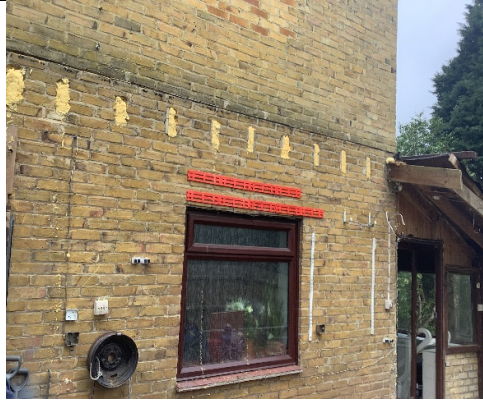
Following the 2023 site visit, no wooden soffit box could be seen to the north-west corner of the house and the fascias and soffits appeared in good condition. The cavity walls to the east of the house and the wooden porch no longer have access for bats to potentially roost in during the summer months.

Photograph 7. Cavity wall east of B1 20/02/23

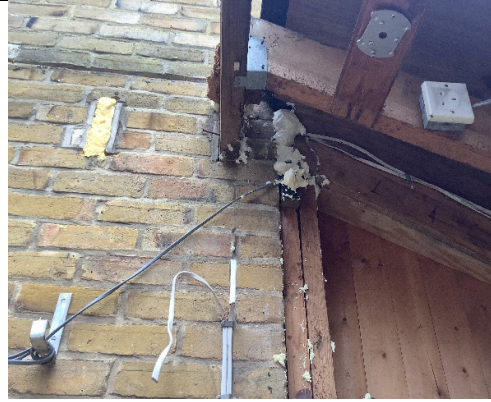
Photograph 8. Wooden Porch east of B1 20/02/23

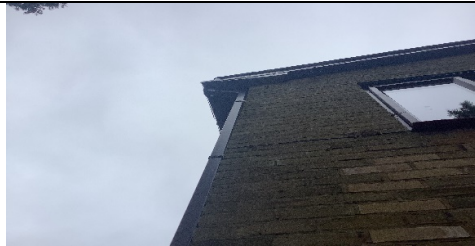
Following the second site visit in February 2023, at the client's request, the site visit update indicates that there are now no potential features for roosting bats to gain access to as of the date of this second site attendance. See photograph 9, Appendix B.

Photograph 9. Fascia and soffit north west of B1  
20/02/23
