**65 HOCOMBE ROAD, CHANDLERS  
FORD, SOUTHAMPTON**

**PRELIMINARY BAT ROOST  
ASSESSMENT**

Report No: RT-MME-158722-01

Date: August 2022

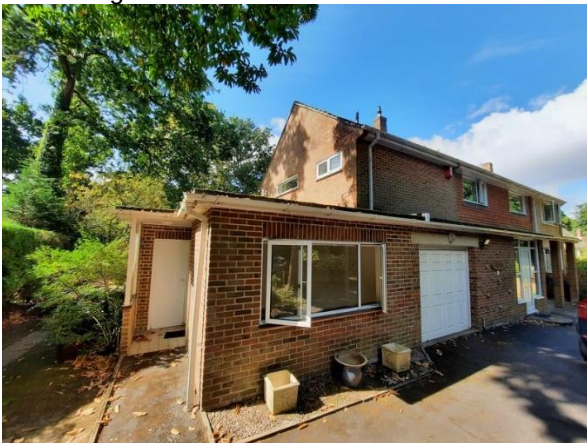
Building 1 is a residential, detached, two-storey brick building with a pitched concrete tiled roof. A single storey extension was present on the east elevation of the building. This building was in a good state of repair and in active usage, although until recently has been unoccupied. Plates 4.1 and 4.2 provide an overview of the building.

**Plate 4.1: Overview of Building 1 (Eastern Elevation)**

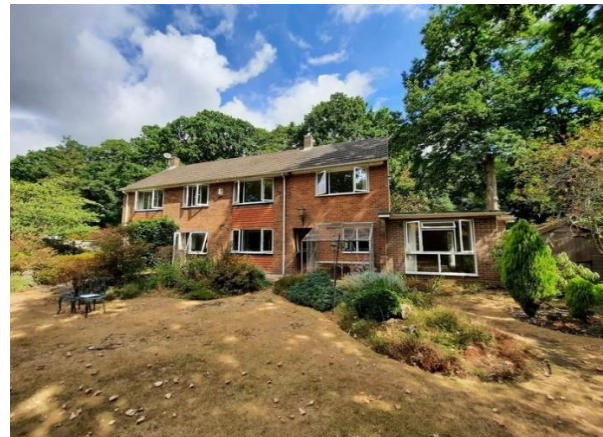
**Plate 4.2: Overview of Building 1 Southern Elevation)**

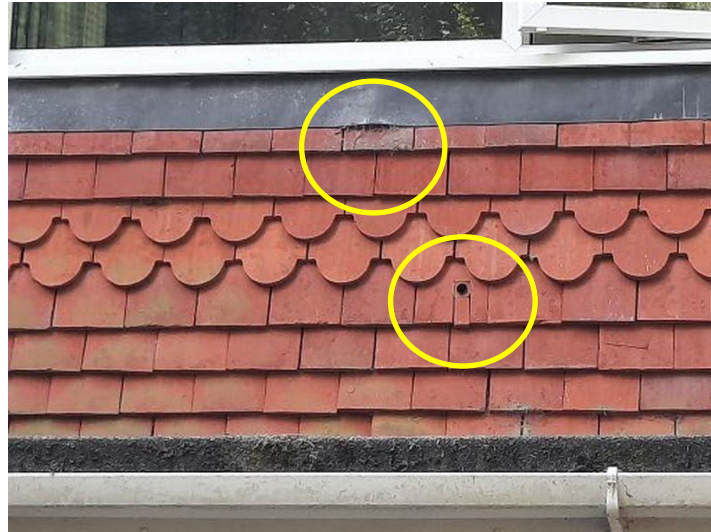
The roof of the building was made up of concrete roof and ridge tiles and were covered in moss. Several holes and warped tiles were present which may provide suitable access points for roosting bats. The northern and southern, elevations had sections of clay hanging tiles of which several features were recorded. (Plate 4.3).

**Plate 4.3: Gaps and Holes within the Hanging Tiles (Northern Elevation).**

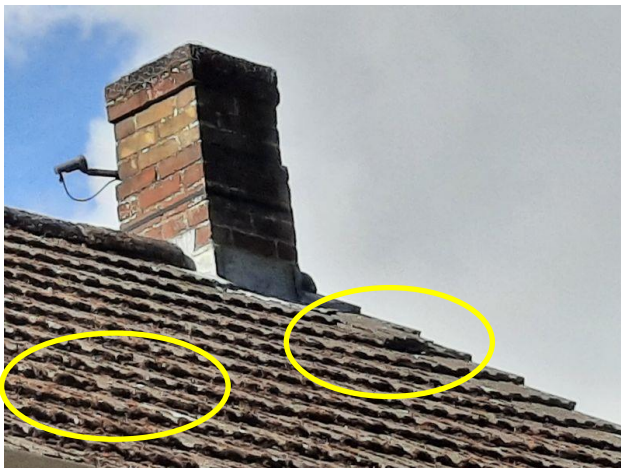
The concrete pitched roof revealed gaps under lifted tiles providing potential for roosting bats to access the internal roof space (Plates 4.4). Two brick chimneys were present along the eastern and western aspects of the ridge tiles and appeared to be in a good state of repair. Further gaps were noted underneath the ridge tiles, lead flashing and warped tiles (Plate 4.5).

**Plate 4.4: Gap under Lifted Tile**

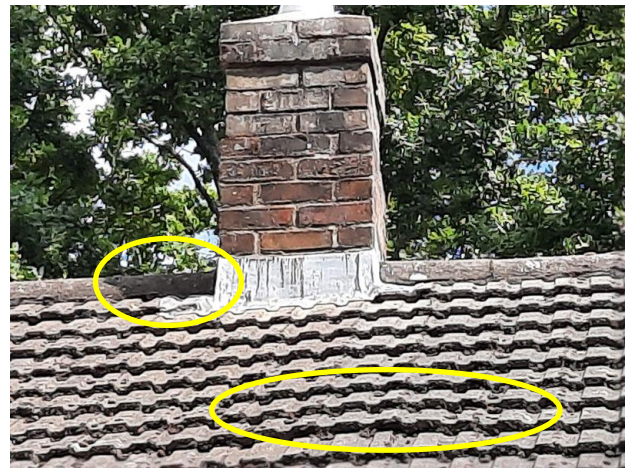
**Plate 4.5: Warped Tiles and Gap under Lead Flashing**

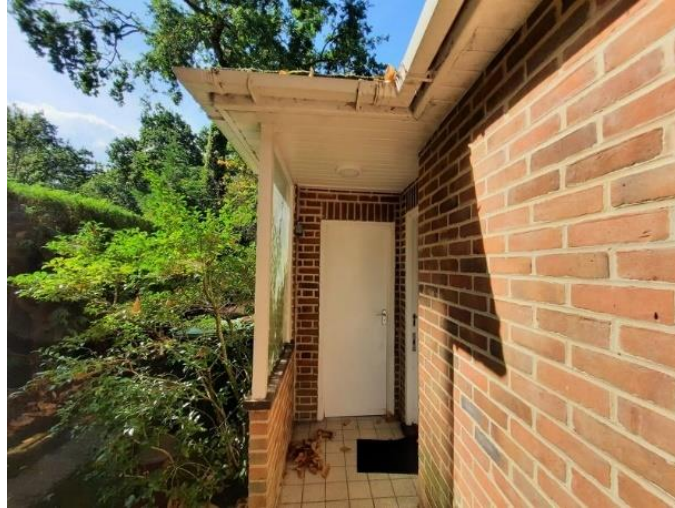
Plastic soffits were present on the southern and northern elevations which were in good condition and tight fitting (Plate 4.6).

**Plate 4.6: Tight Fitting Soffits**

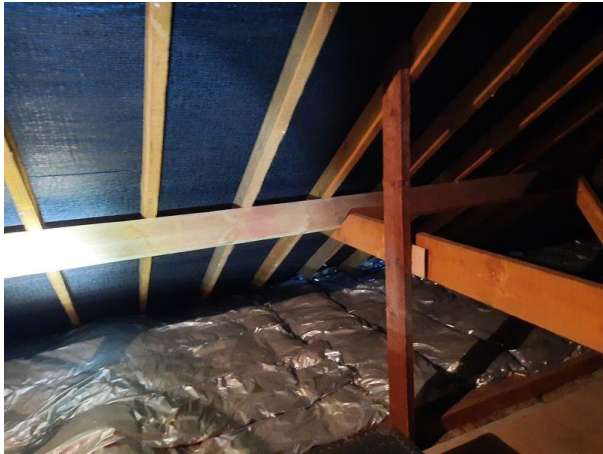
The loft space of the building was an A-framed modern truss with timber rafters and black felt sarking in between the rafters (Plate 4.7) A ridge beam was present which was suitable for roosting bats (Plate 4.8). The apex was approximately 3 m high. The gable ends comprised concrete breeze block and brick and the floors were insulated (Plate 4.9). A separate loft space was located over a previous extension and accessible through a small doorway (Plates 4.10 and 4.11).

**Plate 4.7: View of Felt Sarking**

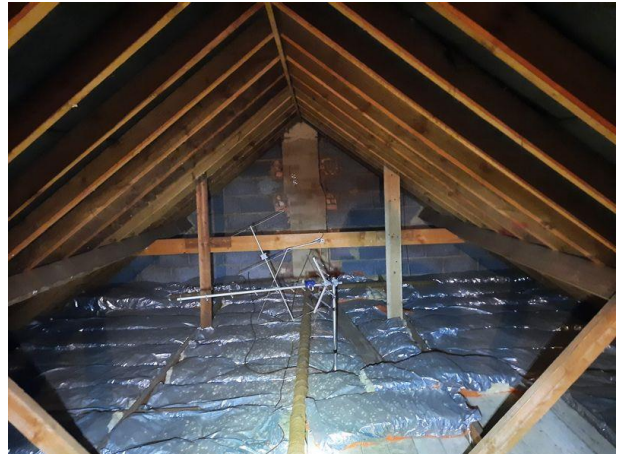
**Plate 4.8: View of Ridge Beam**

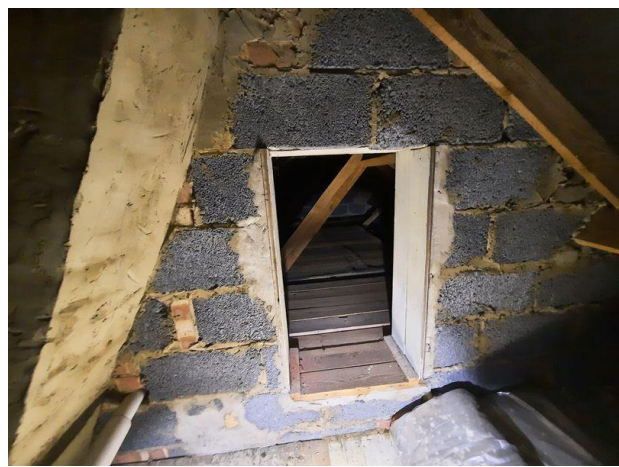
**Plate 4.10: Additional Loft Space Access**

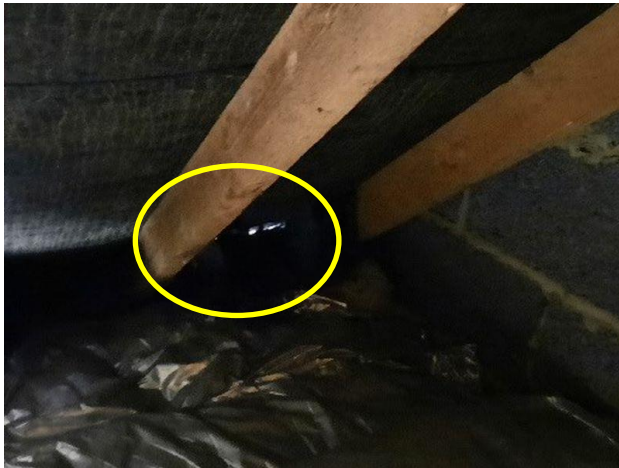
Light entered the loft space from gaps under the eaves (Plate 4.12). The felt sarking was in a good state of repair with the exception of some areas of torn felt (Plate 4.13). Bat droppings were recorded below these features and below the ridge beam. Bat droppings were scattered throughout the loft floor (Plate 4.14). The droppings resembled those of a brown long eared bat species and approximately 20 - 30 droppings were identified in total. These droppings were old and deemed to have been deposited during the previous bat activity season 2021. Droppings were recorded under the ridge beam and below the hole in the sarking.

**Plate 4.12: Light Entering from Underneath Eaves**

Internal inspection of the building identified gaps under the eaves and torn sarking which revealed exposed roof tiles. These features provided access into the loft space. Evidence of roosting bats were recorded in the form of bat droppings which were located beneath the ridge beam and beneath the hole in the sarking.

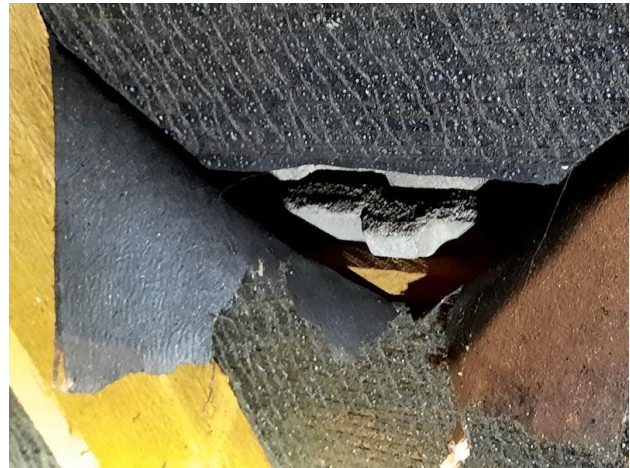
**Plate 4.13: Torn Felt with Access to Roof Tiles**

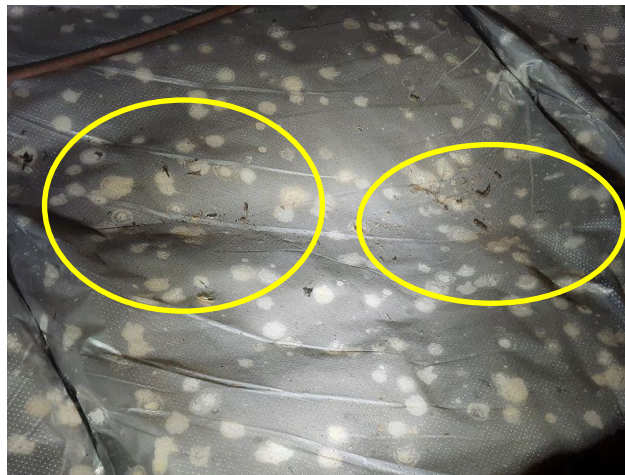
**Plate 4.14: Example of Bat Droppings**

As a bat roost/resting place has been identified in the building, no unlicensed work can be undertaken which will contravene the legislation outlined in Appendix 1.

Prior to any works being undertaken which are likely to result in a breach of the legislation, a development licence must be obtained from Natural England. The licence application process will include the submission of a method statement detailing the current status of bats on site and how the favourable conservation status of the bat population will be maintained. Prior to a licence being issued, planning permission must be granted and relevant conditions relating to protected species and habitat issues must be discharged.

To inform the licence application at least three dusk emergence and/or dawn re-entry surveys must be undertaken during the bat activity season in line with Bat Surveys: Good Practice Guidelines published by the Bat Conservation Trust (Collins, 2016). The bat emergence/re-entry survey season extends from May to September. At least two of the surveys should be undertaken during the peak season for emergence/re-entry surveys between May and August and one of the three surveys should be a dawn re-entry survey. These surveys need to be carried out during the activity season closest to the start date of the proposed development to ensure that the data obtained is current and appropriate for assessment by Natural England.
