ONE  
HORTON  
HEATH

# Detailed Planning Application Upper Acre

Flood Risk Assessment and Water  
Management Strategy Part 2

December 2020

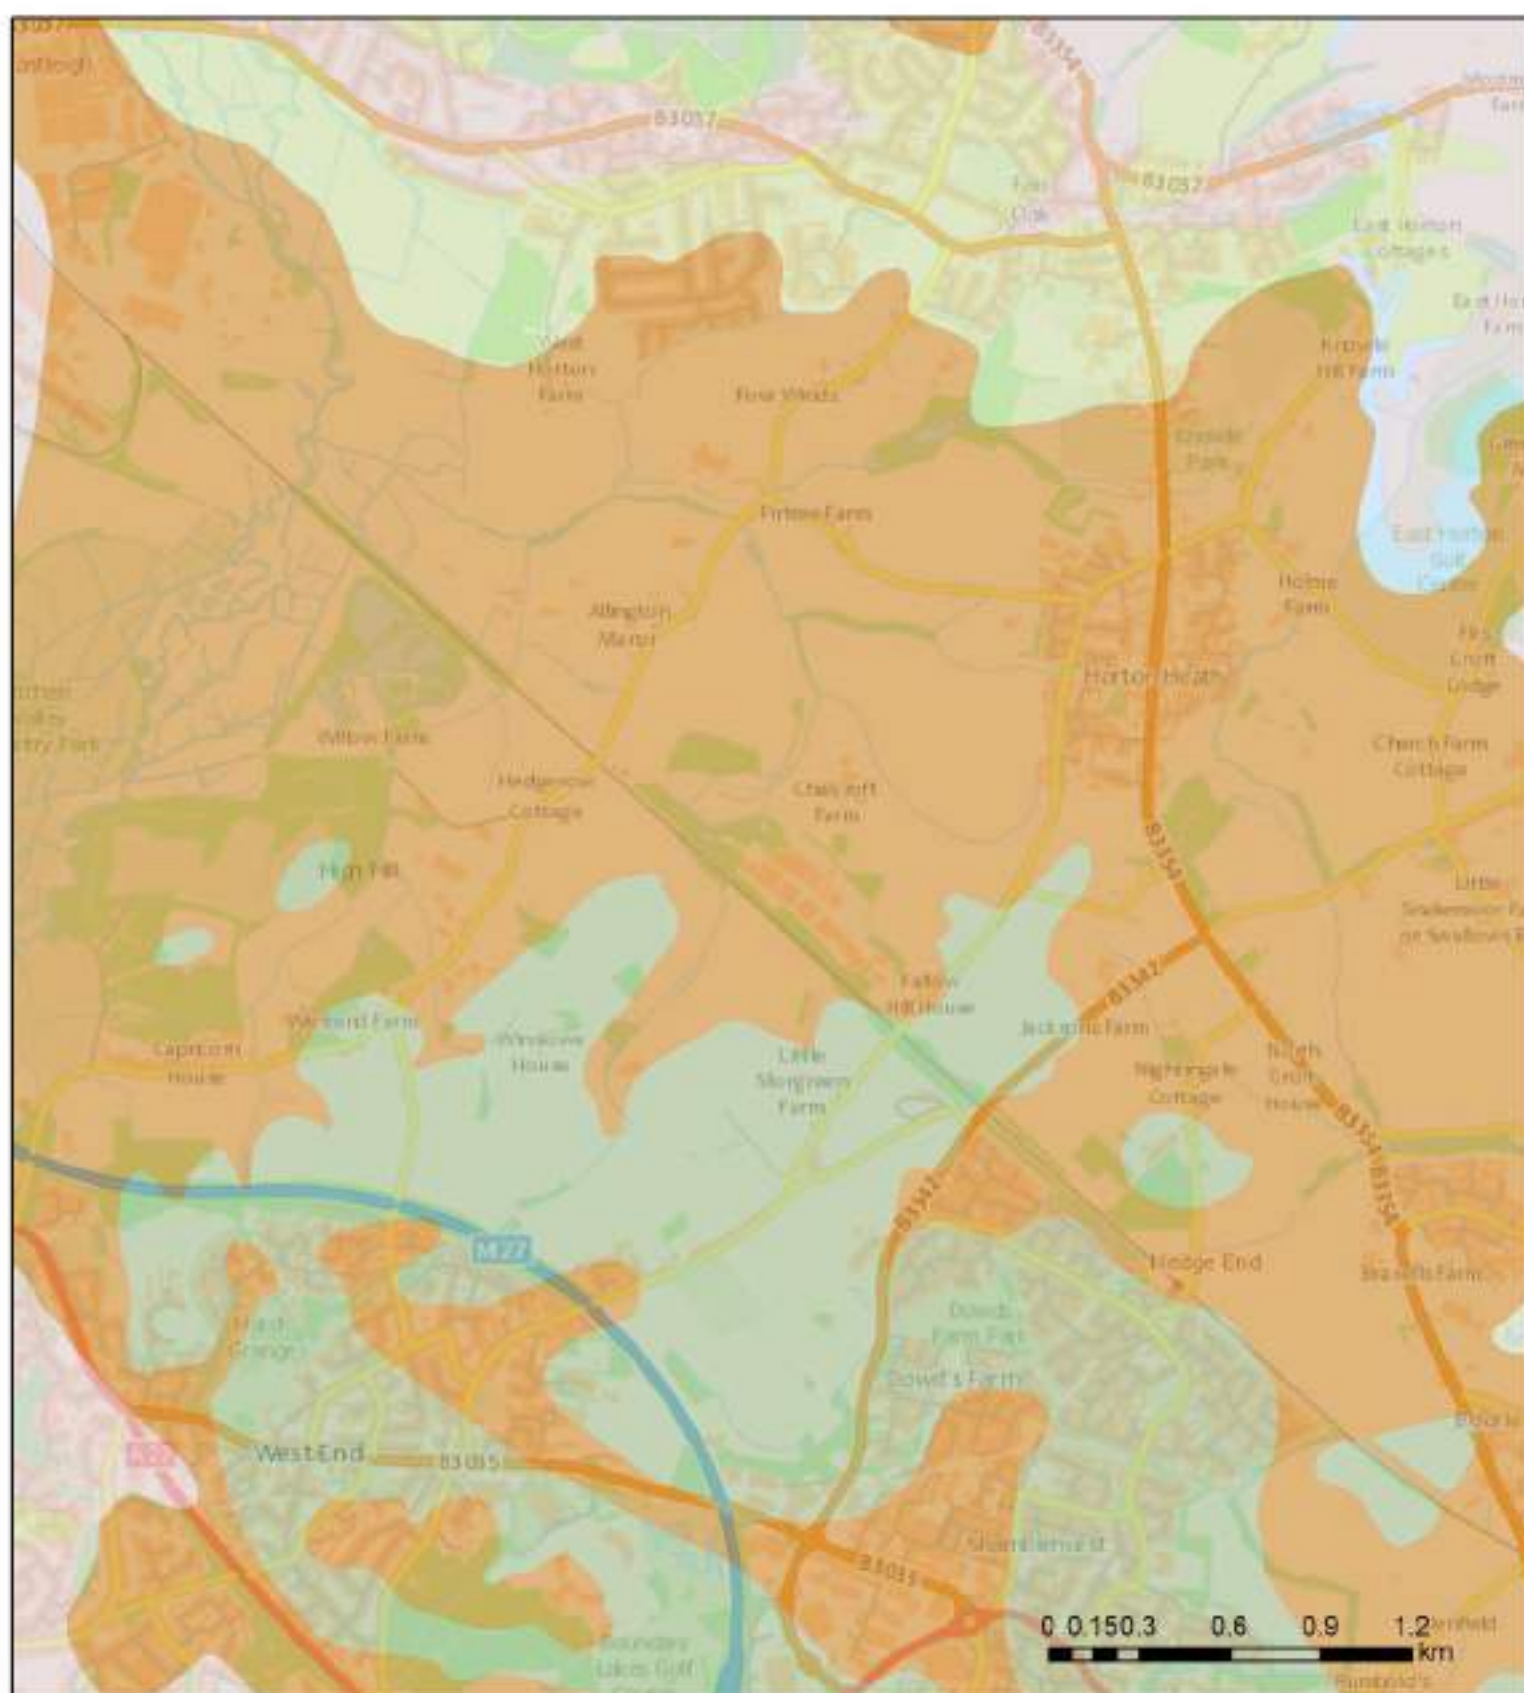
# Bedrock Geology

Bedrock geology 1:50,000 scale

[DURLEY SAND MEMBER - SAND](#)
-

[LONDON CLAY FORMATION - CLAY, SILT AND SAND](#)
-

[PORTSMOUTH SAND MEMBER - SAND](#)
-

[EARNLEY SAND FORMATION - SAND, SILT AND CLAY](#)
-

[LONDON CLAY FORMATION - SAND](#)
-

[MARSH FARM FORMATION - CLAY, SILT AND SAND](#)
