FLOOD RISK STATEMENT

ONE HORTON HEATH- LOWER ACRE  
OCTOBER 2022

PROJECT NAME: One Horton Heath- Lower Acre  
PROJECT NUMBER 5015560  
DOCUMENT NUMBER: 5015560-RDG-XX-XX-DOC-C-9960  
DOCUMENT STATUS: S1- For Information

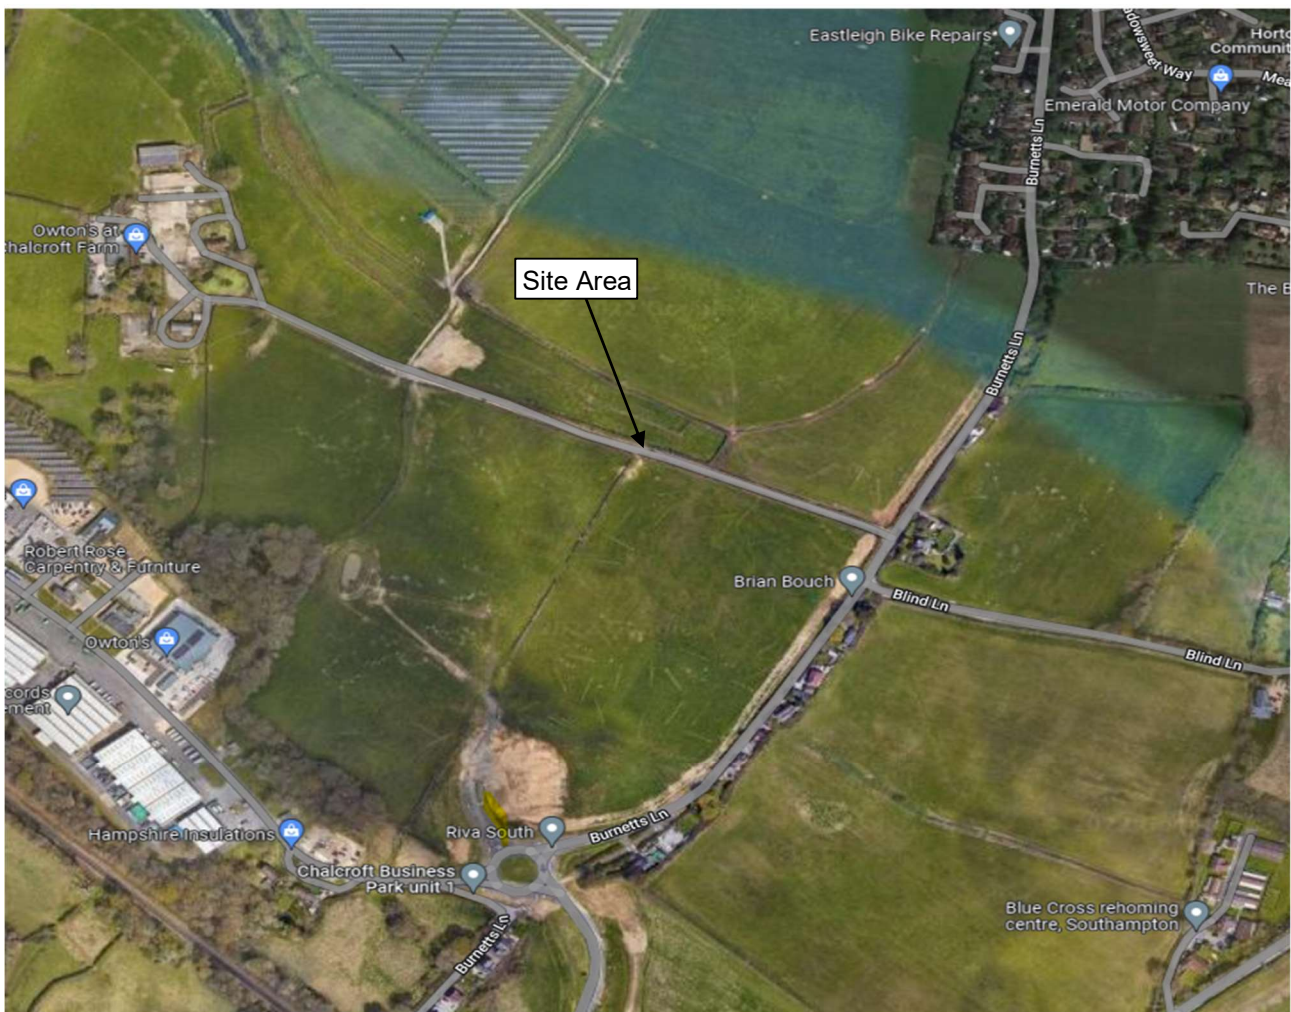
Figure 1 – Site Location Plan

The application site is located south of Horton Heath Village. The site is currently being used as an agricultural field and is bounded by Burnetts Lane on the eastern side. Refer to Appendix A for the Site Plan.

The Ordnance Survey (OS) grid reference for the application site is SU 49072 16324, approximately 449072E, 116324N and the nearest postcode is SO30 2HH. The total site boundary is circa 12.90hectares,

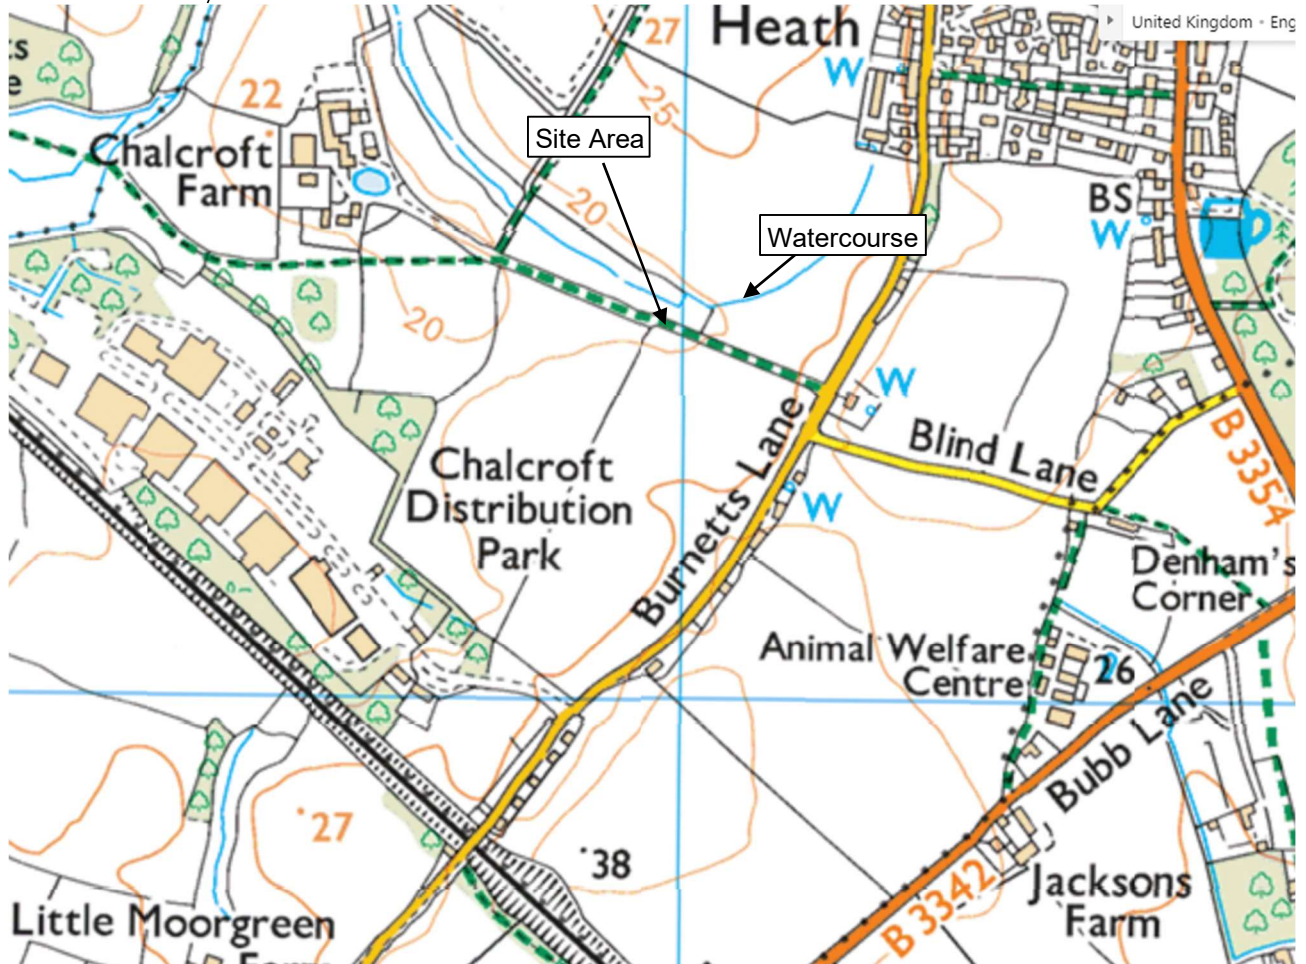
Figure 2 – Watercourse near the site

Environmental Agency (EA) online maps indicate that the nearest main river Itchen is 4700m away from the site. The tributary of River Itchen runs north of the site.

- 6.1.4. An ordinary watercourse flows north of the site, which subsequently discharges to the tributary of River Itchen. According to the report issued by Odyssey, the groundwater level recorded is 2.70m bgl. However, the ground investigation report carried out by Geo-environmental Service for lower acre is between 1.1m bgl and 3.3m bgl.
