# SuDS Drainage Design Report Barchester – Challoner House Care Home, 175 Winchester Road, Chandlers Ford, Eastleigh, SO53 2DU

## Prepared on behalf of Barchester Healthcare Ltd

**Rev. 03**

## FLOOD RISK ASSESSMENT & SUDS STRATEGY

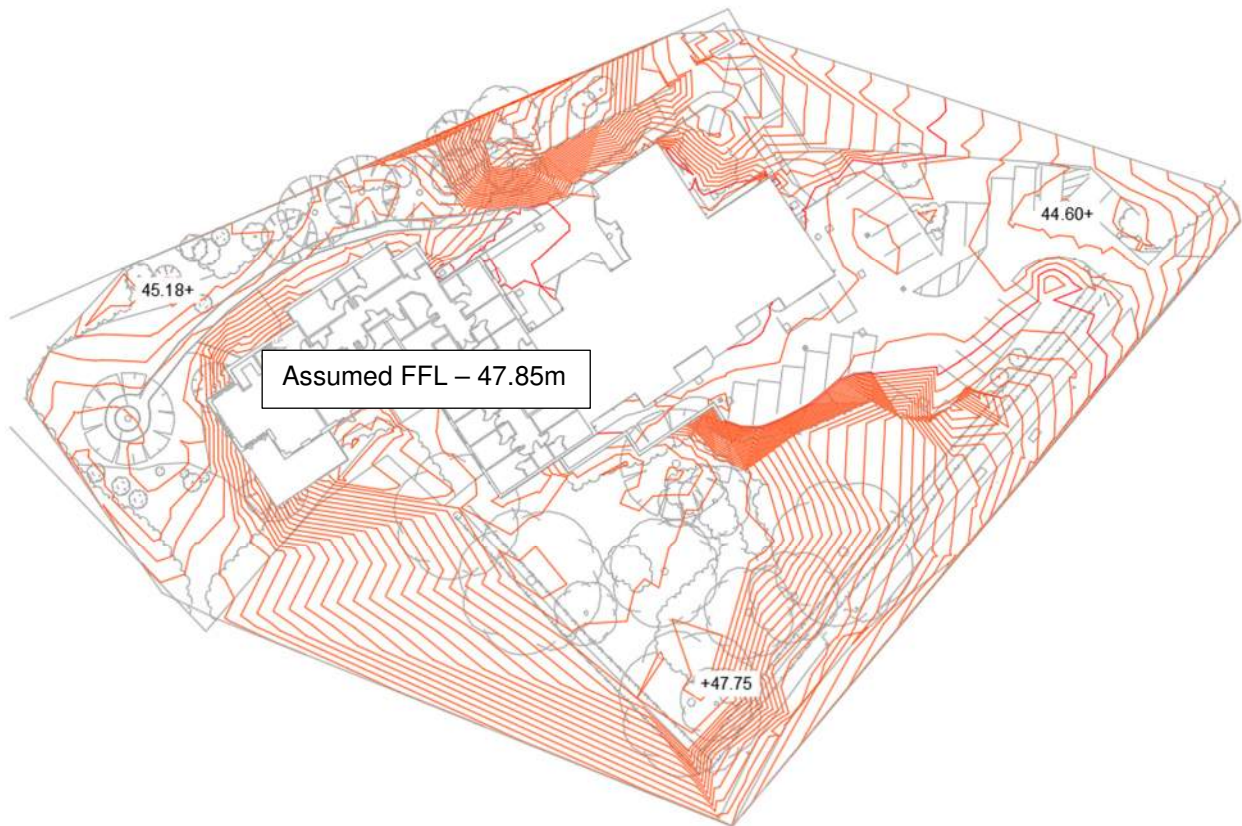
- 3.3.1 The existing site is currently used as a care facility, known as 'Challoner care home'. The site has direct highway access off Winchester Road.
- 3.3.2 A topographical survey of the site was completed and a copy of which is provided in Appendix C. The ground levels vary across the site, ranging from around 47.75mAOD in the Southern corner, to around 44.60mAOD in the Eastern corner.

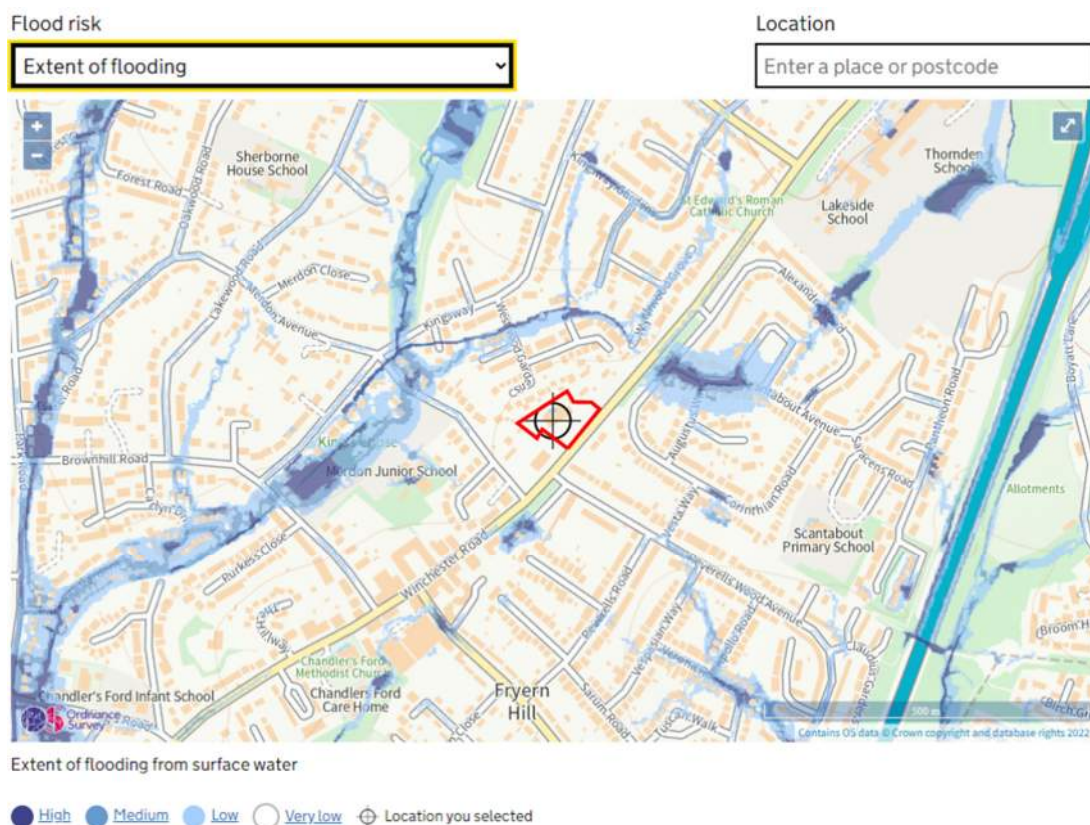
**Fig. 3.3 – Surface water flood map**

| Other flooding incurring at the site | None. While there is Very Low probability of surface water flooding within Winchester Road, there is also no surface water flooding within the proposed site. |

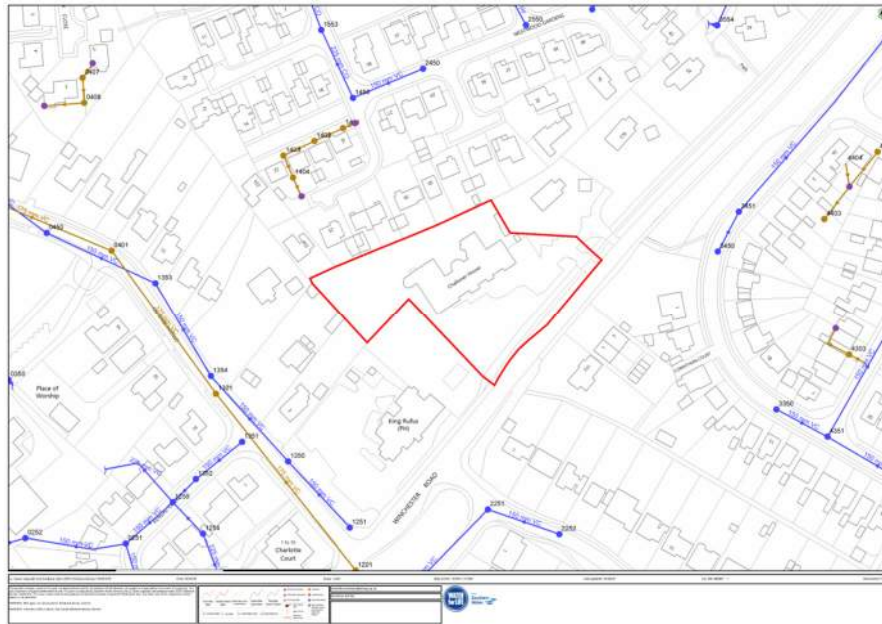
**Fig. 3.6 – Extract from Southern Water Asset Plans**

- 3.5.1** The local sewer authority is Southern Water (SW). As per the public sewer mapping provided by Southern Water, there is currently shown to be no known public sewers within the site or the section of Winchester Road adjacent to the site, with the closest foul sewer being approximately 36m Northwest. A copy of the provided asset plans can be found in Appendix B.
- 3.5.2** There are no publicly maintained surface water sewers serving the existing site.

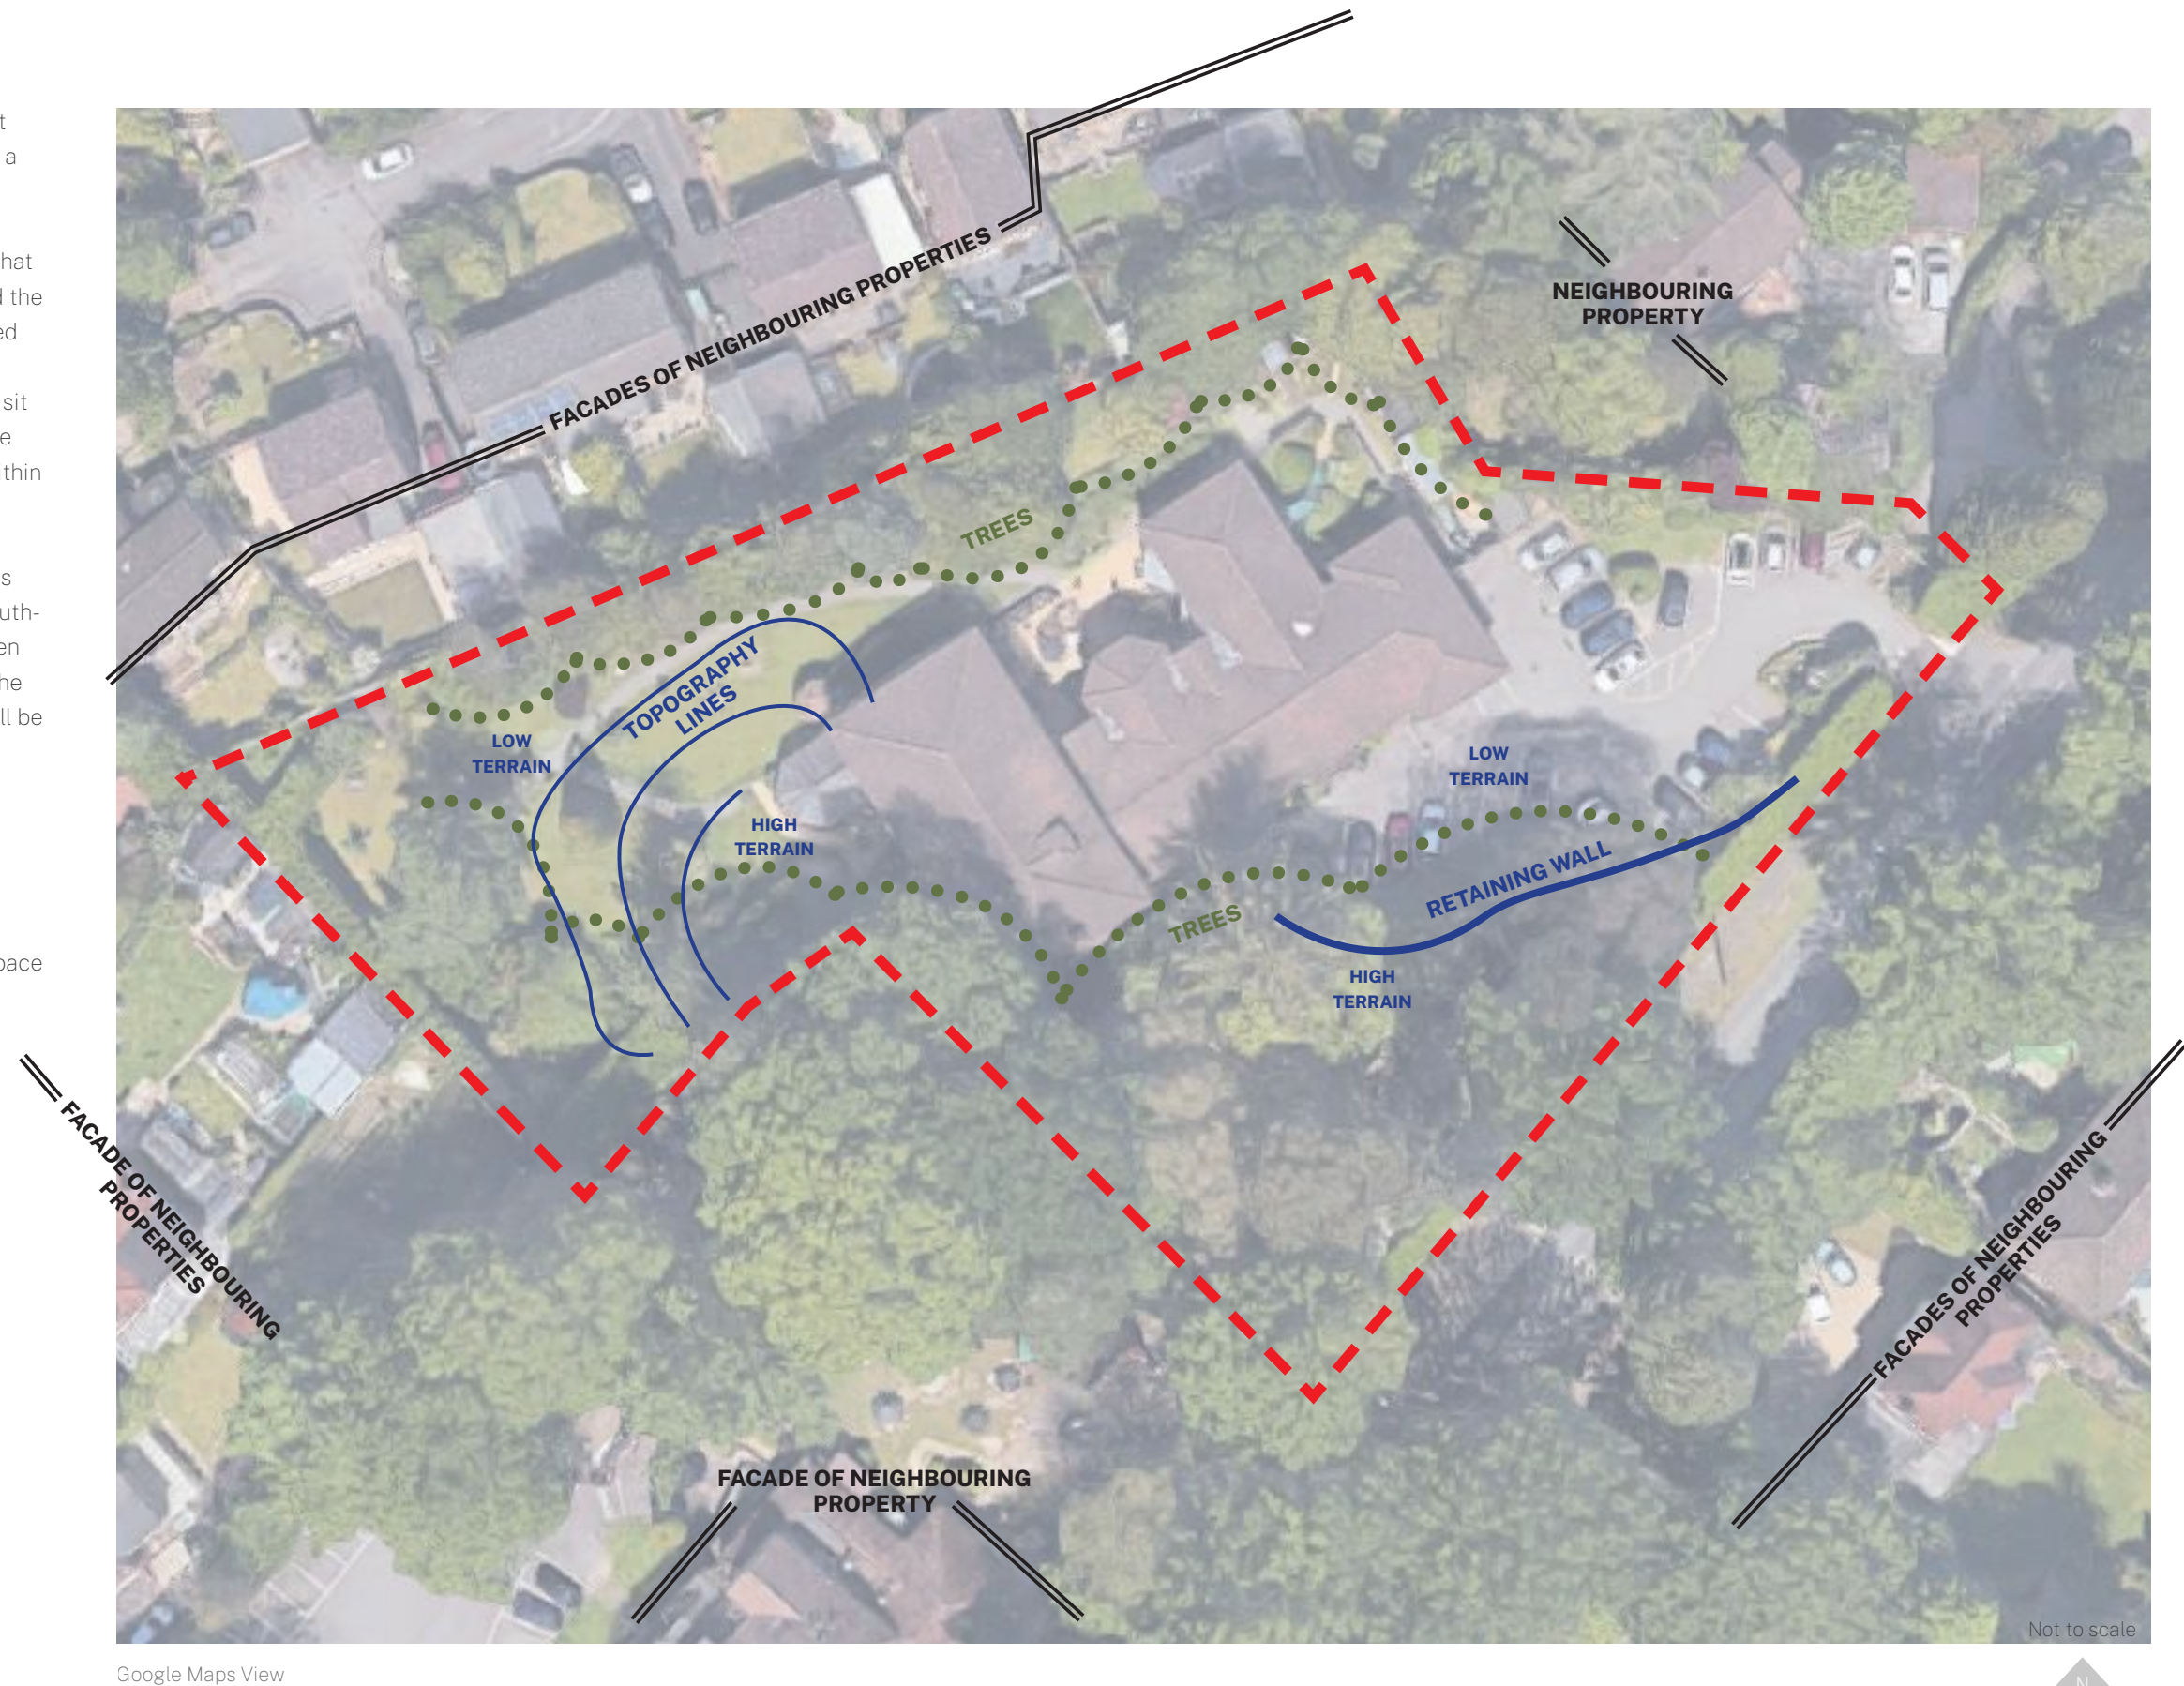
The first constraint involves the neighbouring properties that surround the site including the residential neighbours and the pub. The neighbouring amenity spaces should be protected from damage to outlook, overlooking, sense of enclosure and loss of daylight / sunlight. Therefore the proposal will sit at an appropriate distance away from the boundary and be designed to have an appropriate scale and appearance within the setting.

Secondly, the green dotted line represents where the trees surround the building particularly on the Northern and South-Western boundaries. These create a natural buffer between the existing care home and the properties that surround the site. This will benefit the proposal where any extension will be less exposed.

Finally the proposal will need to consider the topography of the site. The topography lines and retaining wall are illustrated in dark blue, showing the parts of the site that sit on higher ground. The design of the extension will accommodate for this so that users can access outside space from all areas of the scheme.

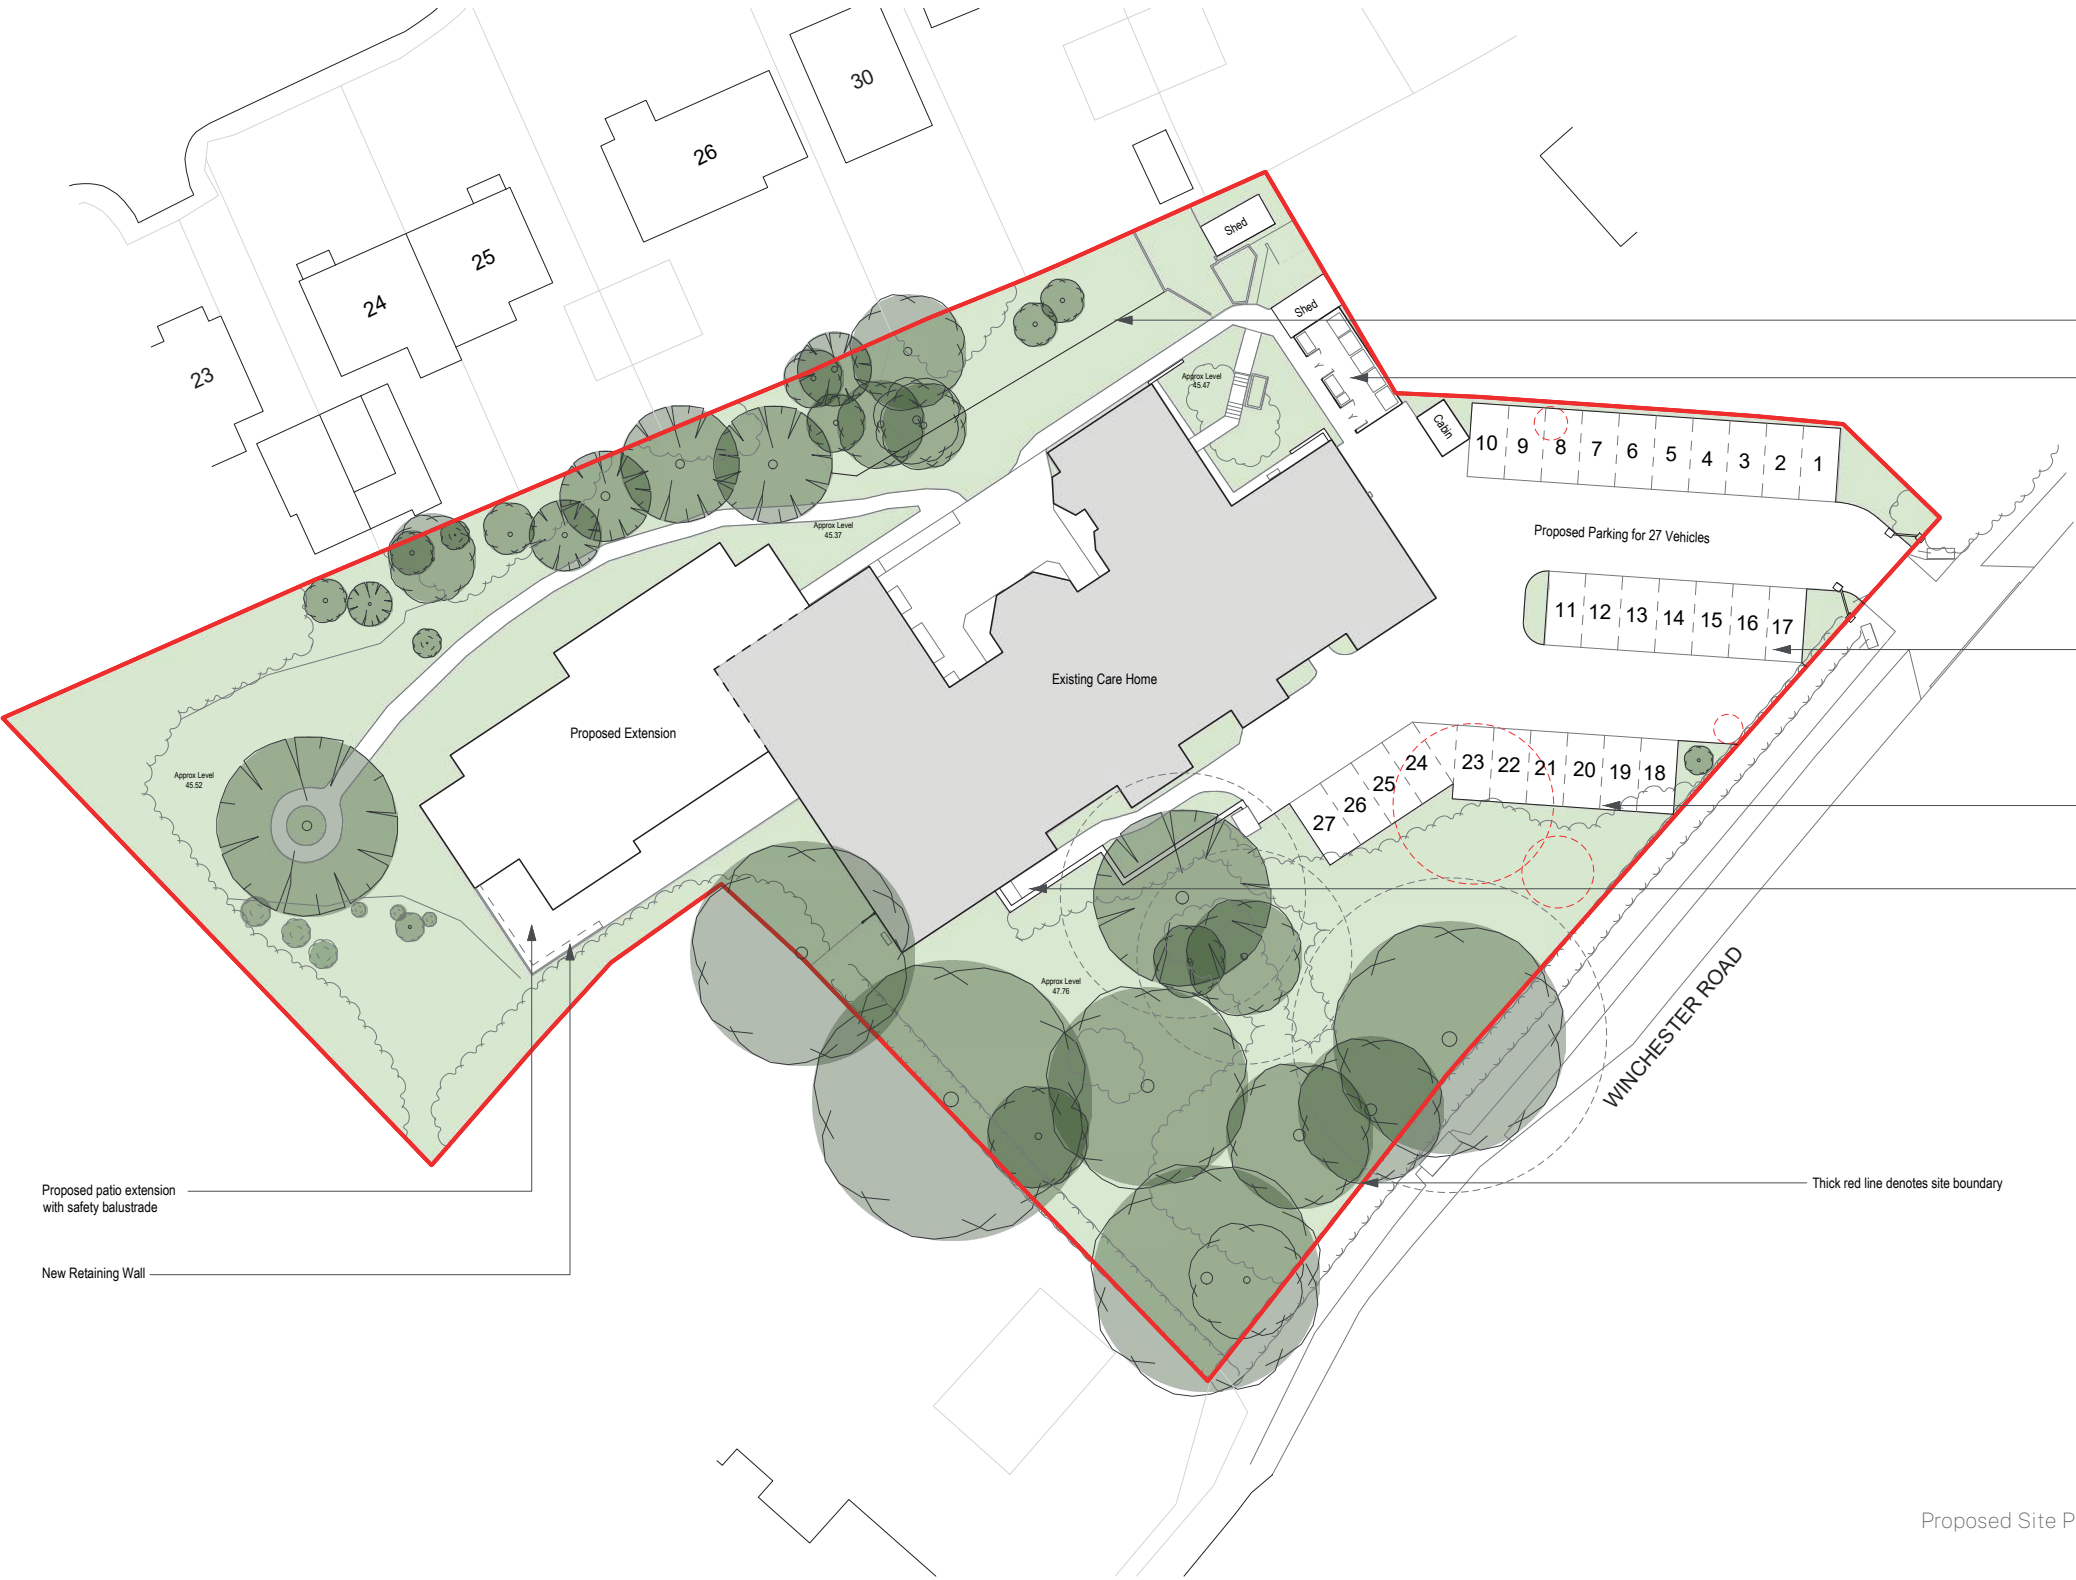
Proposed Site Plan

The previously identified constraints provide a framework for identifying potential development across the site. These have been incorporated in the design of the extension. The proposed site plan illustrates the proposal. The grey area highlighted represents the existing care home footprint. The drawing illustrates how the extension sits within the site.

The extension accommodates for the change in levels. Illustrated on the site plan is the proposed patio with access for residents to and from the day room.

The parking has been rearranged to accommodate for more adequate parking spaces and a more efficient layout of the car park.

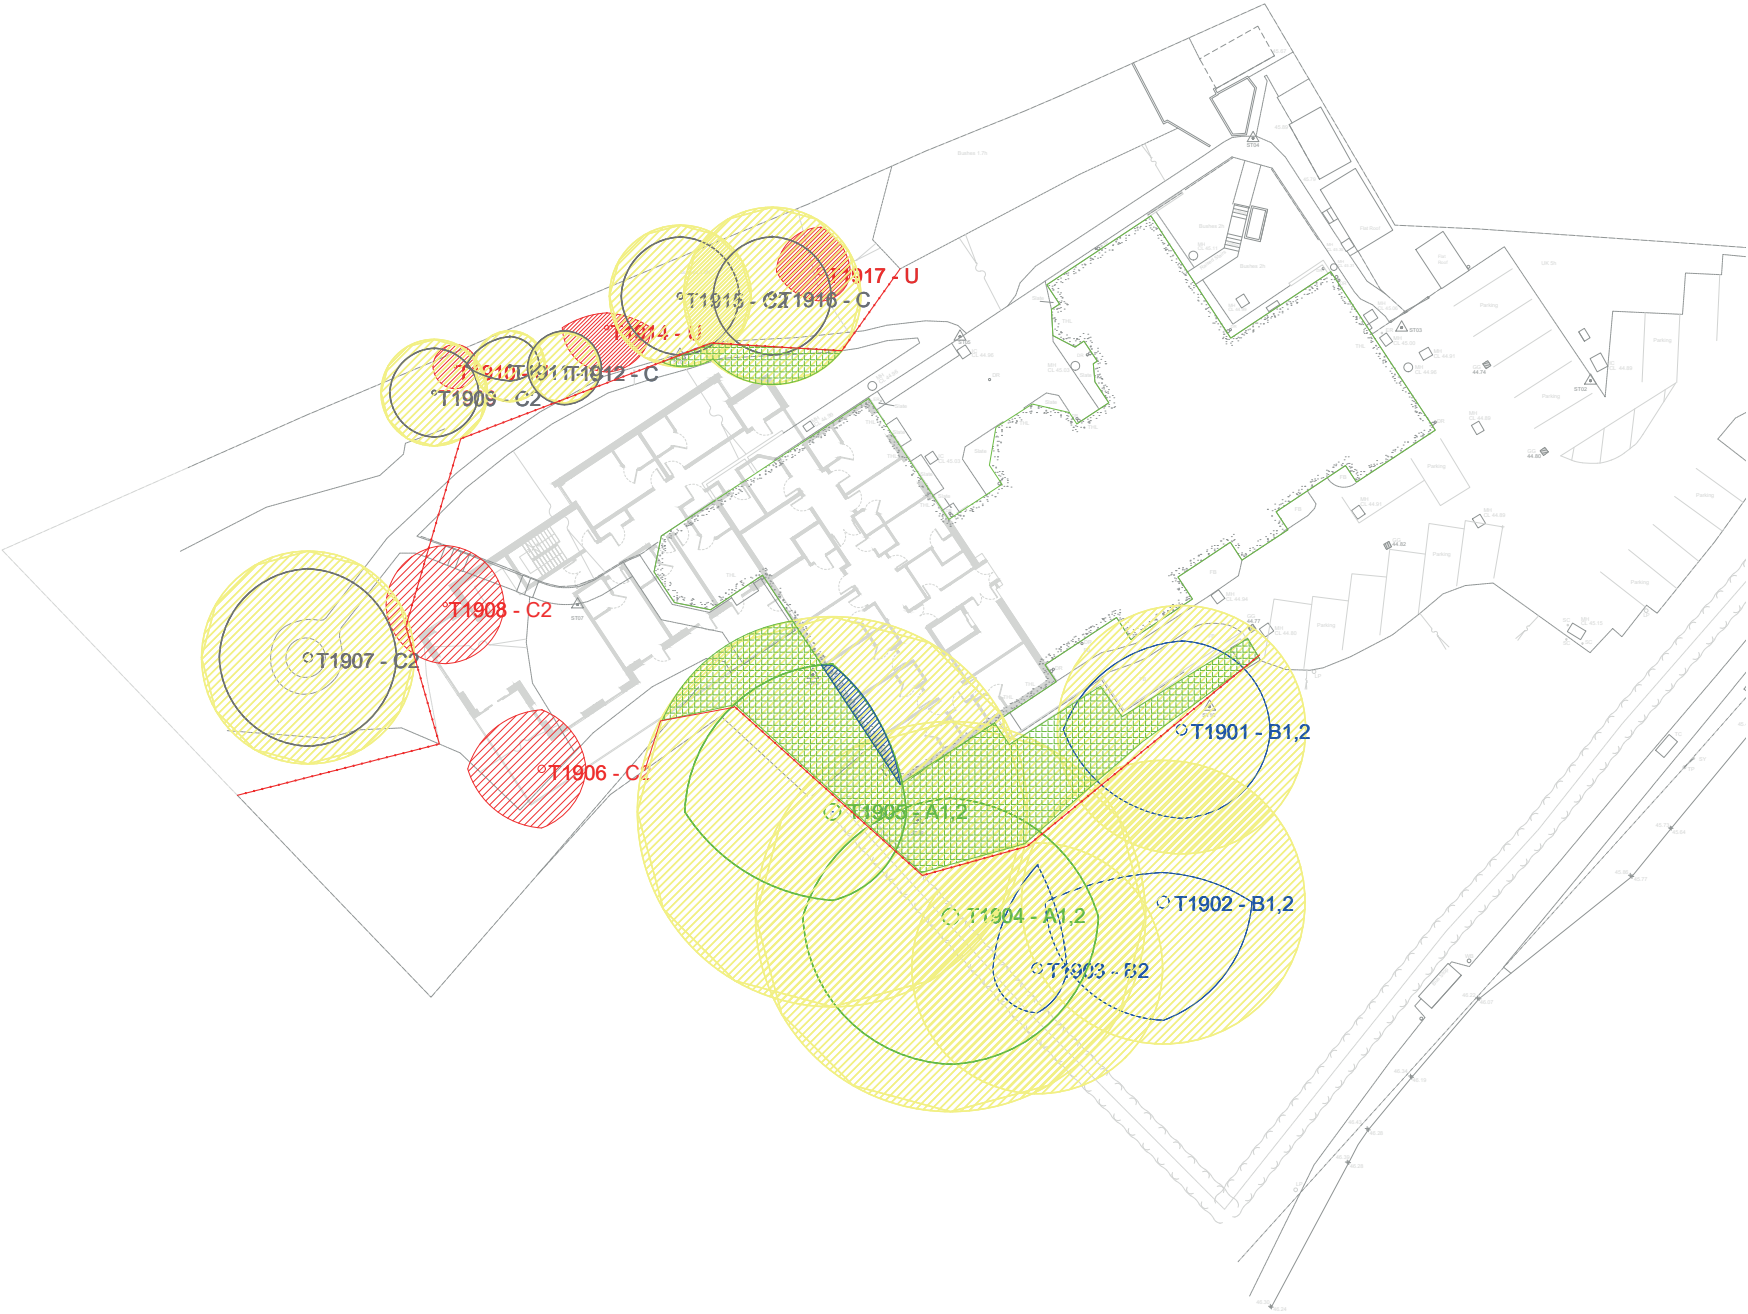
Proposed Tree Report  
Drawing no. J4421 TPP

*‘It will be necessary to remove five comparatively low value trees, this is due to three trees being in poor condition (T1910, T1914 & T1917) and two requiring removal to facilitate the development (T1906 & T1908).’*

The removed trees are highlighted in red and retained trees highlighted in yellow. The red line denotes the protection zone around protected trees inhibiting development beyond this line.

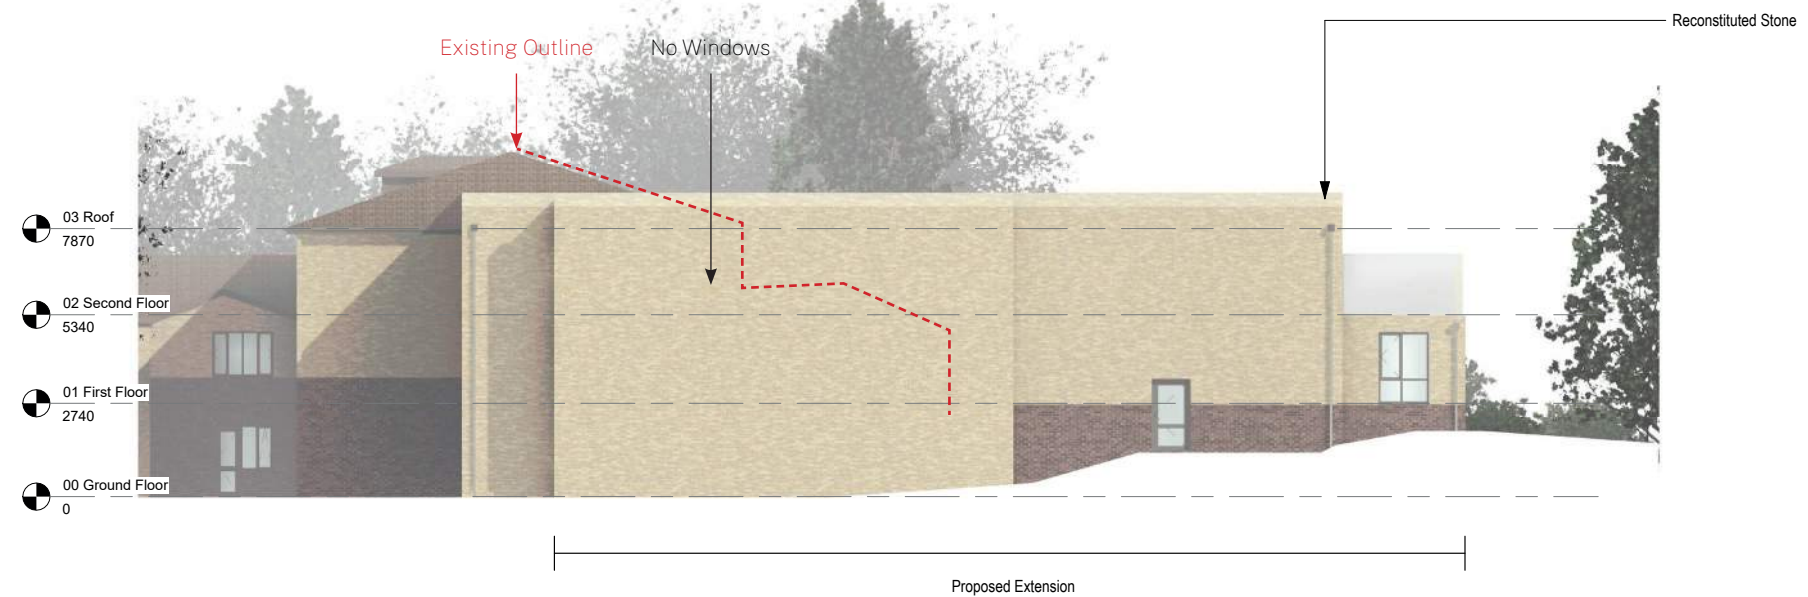
Proposed North Elevation  
Not to scale

Again, the proposed materials, scale and elevational design reflect that of the original building. The facing facade houses day space and so incorporates windows out onto the gardens. This side also shows the terrace. Windows have been allocated to bedrooms (shown on the far left of the elevation on both first and second floor) to give outlook to the bedrooms without overlooking the neighbours to the North.

This elevation in real life is obscured by a line of trees. These have been removed in this illustration to show the appearance of the facade for the application.

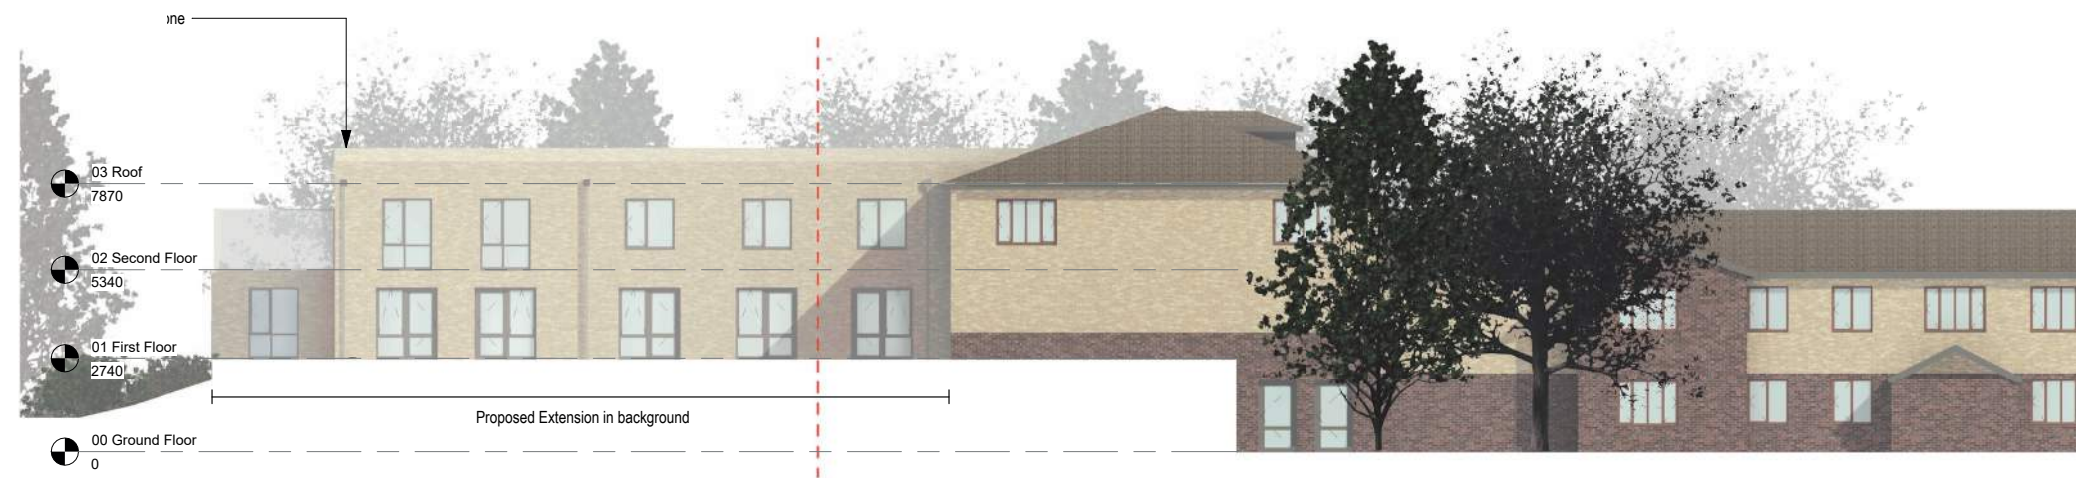
Proposed South Elevation  
Not to scale

Again, the materials, scale and elevational design reflect that of the original building. The extension on the South Elevation in real life is hidden behind many trees and again some of these have been removed in this illustration to show the appearance of the facade for the application.

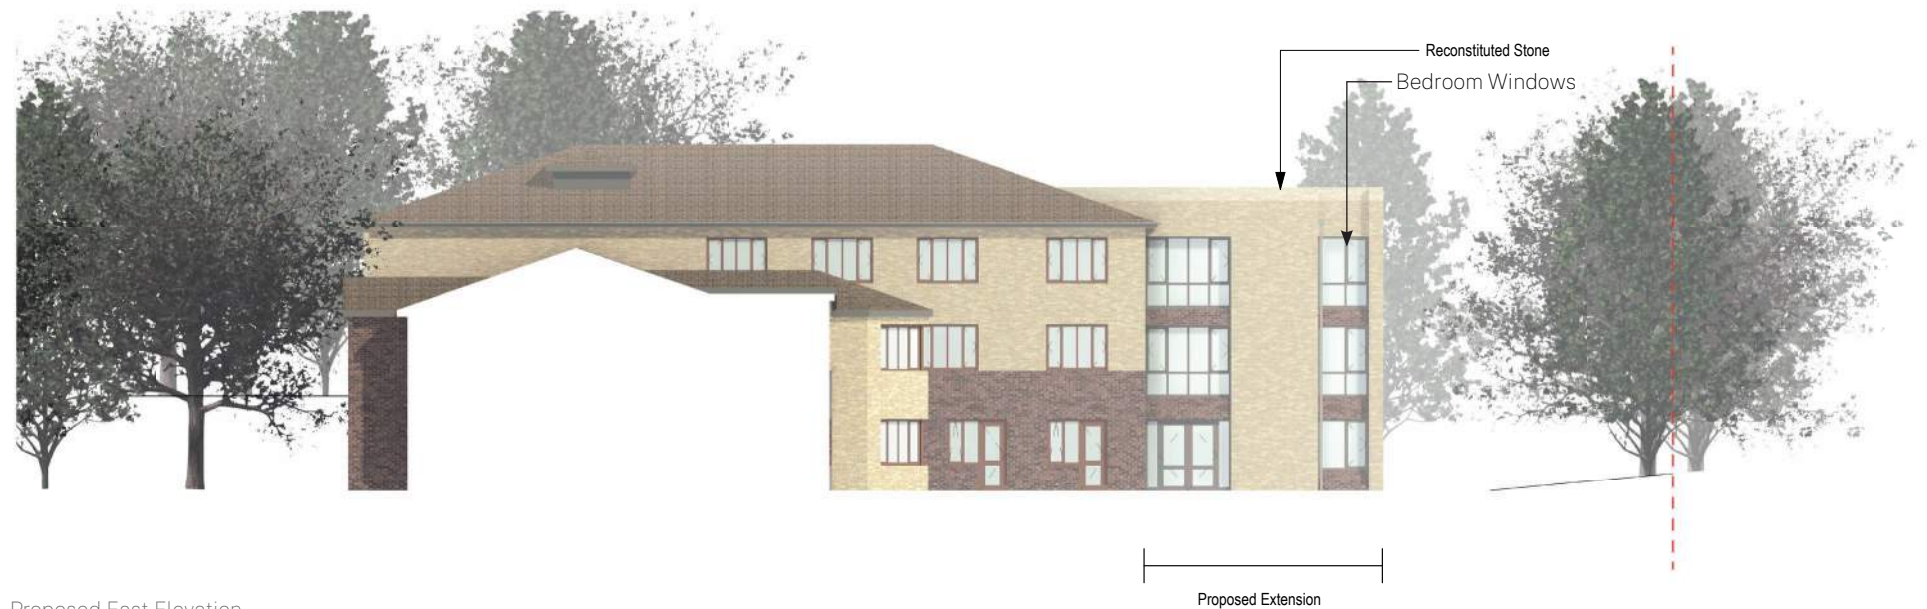
Proposed East Elevation  
Not to scale

The East elevation again shows the windows that have been allocated to bedrooms (shown on the far right of the elevation on both first and second floor) to give outlook to the bedrooms without overlooking the neighbours to the North.

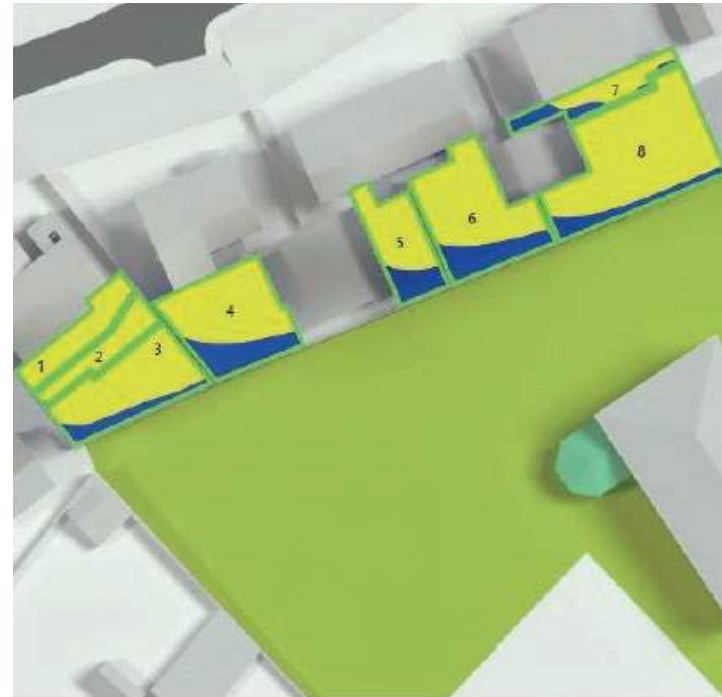
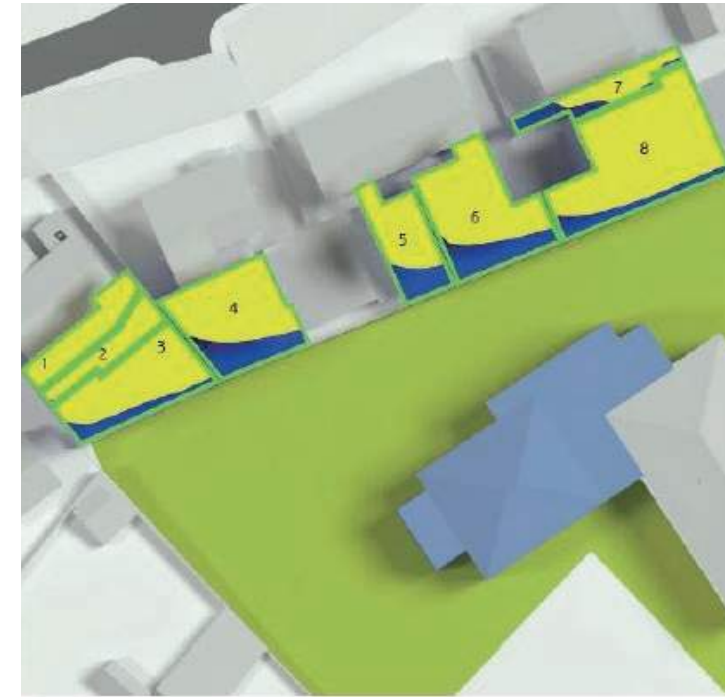
In addition to the effects on rooms and windows, our sunlight amenity/overshadowing assessments also confirm that the neighbouring gardens will not be adversely affected by the proposed development. All of the garden spaces will fully satisfy the BRE guidance in terms of overshadowing and experience no material change when compared to the pre-existing position.'

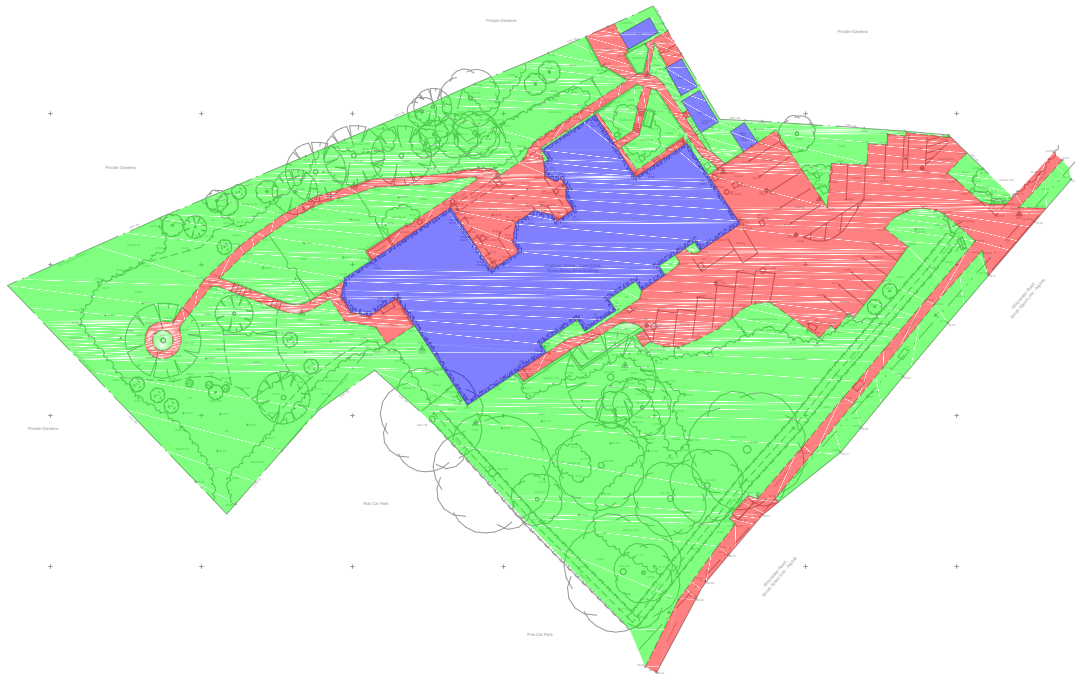
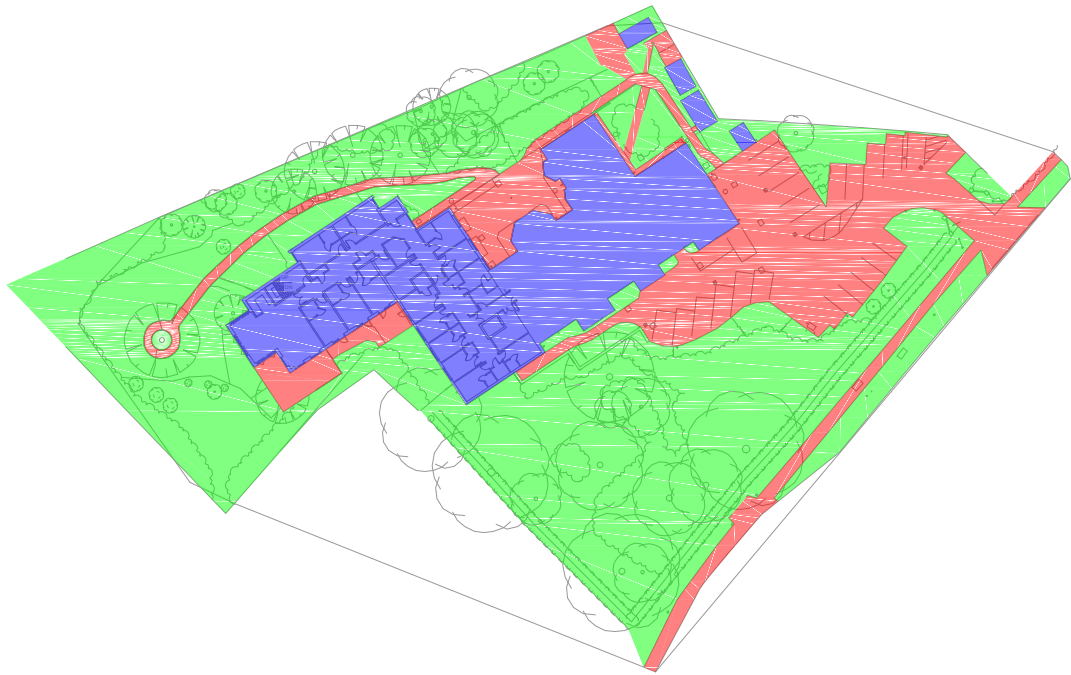
#### EXISTING AREAS:

THE DEMOLITION OF THE WESTERN WING OF THE BUILDING WILL RESULT IN A LOSS OF 321m<sup>2</sup> ROOF AREA. HOWEVER, THE AREA WHICH WAS PREVIOUSLY LOST IS TO BE REPLACED BY THE NEW EXTENSION PLUS A GAINED 257m<sup>2</sup> OF ROOF AREA, THEREFORE THE AREA OF WATER RUN-OFF THE NEW SYSTEM WILL HAVE TO DEAL WITH WILL BE FOR THE WHOLE NEW EXTENSION AREA OF 578m<sup>2</sup>.

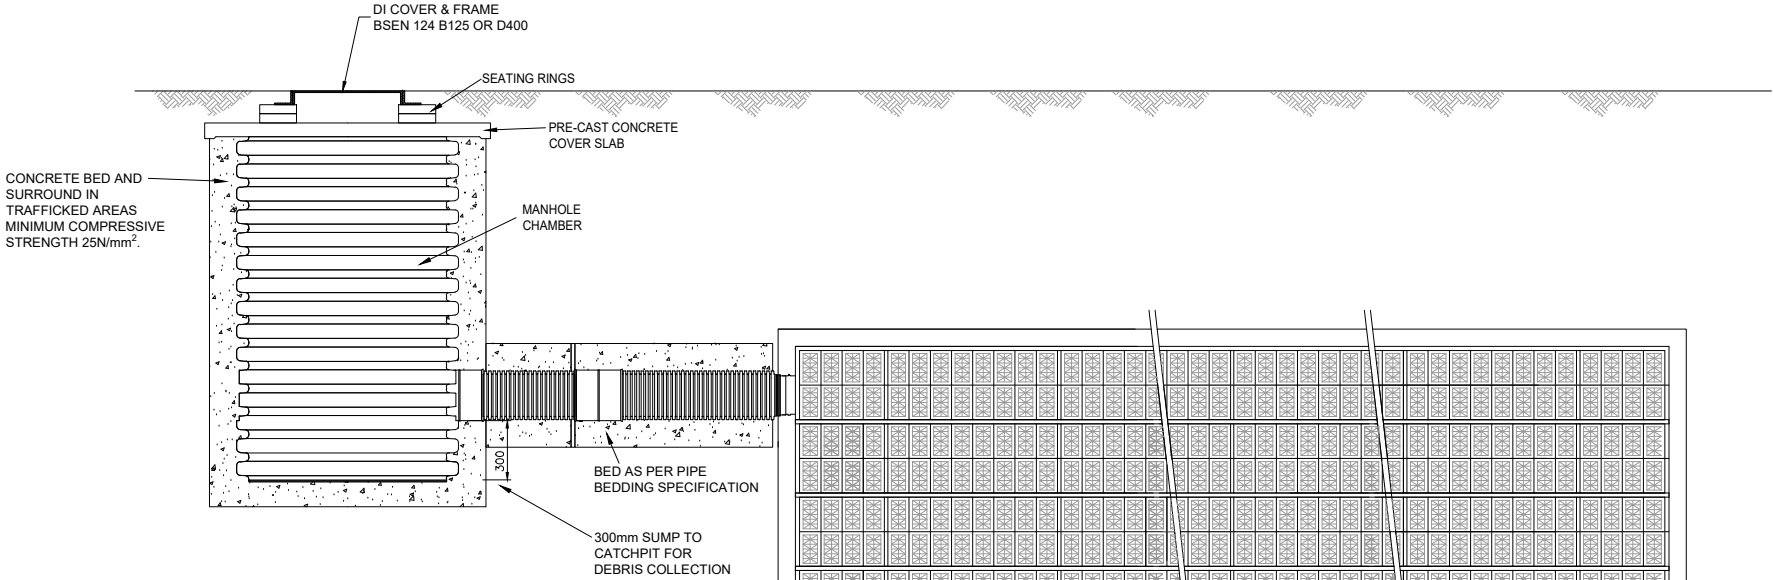
UNITS TO BE WRAPPED IN AN PERMEABLE GEOTEXTILE WRAP AS RECOMMENDED AND SPECIFIED BY THE MANUFACTURER IN WAVINS 'STORMWATER MANAGEMENT -PRODUCT & INSTALLATION' MANUAL. UNITS TO BE SURROUNDED IN 100mm OF SHARP SAND. PIPE ENTRY POINTS AND GEOTEXTILE TO BE SEALED IN ACCORDANCE WITH MANUFACTURERS RECOMMENDATIONS, INCLUDING WELDED DOUBLE SEAMS. WAVIN (01249 766600) AQUACELL UNITS TO BE USED UNLESS SPECIFIC AGREEMENT GIVEN BY CLIENT FOR ALTERNATIVE APPROVED PRODUCT.

UNITS TO BE WAVIN AQUACELL ECO OR SIMILAR APPROVED. OTHER UNITS ONLY TO BE AUTHORISED IF APPROVED BY ENGINEER. VERTICAL LOADING CAPACITY 56t/m<sup>2</sup> HORIZONTAL LOADING CAPACITY 7.7t/m<sup>2</sup>
