## PRELIMINARY BAT ROOST ASSESSMENT

2 SHARON ROAD, WEST END, SOUTHAMPTON, SO30 3AS

FINAL REPORT

March 2023

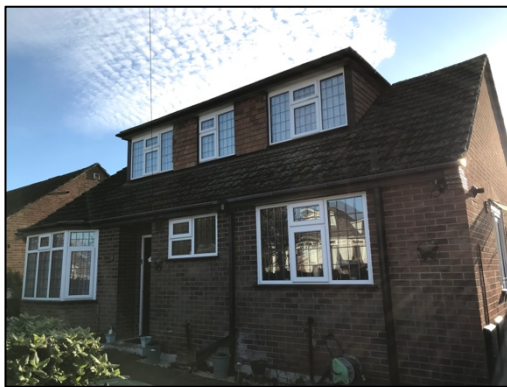
The house comprises a single-storey brick-built bungalow which rises to a pitched and gable-end design roof clad with concrete interlocking roof and ridge tiles (Figure 1). The house is oriented northeast to southwest. A brick-built flat roof extension clad with roofing felt extends from the south-western elevation of the building (Figure 2). Two flat roof dormer windows extend from the north-eastern and south-western roof faces, the sides are clad with hanging concrete tiles and the face with uPVC boards. Lead flashing covers the joins between the dormer windows and main roof faces. The roof extends beyond the wall plate and the eaves are enclosed with uPVC fascia boards and under boards which adjoin to uPVC guttering. A bay window extends from the easternmost end of the north-eastern elevation (Figure 3). The windows and doors are set in uPVC frames that are tight fitting to the surrounding brickwork.

**Figure 1** – north-eastern elevation and dormer windows

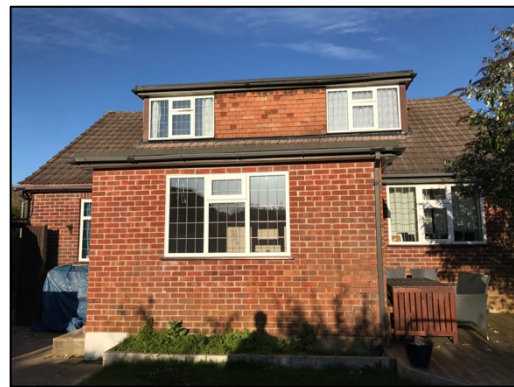
**Figure 2** – south-western elevation with extension and dormer windows

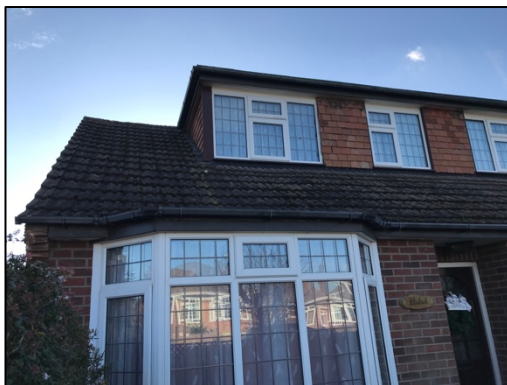
**Figure 3** – north-eastern elevation with bay window and dormer windows

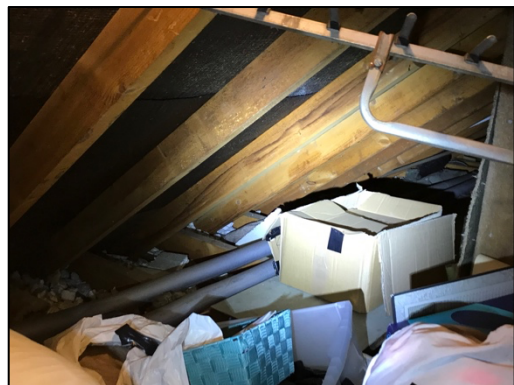
Internally, the house supports two distinct roof voids; both voids are at the side eaves which extend the full length of the building's north-eastern and south-western roof faces (Figure 7). Both voids support fibreglass insulation on the floor and heavy-duty bitumen lining on the roof (Figure 4). The voids are partially boarded and gaps in the eaves are infilled with fibreglass insulation. The spaces are used for storage and feature light cobwebbing throughout.

**Figure 4** – roof void with bitumen lining and stored items

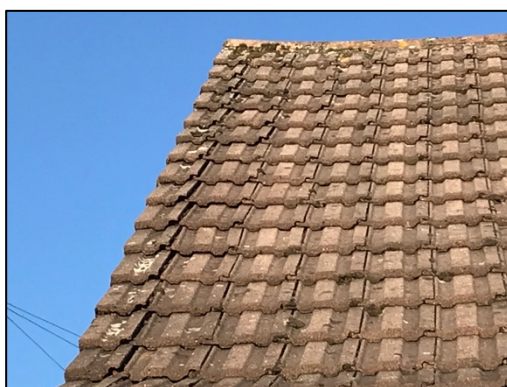
| <b>Suitability</b> | <b>Evidence</b> |
|---|---|
| <b>Exterior</b><br>The following suitable access/egress and roosting features were recorded externally during the survey:<br><ul style="list-style-type: none"> <li>- Lifted tiles on the south-western roof face (Figure 5).</li> <li>- Gaps under the hanging tiles on the dormer windows (Figure 6).</li> <li>- Slightly lifted sections of lead flashing.</li> </ul> | No evidence of activity was recorded externally during the survey. |

**Figure 5 – lifted interlocking concrete tiles**

If the final plans include the extensions of the dormer windows, in order to provide robust confirmation of the status of bat roosts at the site and the extent that they may be affected by the proposed development as required by Circular 06/2005, further survey work in accordance with Natural England standing advice and the BCT Good Practice Guidelines is required for the roof. This same survey work will be used to inform the third test of the Habitat Regulations.

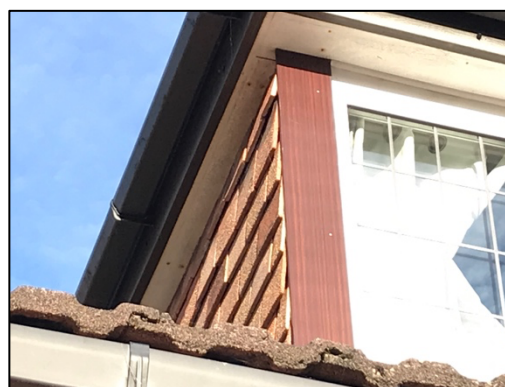
**Figure 6 – gaps under hanging tile on dormer windows**

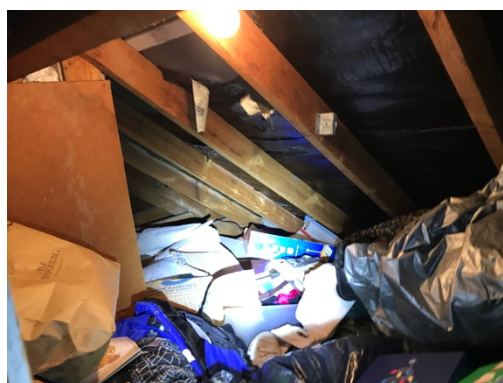
| <b>Suitability</b> | <b>Evidence</b> |
|---|---|
| <b>Interior</b><br>The following access/egress and roosting features were recorded internally during the survey:<br><ul style="list-style-type: none"> <li>- Tears in the bitumen lining causing hanging folds (Figure 7).</li> </ul> | No evidence of activity was recorded internally during the survey. |

**Figure 7 – tears in bitumen lining and hanging folds**
