Tree Report (BS 5837:2012): for: -

Proposed development of 10-Bed Proposed extension to existing Care Home of Challoner House at: -

Challoner House, 175 Winchester Road, Eastleigh, S053 2DU

April 2023 – Rev D – New parking layout and additional tree removals.

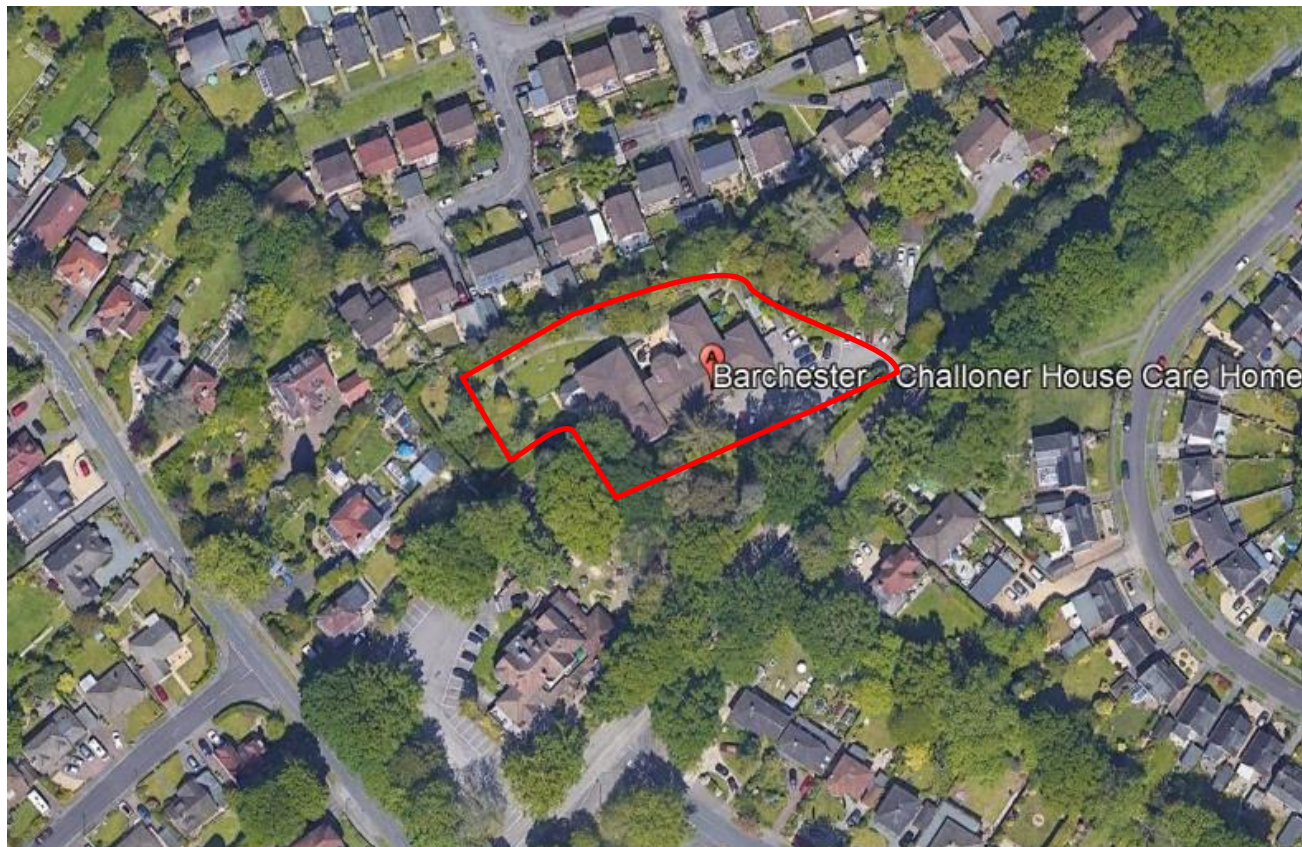
- 3.3.** The site (bordered red in image below) comprises the land we have been requested to survey of Challoner House, 175 Winchester Road, Eastleigh, S053 2DU.

Image above to illustrate survey & site extents (OS Grid Ref: SU 44241 21388)

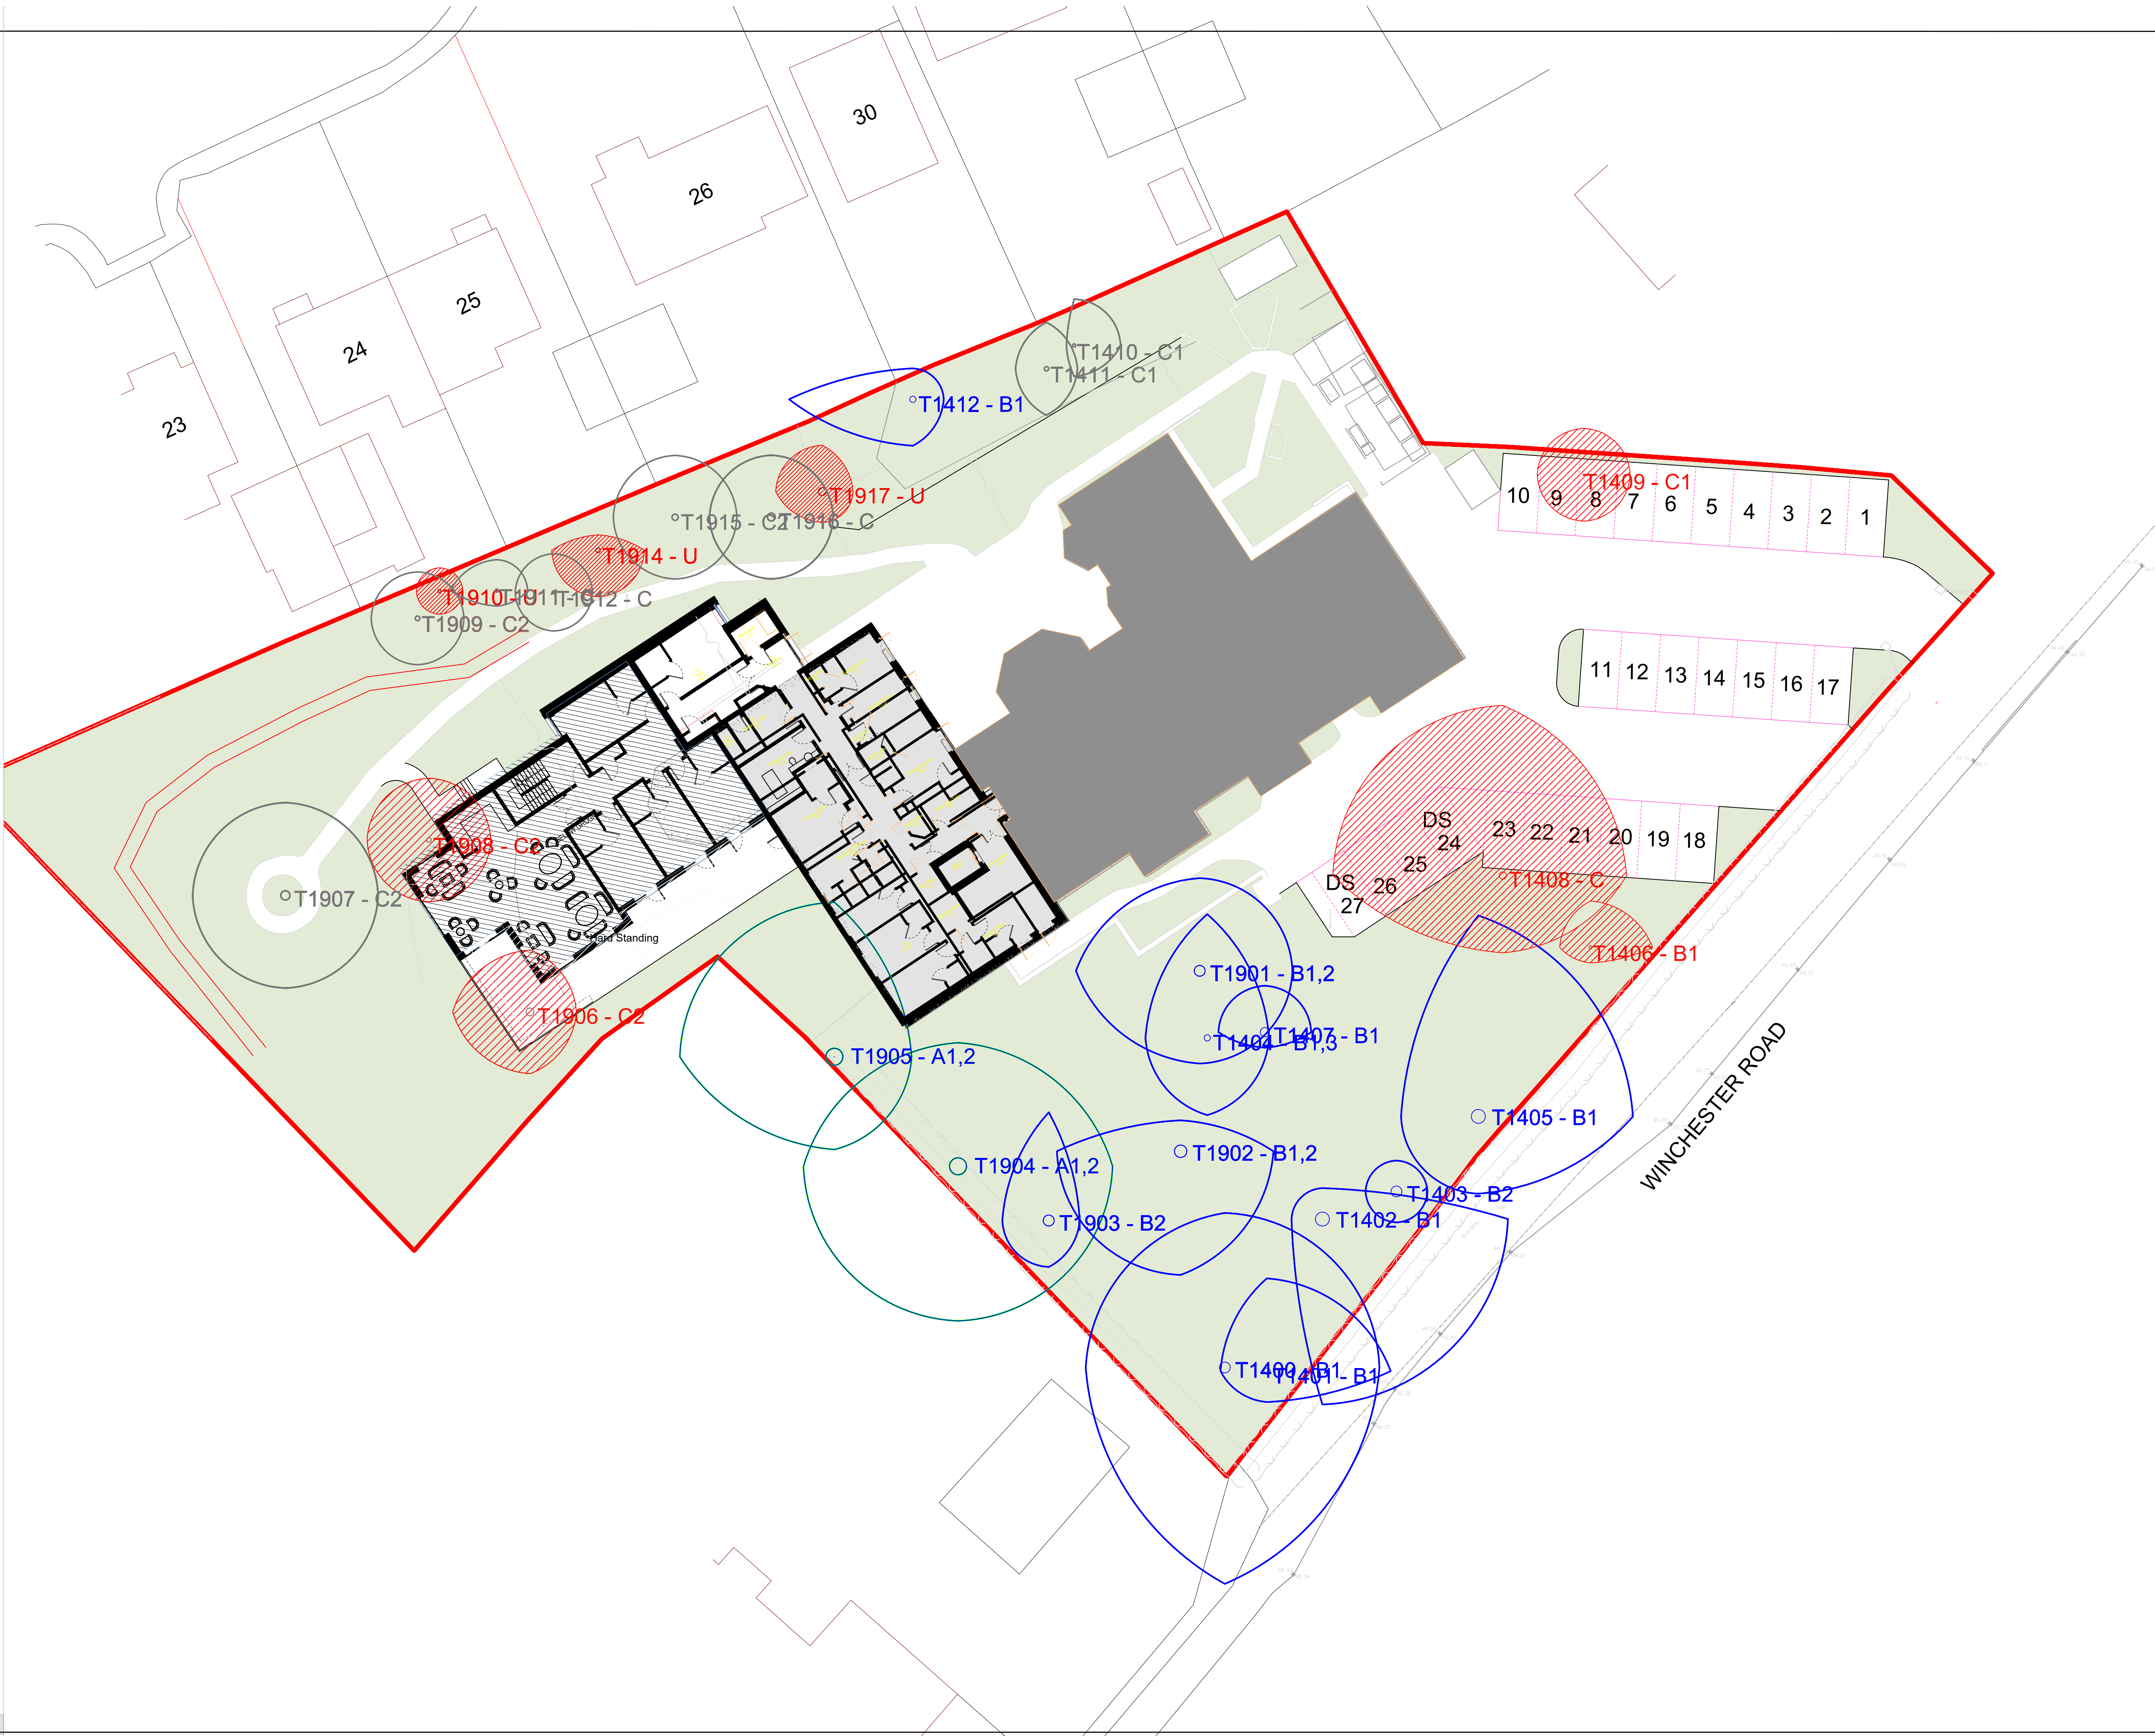
## Proposed Layout Tree Removal Plan

Tree survey data super imposed on site plans produced by other parties. All tree locations have been plotted using hand held GPS and their positions should be checked on site where they might impose a constraint, especially where levels are likely to change. Only trees with locations provided within the topographical survey (Orig No: 4268YOLS-01) have been matched with the co-ordinates contained within the aforementioned survey.

Third party tree measurements are estimated due to a lack of access to third party land and stated in tree data within the report.

T1910, T1914 and T1917 are scheduled to be removed due to poor condition and therefore considered to have no retention value. T1906 and T1908 are scheduled for removal due to their close proximity to the new western elevation with significant RPA encroachment and assumed ground level changes. T1406, T1408 and T1409 are to be removed due to the new parking layout.

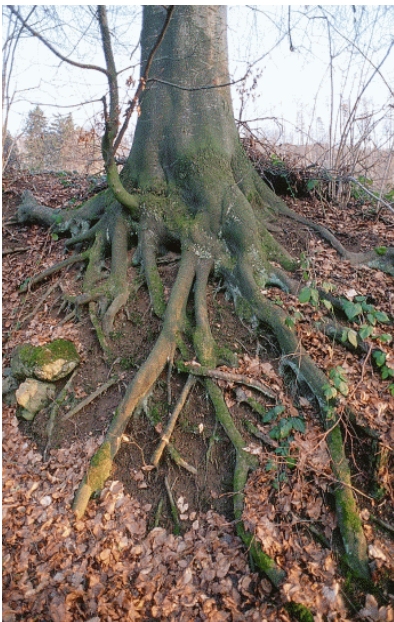
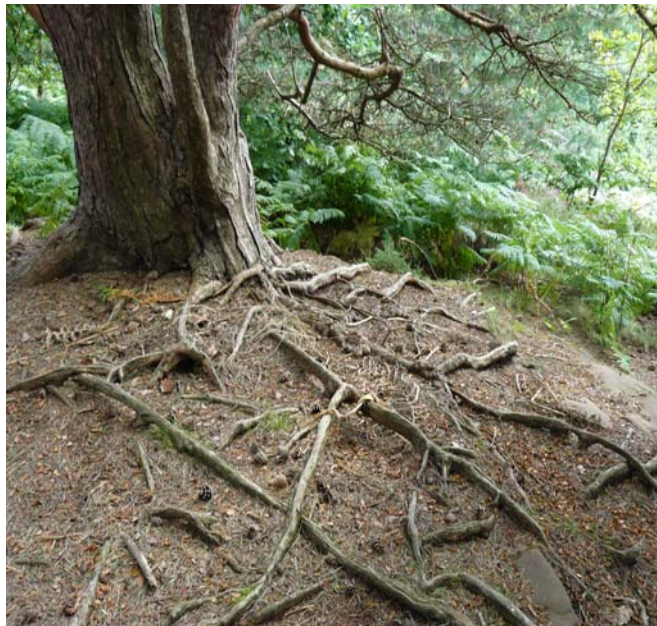
The base of a trunk typically flares out in buttresses extending into the main lateral structural roots. These rapidly subdivide into the mass of smaller roots which serve to anchor the tree into the soil and transport water and nutrients. Even at a short distance (3m) from a large mature tree, most roots will be less than 10mm in diameter, but these may extend to well beyond the branch spread of the tree. A mass of fine roots, less than 1 mm in diameter, develop off all parts of this root system. These fine roots also absorb the water and nutrients, which are essential for the growth of the tree.

The main structural roots (close to the trunk) develop as the tree grows in response to the need for physical stability. Beyond these major roots growth is influenced by the availability of water, air and nutrients in the soil. Disturbance of soil provides ideal conditions for root growth. Apparatus is often cooler than the surrounding soil encouraging moisture within the soil to condense on its surface stimulating root growth close to the apparatus. For all these reasons root growth is often most prolific within the backfilled trench and in the soil around the apparatus.

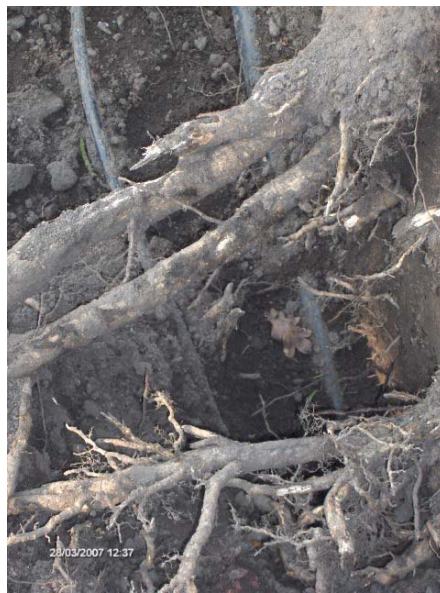
- the severance of a root, for example by trenching will destroy all parts of the root beyond that point. Even roots less than 10mm in diameter may be serving the fine roots over a wide area. The larger the root severed, the greater the impact on the tree.

**Typical root damage caused by excavation works**

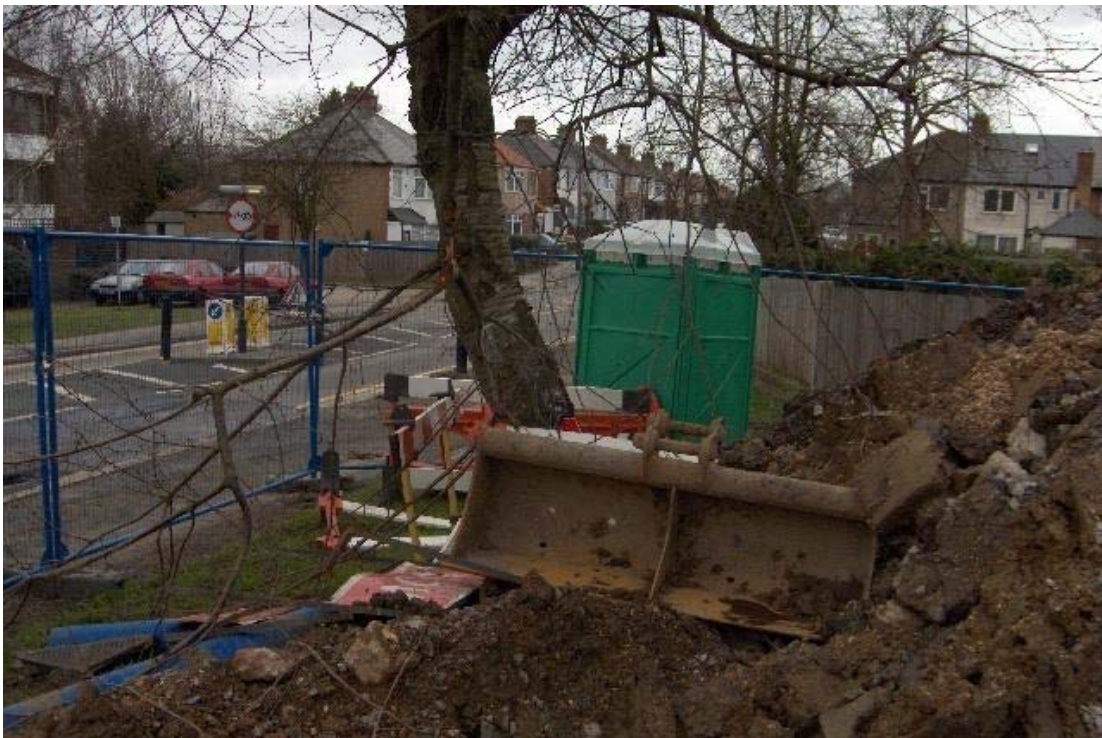
- compaction of the soil. Incidental compaction may occur from storage of materials and / or the passing of heavy equipment over the roots. This can restrict or even prevent gaseous diffusion through the soil, and thereby asphyxiate the roots. The roots must have oxygen for survival, growth and effective functioning.

### **Poor site management within the Precautionary Zone**
