**Our Ref:** WT 008-22 AIA-ltr

**Re: Tree information relating to planning application at Cottage Cattery, Saxon Court, Burnetts Lane, Horton Heath, SO50 7DJ**

## **Appendix 1 - The Tree protection Plan WTP 1:** Illustrating tree protection and management proposals

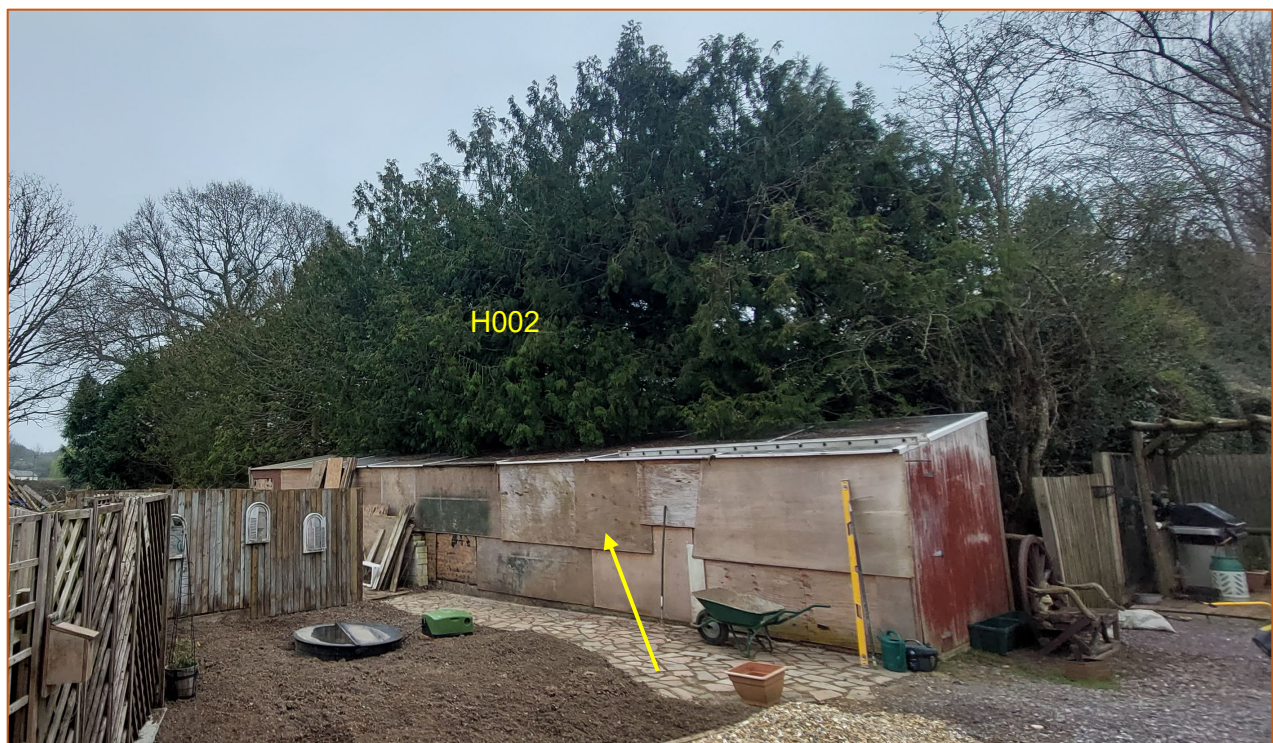
**Demolition of the former cattery pens:** This existing light structure can be easily dismantled by hand without the need for significant disruption within the RPAs of H002 (Image 1). There will be no fires in connection with the development activities, and no storage or mixing of harmful materials will be allowed within RPAs of retained trees. The combination of these measures with the proposed tree protective barriers will reduce any risk of damage to retained trees.

**Image 1:** The former cattery pens are located close to H002

Once this existing light structure (former cattery pens) is dismantled, temporary fencing can be erected in this area to protect T001 if there are concerns that construction activities may encroach into its RPA

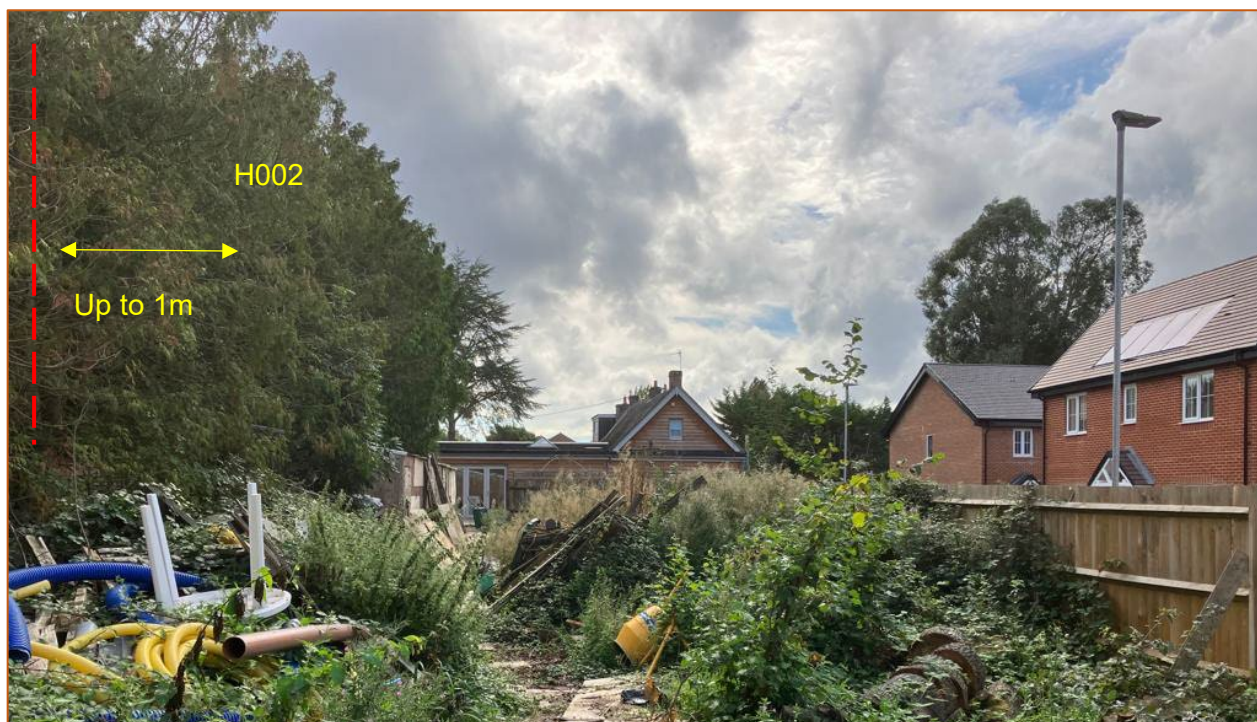
**Facilitation pruning:** Some of the lateral branches from H002 that overhang the site will need to be cut back by up to 1m (back to fence/boundary line) to ensure that there is sufficient clearance from the proposed dwelling (Image 3). Whilst the hedge provides some useful boundary cover, the trees are low quality (Category C), and only secondary and tertiary branches will need to be pruned. These are small in diameter and any pruning wounds created will be easily occluded by the tree with new regrowth likely to form in the following season. Provided the work is carried out in accordance with BS3998: 2010 '*Tree Work Recommendations*', it is unlikely to have a detrimental impact on the health or amenity value of the trees.

**Image 3:** Some minor pruning of the lateral branches is required to facilitate the installation of the proposed dwelling

The existing fence will provide an adequate barrier from construction, so temporary protective fencing is not required. However, some branches will need to be pruned back by up to 1m (up to the boundary line) to provide suitable access and maintain future clearance along this side of the proposed dwelling.
