## Boundary Lake Golf Course Fifth Hole Flood and Drainage Appraisal

This flood and drainage appraisal has been provided for the proposed amendment to the fifth hole at the Boundary Lake Golf Course of the Ageas Bowl.

The proposed amendment is for the creation of an earth formed and landscaped bund situated along the south-eastern boundary of the site.

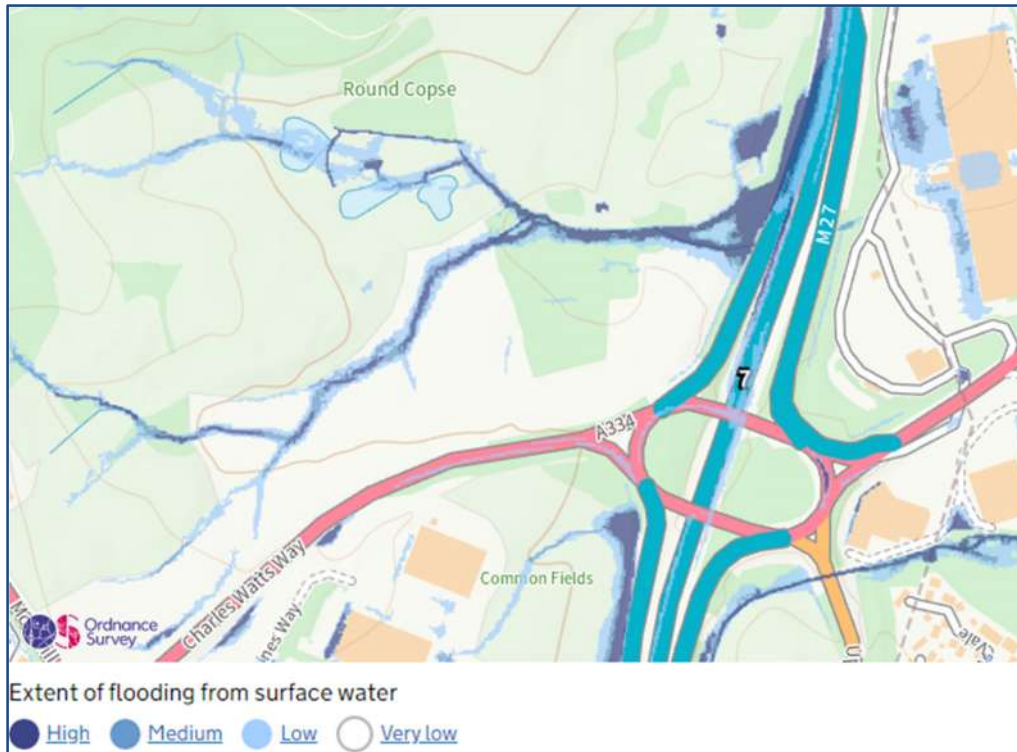
**Figure 3 – Long Term Flood Map – Surface Water**

An extract from the Long Term Flood Map has been included as **Figure 3**. This shows the site to be mainly located outside of an area that could be affected by surface water flooding, and therefore classified as having a very low level of risk. There is a surface water flow path shown along the south-eastern boundary of the site, indicating the flow of water from the westerly and

north-westerly part of the golf course and then away to the north-east. The flood risk associated with this is classified as low, and therefore not considered to be significant.

There is a surface water flow path along the south-eastern site boundary, with this classified as a low level of risk and therefore not considered to be significant.

It is anticipated that the surface water flow path that is indicated along the south-eastern site boundary would drain between the outside edge of the bund and the road embankment. Given the orientation of the bund along the south-eastern site boundary, it would also help to convey surface water to the north-east and towards the watercourse that drains from the southern part of Telegraph Woods. In addition to providing access, the lower section of the bund would also allow surface water runoff from the inside edge of the bund to drain to the north-east.

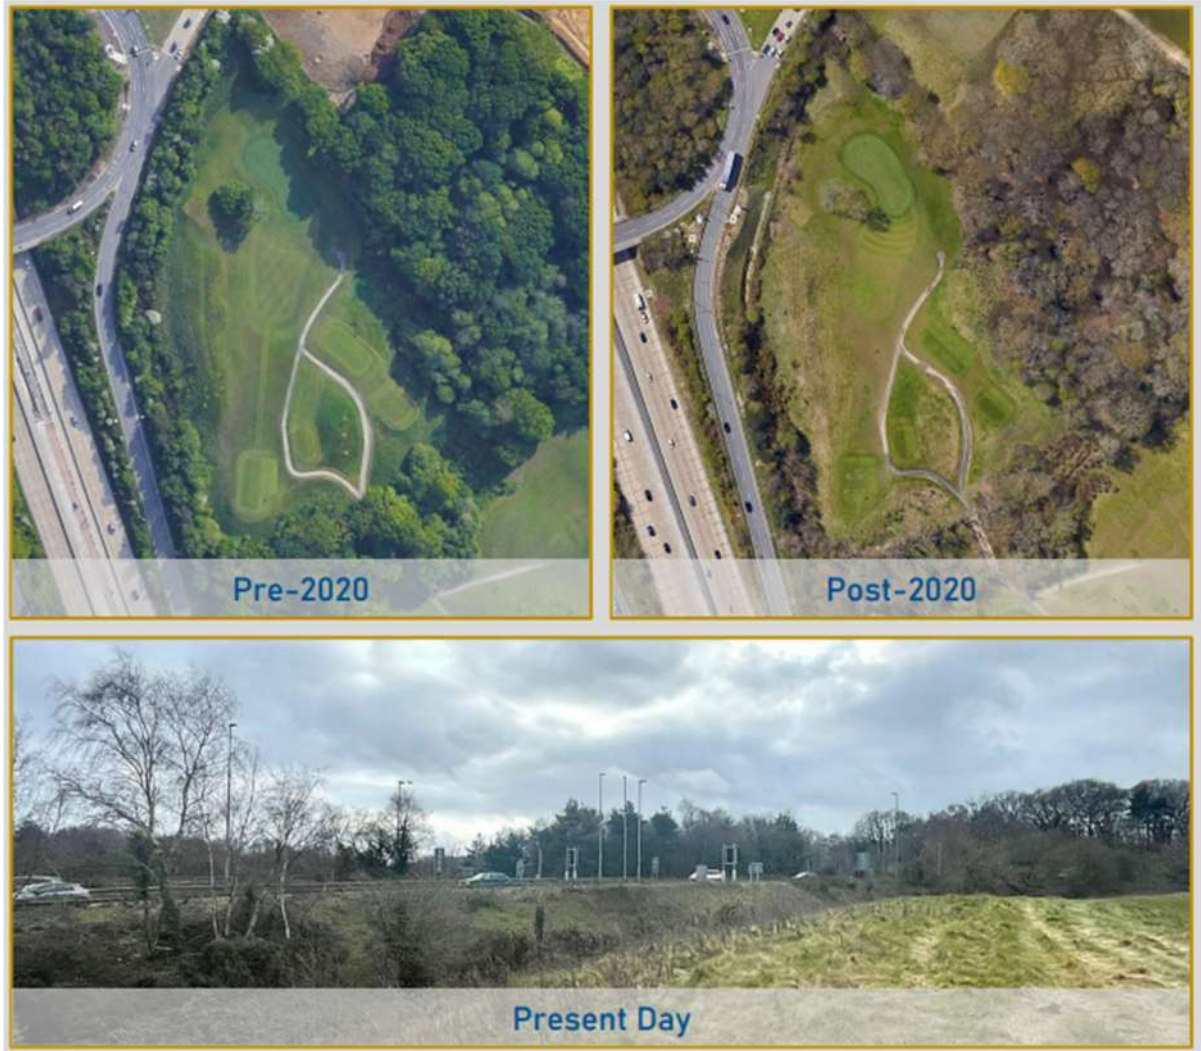
### Photos of the Site

The tree cover that provided this sound and visual barrier was removed as a result of road improvement works on 20<sup>th</sup> November 2020. The proposed landscaping as part of the amendment of the hole would re-instate the natural corridor and also enhance the biodiversity.
