## PRELIMINARY BAT ROOST ASSESSMENT

39 VERDON AVENUE, HAMBLE-LE-RICE, SOUTHAMPTON, SO31 4HW

DRAFT REPORT

February 2023

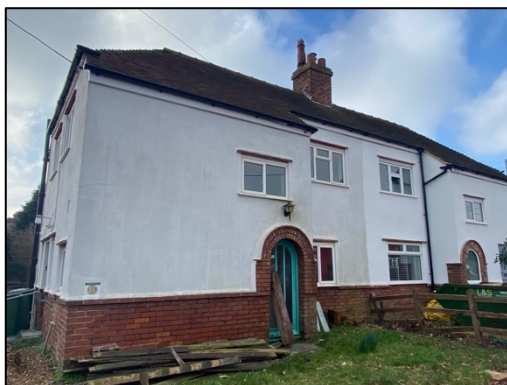
The building comprises a two-storey brick-built and rendered semi-detached house which rises to a pitched and hipped roof design clad with clay roof, ridge and hip tiles (Figure 1). The building is oriented north-east to south-west. The easternmost end of the north-eastern elevation extends beyond the wall plate and features a small catslide roof. A single-storey mono-pitched conservatory and brick-built extension protrude from the south-western elevation of the main house (Figure 2). The conservatory is clad with polycarbonate sheets and the extension with clay roof tiles. The roof of the house extends beyond the wall plates and the eaves are enclosed with uPVC fascia and underboards with uPVC guttering closely adjoining the eaves. Two brick-built chimney stacks are present and surrounded by lead flashing at their respective bases. All windows and doors are set in either wooden or uPVC frames and all are tight fitting to surrounding brickwork.

**Figure 1** – north-eastern elevation of the house

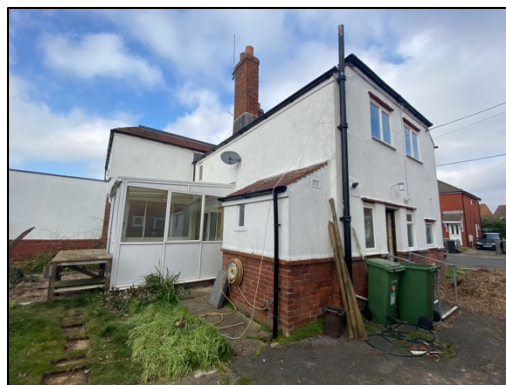
**Figure 2** – rear conservatory and brick-built extension

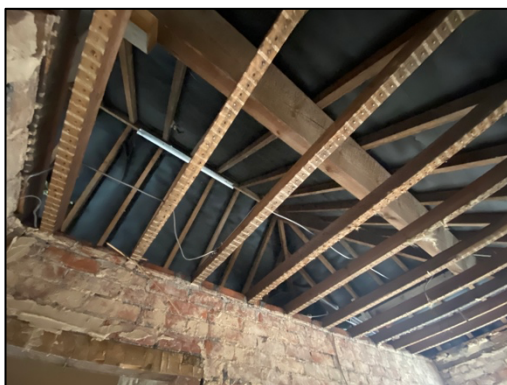
Internally, the house does not support a roof void. The house is stripped, with the wooden beams and underside of the heavy-duty bitumen felt lining exposed (Figures 3 & 4). All rooms remain open with direct continuous access throughout.

**Figure 3** – open interior with exposed bitumen lining

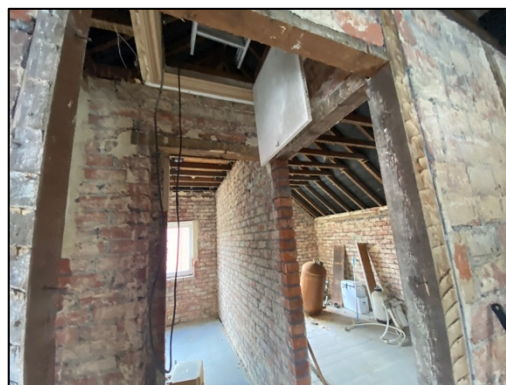
**Figure 4** – direct continuous access between all interior rooms

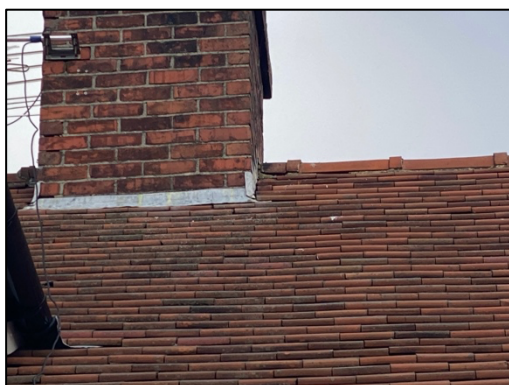
| | <i>Suitability</i> | <i>Evidence</i> |
|---|---|---|
| <i>Exterior</i> | <p>The following suitable access/egress and roosting features were recorded externally during the survey:</p> <ul style="list-style-type: none"> <li>- Gaps under the roof tiles (Figure 5).</li> <li>- Lifted lead flashing surrounding the main chimneys.</li> <li>- Missing mortar under ridge and hip tiles (Figure 6).</li> </ul> | No evidence of roosting activity was recorded externally during the survey. |

**Figure 5** – gaps under roof tiles and under lead flashing

The house is considered to support moderate roost suitability i.e. a structure which could be used by bats but is not likely to support a roost of high conservation status (e.g. maternity roost). This assessment is based on the level of activity recorded during the survey and the nature of the identified potential access and roost features on the house.

In accordance with these guidelines, further survey effort will take the form of dusk emergence and/or dawn re-entry presence/absence surveys undertaken during the bat active season. The recommended minimum number of presence/absence surveys for a building with moderate roost suitability is two. If activity is higher than expected, additional surveys may be required.

Surveyors will be equipped with high- specification time expansion or full spectrum bat detectors with digital recording capability. They will remain in place monitoring and recording bat activity from 15 minutes before sunset to up to 1.5 - 2 hours after sunset for a dusk visit or 2 hours before sunrise until up to 15 minutes after sunrise for a dawn visit. There needs to be a minimum of two weeks between the visits.

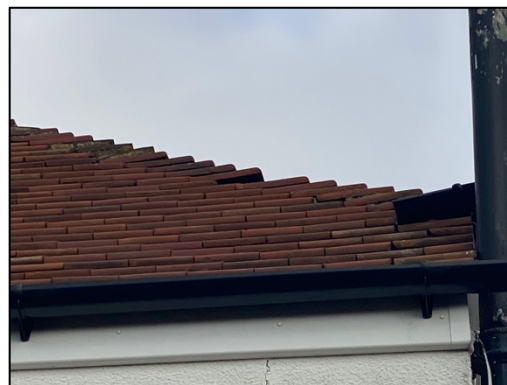
**Figure 6** – missing mortar under hip tiles

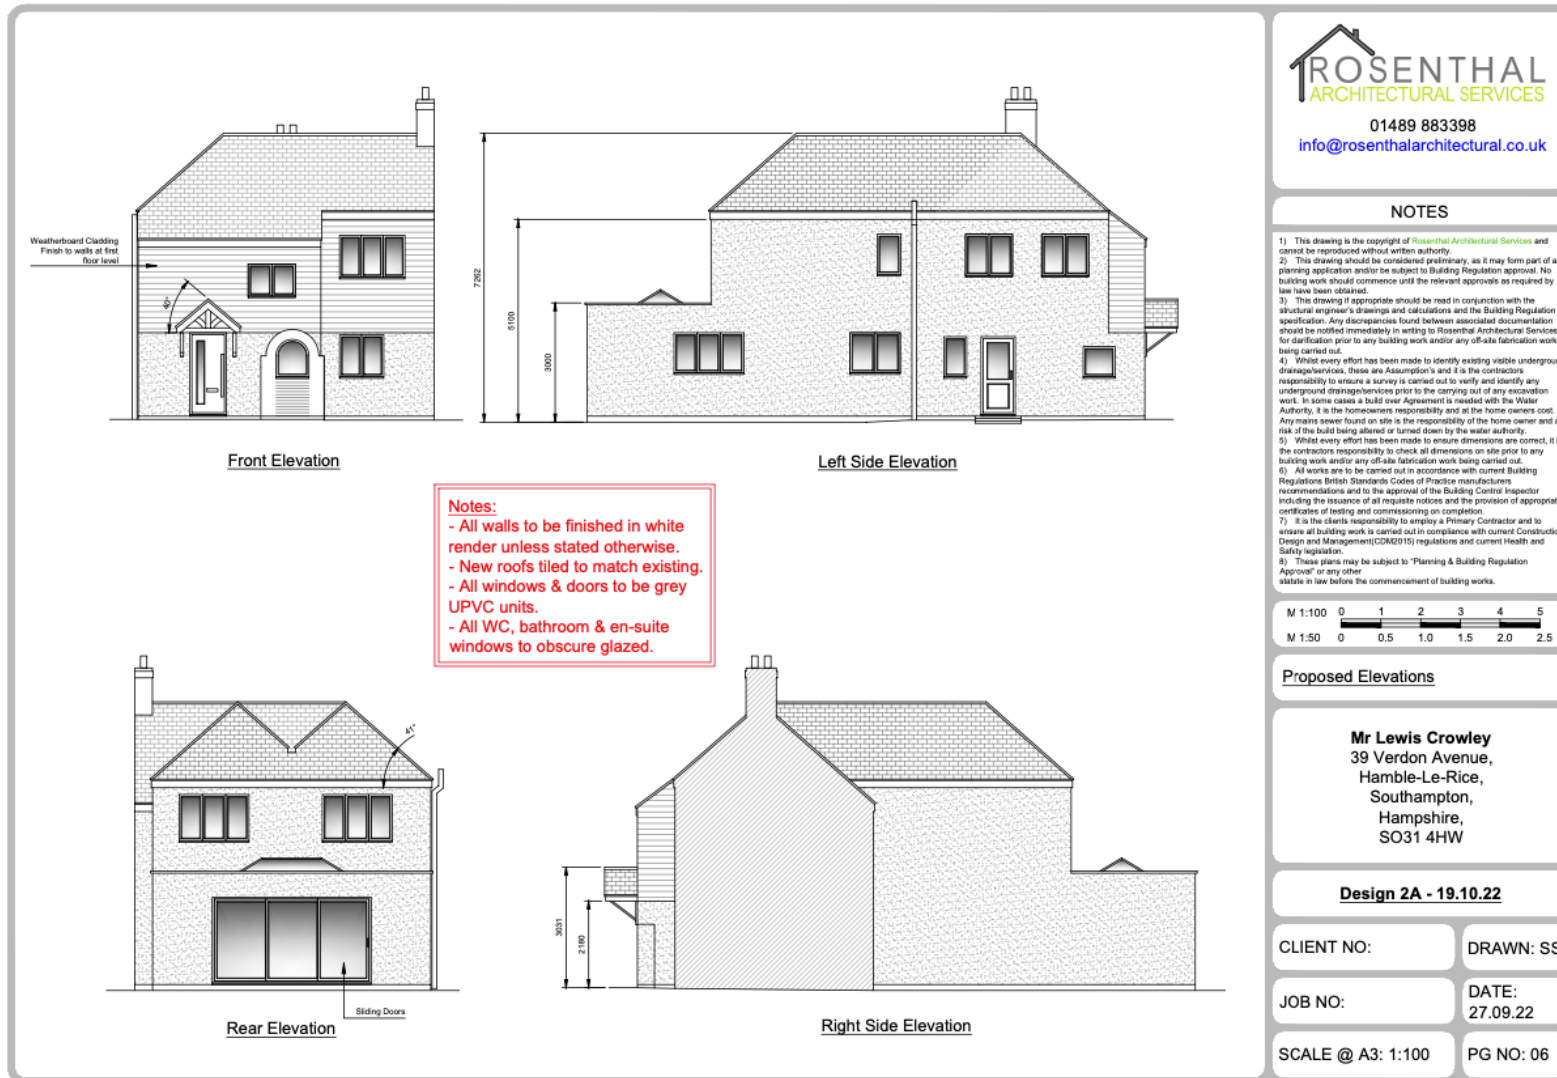
## Appendix 1 – Proposal plans for house

The current proposal is for the construction of a single and two-storey double pitched and hipped rear extension and the addition of weatherboarding to the front elevation of the house.
