**REMEDIATION STRATEGY AND VERIFICATION PLAN**

**BOORLEY GARDENS, WINCHESTER ROAD**

**BELLWAY HOMES & MILLER HOMES**

| Reference: | GE20346/RSVPv4/MAR23 |

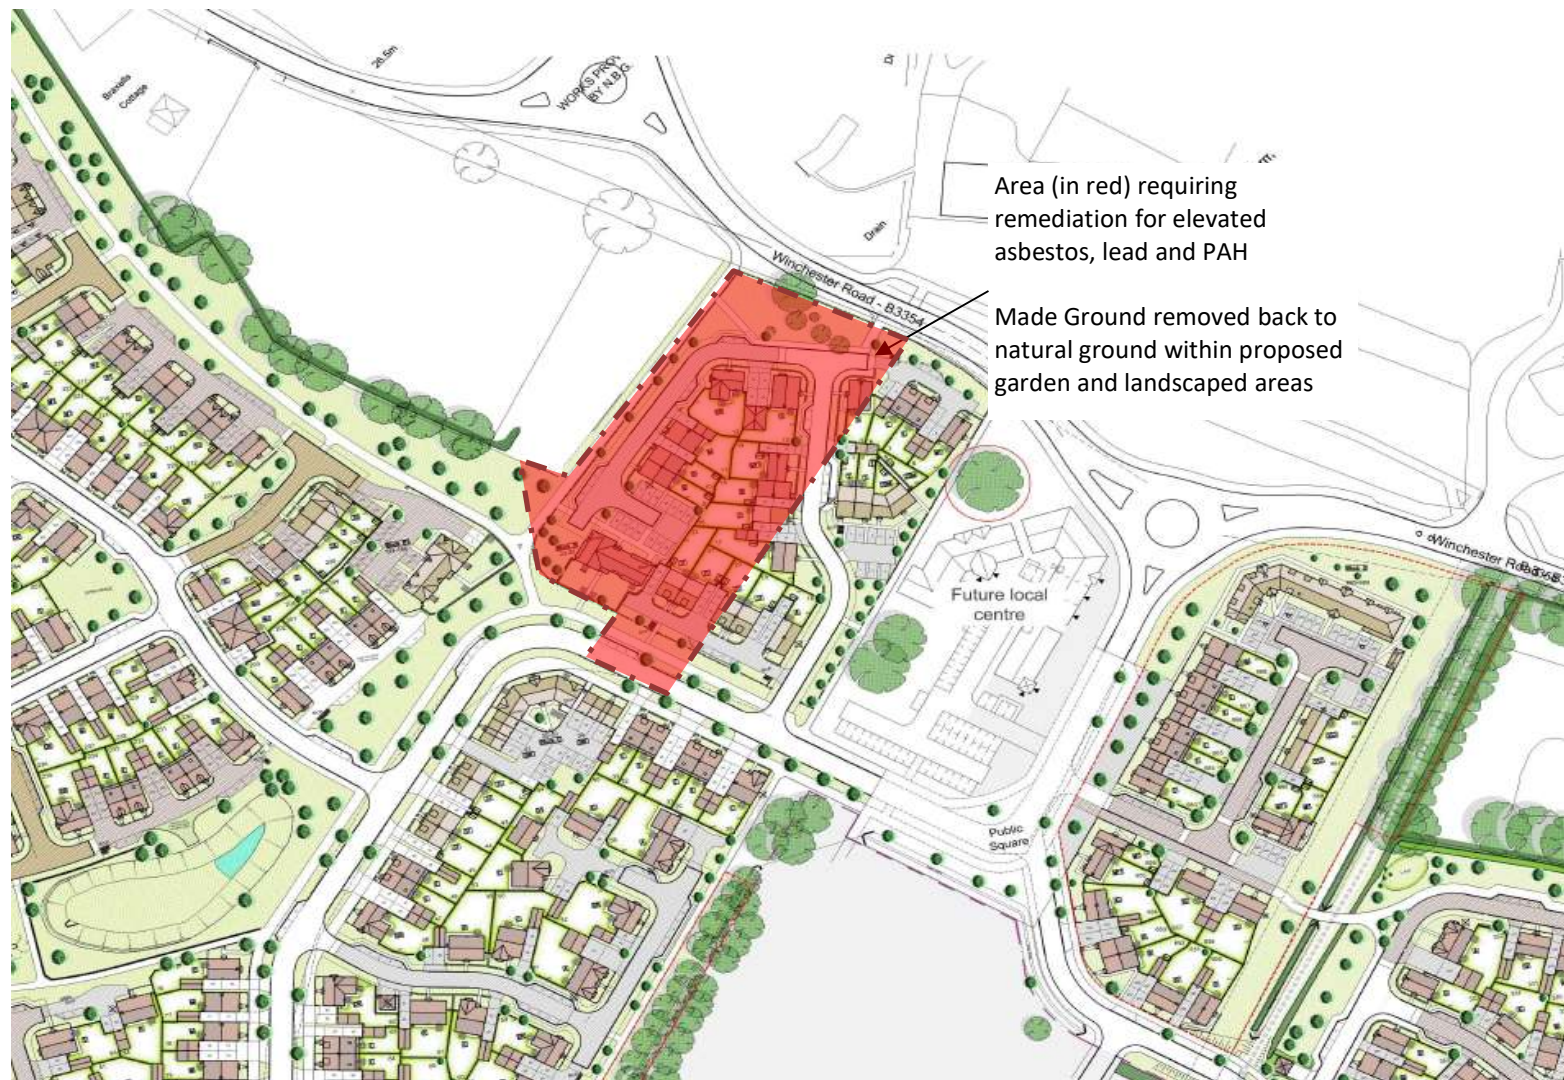
| <b>Project:</b> | Boorley Gardens, Winchester Road, Hedge End | | | <b>Title</b> | Constraints Plan (Soils) | |

Assessment of the investigation findings has identified potential hazards which were considered to require intervention (remediation) to mitigate the risk of harm in one section of the site. Remediation works are proposed to break the identified plausible pollutant linkages associated with the contaminant of concern identified within proposed gardens and soft landscaped areas thereby mitigating the associated risk of harm to human health.
