## BAT ROOST ASSESSMENT

14 SOUTHERN ROAD, WEST END, SOUTHAMPTON, SO30 3ER

FINAL REPORT

June 2023

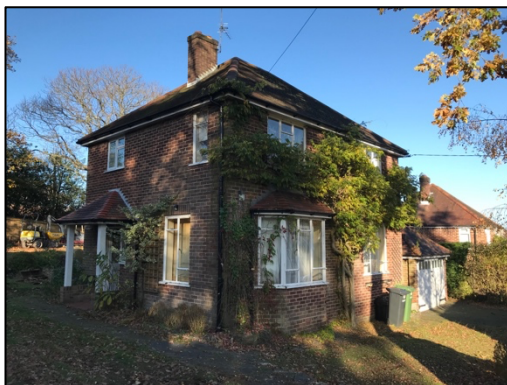
The house comprises a brick-built two-storey structure which rises to a pitched and hipped design roof clad with machine cut clay roof, ridge and hip tiles (Figure 1). The house is oriented southwest to northeast. A bay window is present on the south-eastern elevation and a wooden framed porch extends from the south-western elevation, both are clad with clay roof and hip tiles (Figure 2). The roof extends beyond the wall plate and the eaves are enclosed with wooden underboards and fascia boards which closely adjoin to uPVC guttering. A brick-built chimney extends from the south-western roof face and is surrounded by lead flashing at the base. A lean-to roof extends from the north-eastern elevation of the house and adjoins to the south-western elevation of the garage (Figure 3). The windows and doors are set in metal frames with wooden sills and are tight fitting to the surrounding brickwork. The south-eastern elevation supports a *Wisteria* sp. plant.

**Figure 1** – south-eastern and south-western elevations of the house

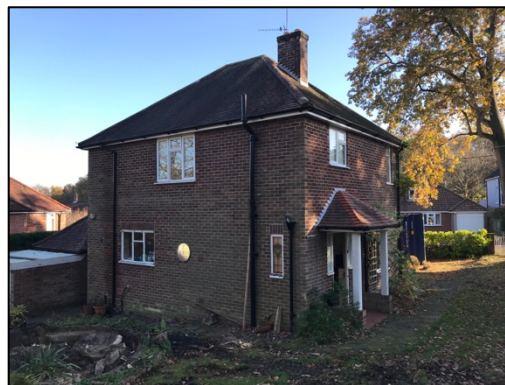
**Figure 2** – south-western and north-western elevations of house with wooden framed porch

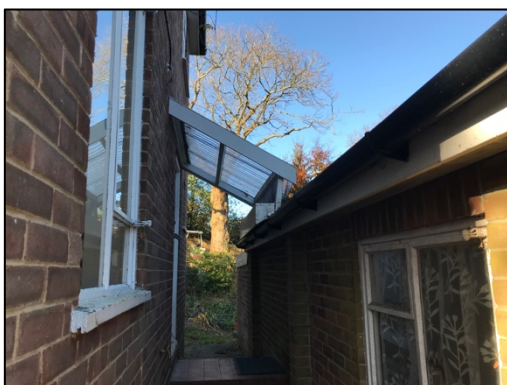
**Figure 3** – lean-to roof on north-eastern elevation

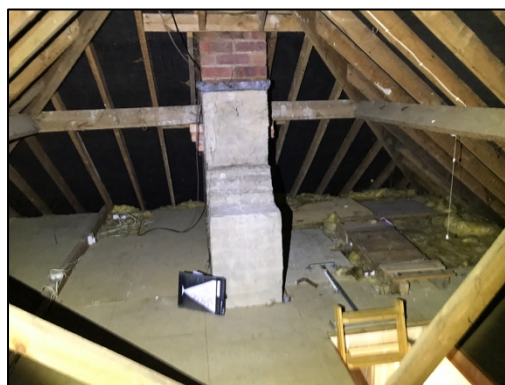
Internally, the building supports a single roof void which is lined with heavy-duty bitumen felt. The void supports fibreglass insulation, including up to the eaves, and the floor is boarded (Figure 4). There is heavy cobwebbing present throughout the void.

**Figure 4** – roof void with boarded floor

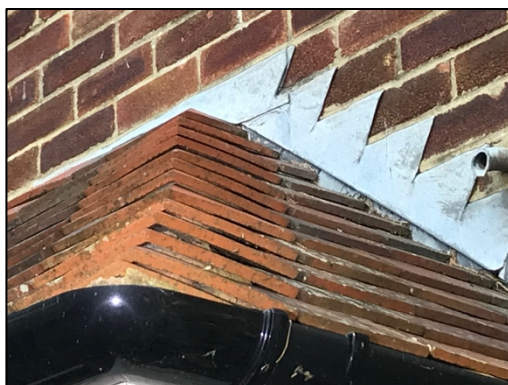
| <b>Suitability</b> | <b>Evidence</b> |
|---|---|
| <b>Exterior</b><br>The following suitable access/egress and roosting features were recorded externally during the survey:<br><ul style="list-style-type: none"> <li>- Lifted roof tiles on the main roof, bay window and porch (Figure 5).</li> <li>- Missing mortar under hip and ridge tiles (Figure 6).</li> <li>- Gaps in chimney brickwork.</li> </ul> | No evidence of roosting activity was recorded externally during the survey. |

**Figure 5** – lifted hip tiles on porch

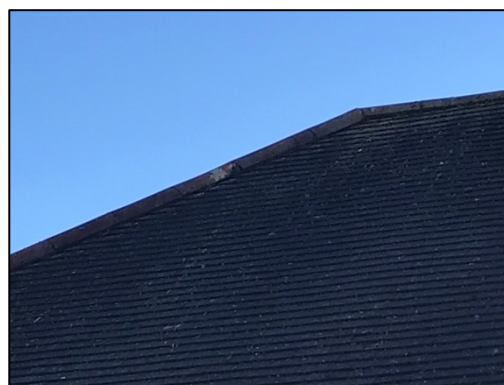
**Figure 6** – missing mortar under ridge and hip tiles on main roof

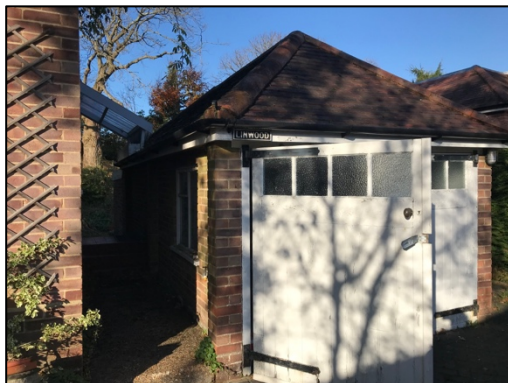
The garage comprises a brick-built structure which rises to a pitched and hipped design roof clad with machine cut clay roof, ridge and hip tiles (Figure 7). The garage is oriented southeast to northwest. A flat roof extension clad with polycarbonate sheets, protrudes from the south-eastern elevation (Figure 8). The roof extends beyond the wall plate and the eaves are enclosed with wooden underboards and fascia boards which closely adjoin to uPVC guttering. A set of wooden double doors are present on the south-eastern elevation and a single wooden door is located on the north-western elevation. The windows and doors are set in metal and wooden frames and are tight fitting to the surrounding brickwork.

**Figure 7** – south-eastern and south-western elevations of the garage with double doors

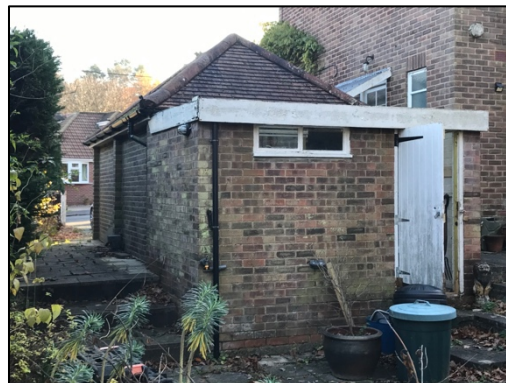
**Figure 8** – north-west and north-eastern elevations of the garage with extension

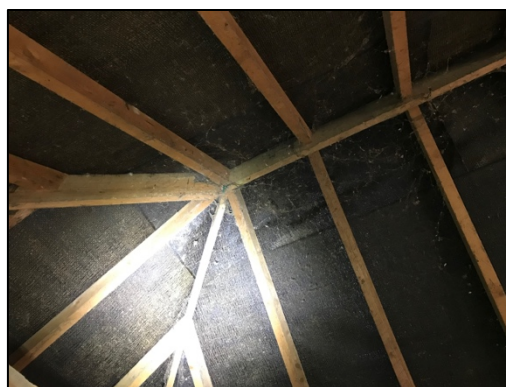
Internally, the garage does not support a roof void. The roof is lined with heavy-duty bitumen felt (Figure 9). The space is predominantly used for storage with heavy cobwebbing throughout.

**Figure 9** – internal view of the garage roof

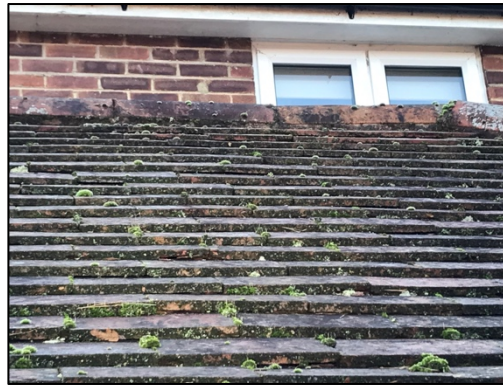
| <b><i>Suitability</i></b> | <b><i>Evidence</i></b> |
|---|---|
| <b><i>Exterior</i></b> | <p>The following suitable access/egress and roosting features were recorded externally during the survey:</p> <ul style="list-style-type: none"> <li>- Lifted roof tiles (Figure 10)</li> </ul> <p>No evidence of roosting activity was recorded externally during the survey.</p> |

**Figure 10** – lifted roof tiles on north-eastern roof face
