## BAT ROOST ASSESSMENT

2 SHARON ROAD, WEST END, SOUTHAMPTON, SO30 3AS

FINAL REPORT

June 2023

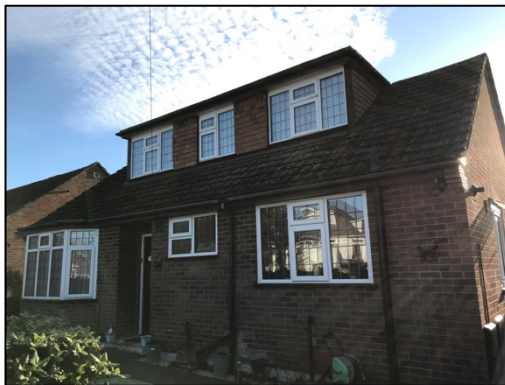
The house comprises a single-storey brick-built bungalow which rises to a pitched and gable-end design roof clad with concrete interlocking roof and ridge tiles (Figure 1). The house is oriented northeast to southwest. A brick-built flat roof extension clad with roofing felt extends from the south-western elevation of the building (Figure 2). Two flat roof dormer windows extend from the north-eastern and south-western roof faces, the sides are clad with hanging concrete tiles and the face with uPVC boards. Lead flashing covers the joins between the dormer windows and main roof faces. The roof extends beyond the wall plate and the eaves are enclosed with uPVC fascia boards and under boards which adjoin to uPVC guttering. A bay window extends from the easternmost end of the north-eastern elevation (Figure 3). The windows and doors are set in uPVC frames that are tight fitting to the surrounding brickwork.

**Figure 1** – north-eastern elevation and dormer windows

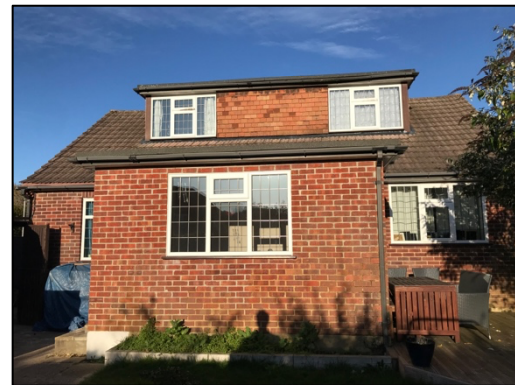
**Figure 2** – south-western elevation with extension and dormer windows

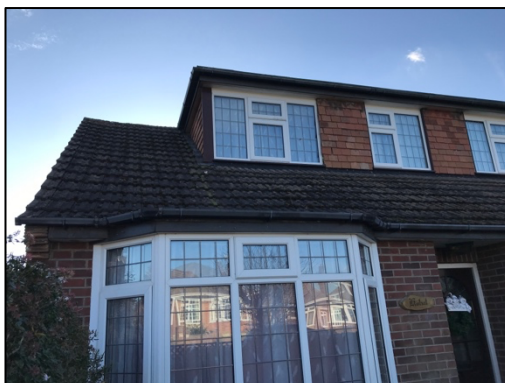
**Figure 3** – north-eastern elevation with bay window and dormer windows

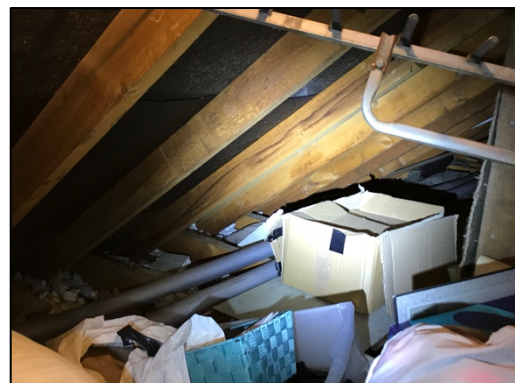
Internally, the house supports two distinct roof voids; both voids are at the side eaves which extend the full length of the building's north-eastern and south-western roof faces (Figure 7). Both voids support fibreglass insulation on the floor and heavy-duty bitumen lining on the roof (Figure 4). The voids are partially boarded and gaps in the eaves are infilled with fibreglass insulation. The spaces are used for storage and feature light cobwebbing throughout.

**Figure 4** – roof void with bitumen lining and stored items

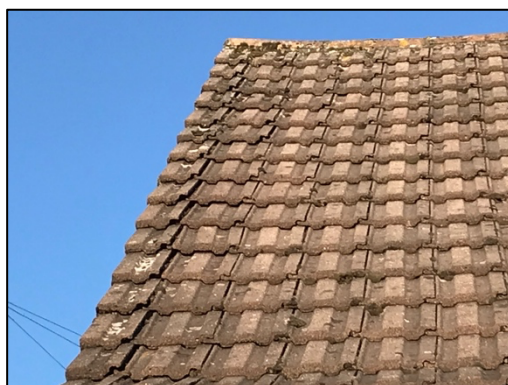
| <b>Suitability</b> | <b>Evidence</b> |
|---|---|
| <b>Exterior</b> | <p>The following suitable access/egress and roosting features were recorded externally during the survey:</p> <ul style="list-style-type: none"> <li>- Lifted tiles on the south-western roof face (Figure 5).</li> <li>- Gaps under the hanging tiles on the dormer windows (Figure 6).</li> <li>- Slightly lifted sections of lead flashing.</li> </ul> |

**Figure 5 – lifted interlocking concrete tiles**

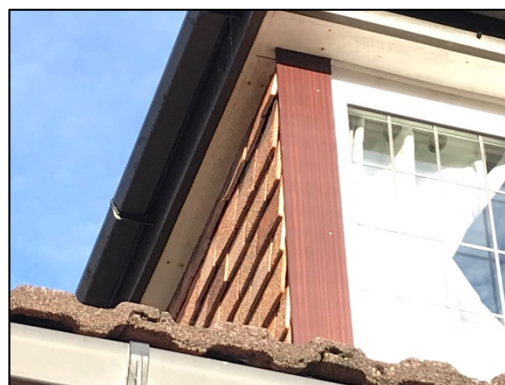
**Figure 6 – gaps under hanging tile on dormer windows**

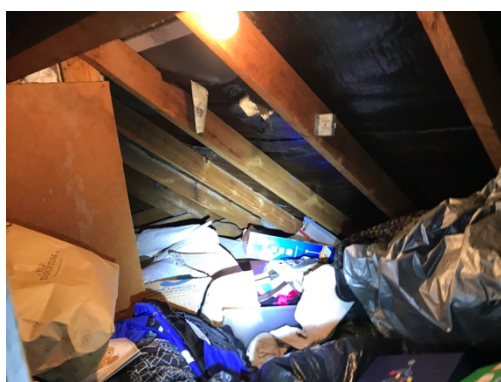
| <b>Suitability</b> | <b>Evidence</b> |
|---|---|
| <b>Interior</b> | <p>The following access/egress and roosting features were recorded internally during the survey:</p> <ul style="list-style-type: none"> <li>- Tears in the bitumen lining causing hanging folds (Figure 7).</li> </ul> |

**Figure 7 – tears in bitumen lining and hanging folds**
