**HOME FARM, HEDGE END**

**GROUND CONDITION DESK TOP STUDY**

**NOVEMBER 2022**

**Report No.** J22-077-R01

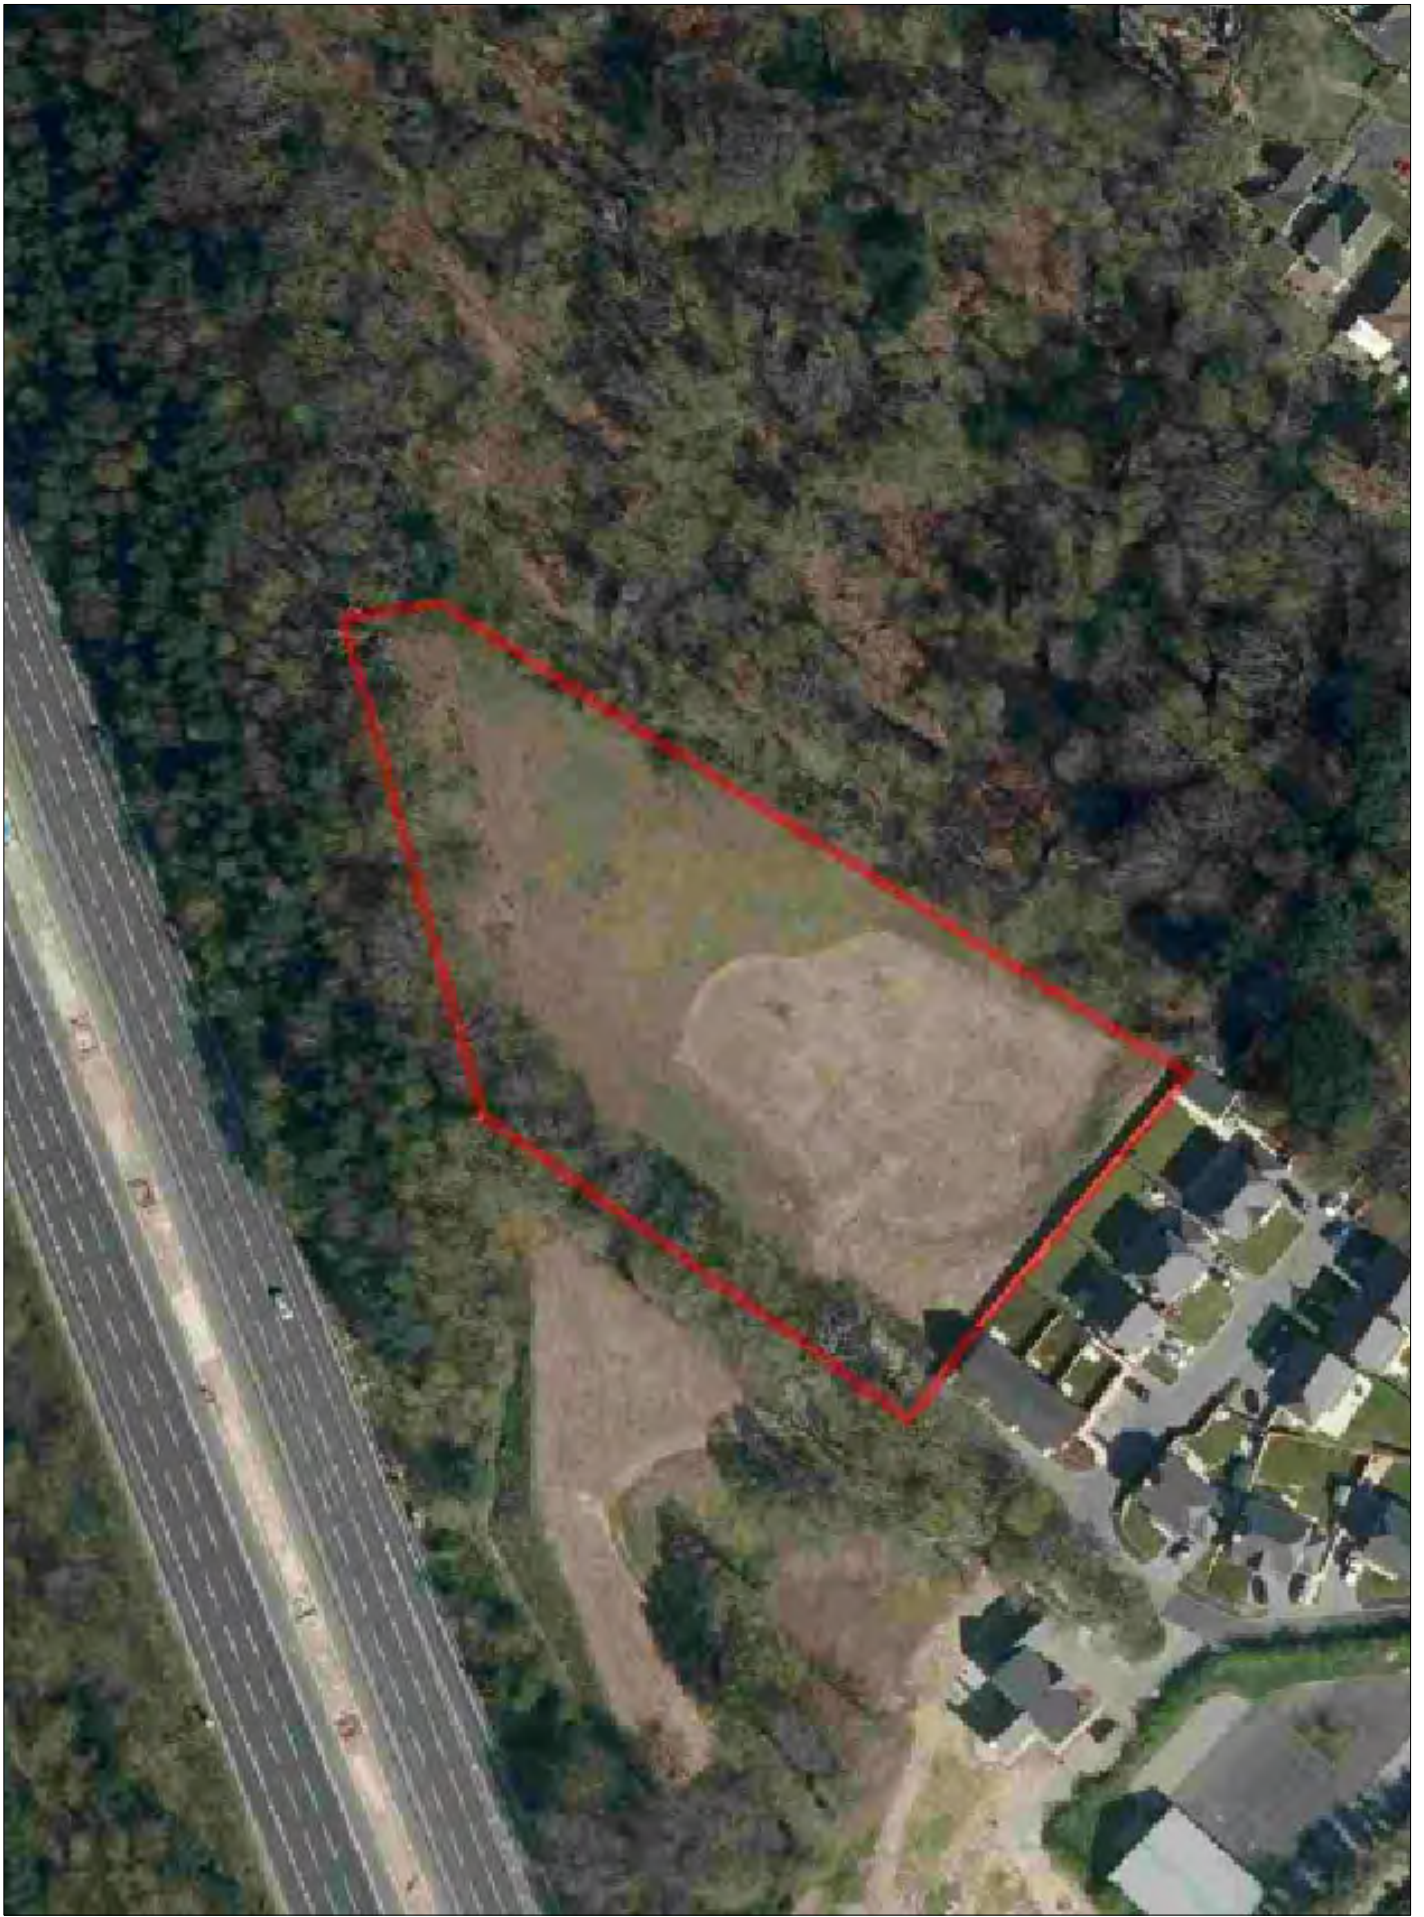
**FIGURE 2:LAYOUT PLAN**

client  
WYKEHAM HOMES  
site  
HOME FARM, HEDGE END  
title  
EXISTING LAYOUT PLAN

The site is bounded to the northeast, northwest and southwest by wooded areas with the M27 motorway approximately 40m beyond to the west. The southeast boundary of the site is formed by a fence line separating the site from a recently constructed residential development that fronts the new road of Home Farm.

The 2020 aerial image in the Groundsure report indicated earthworks to have taken place across the east of the study site and the grass had not grown back across the affected area. A comparison of the topographical surveys for the study site from 2015 and 2022 indicate that the site levels have been raised by up to approximately 2m across the east of the site.
