# Arboricultural Implications Assessment and Method Statement for land at Home Farm, St Johns Road, Hedge End

Arboricultural Implications Assessment and Method Statement

**Land at Home Farm, St Johns Road, Hedge End**

Report Ref: **221513 - AIA**

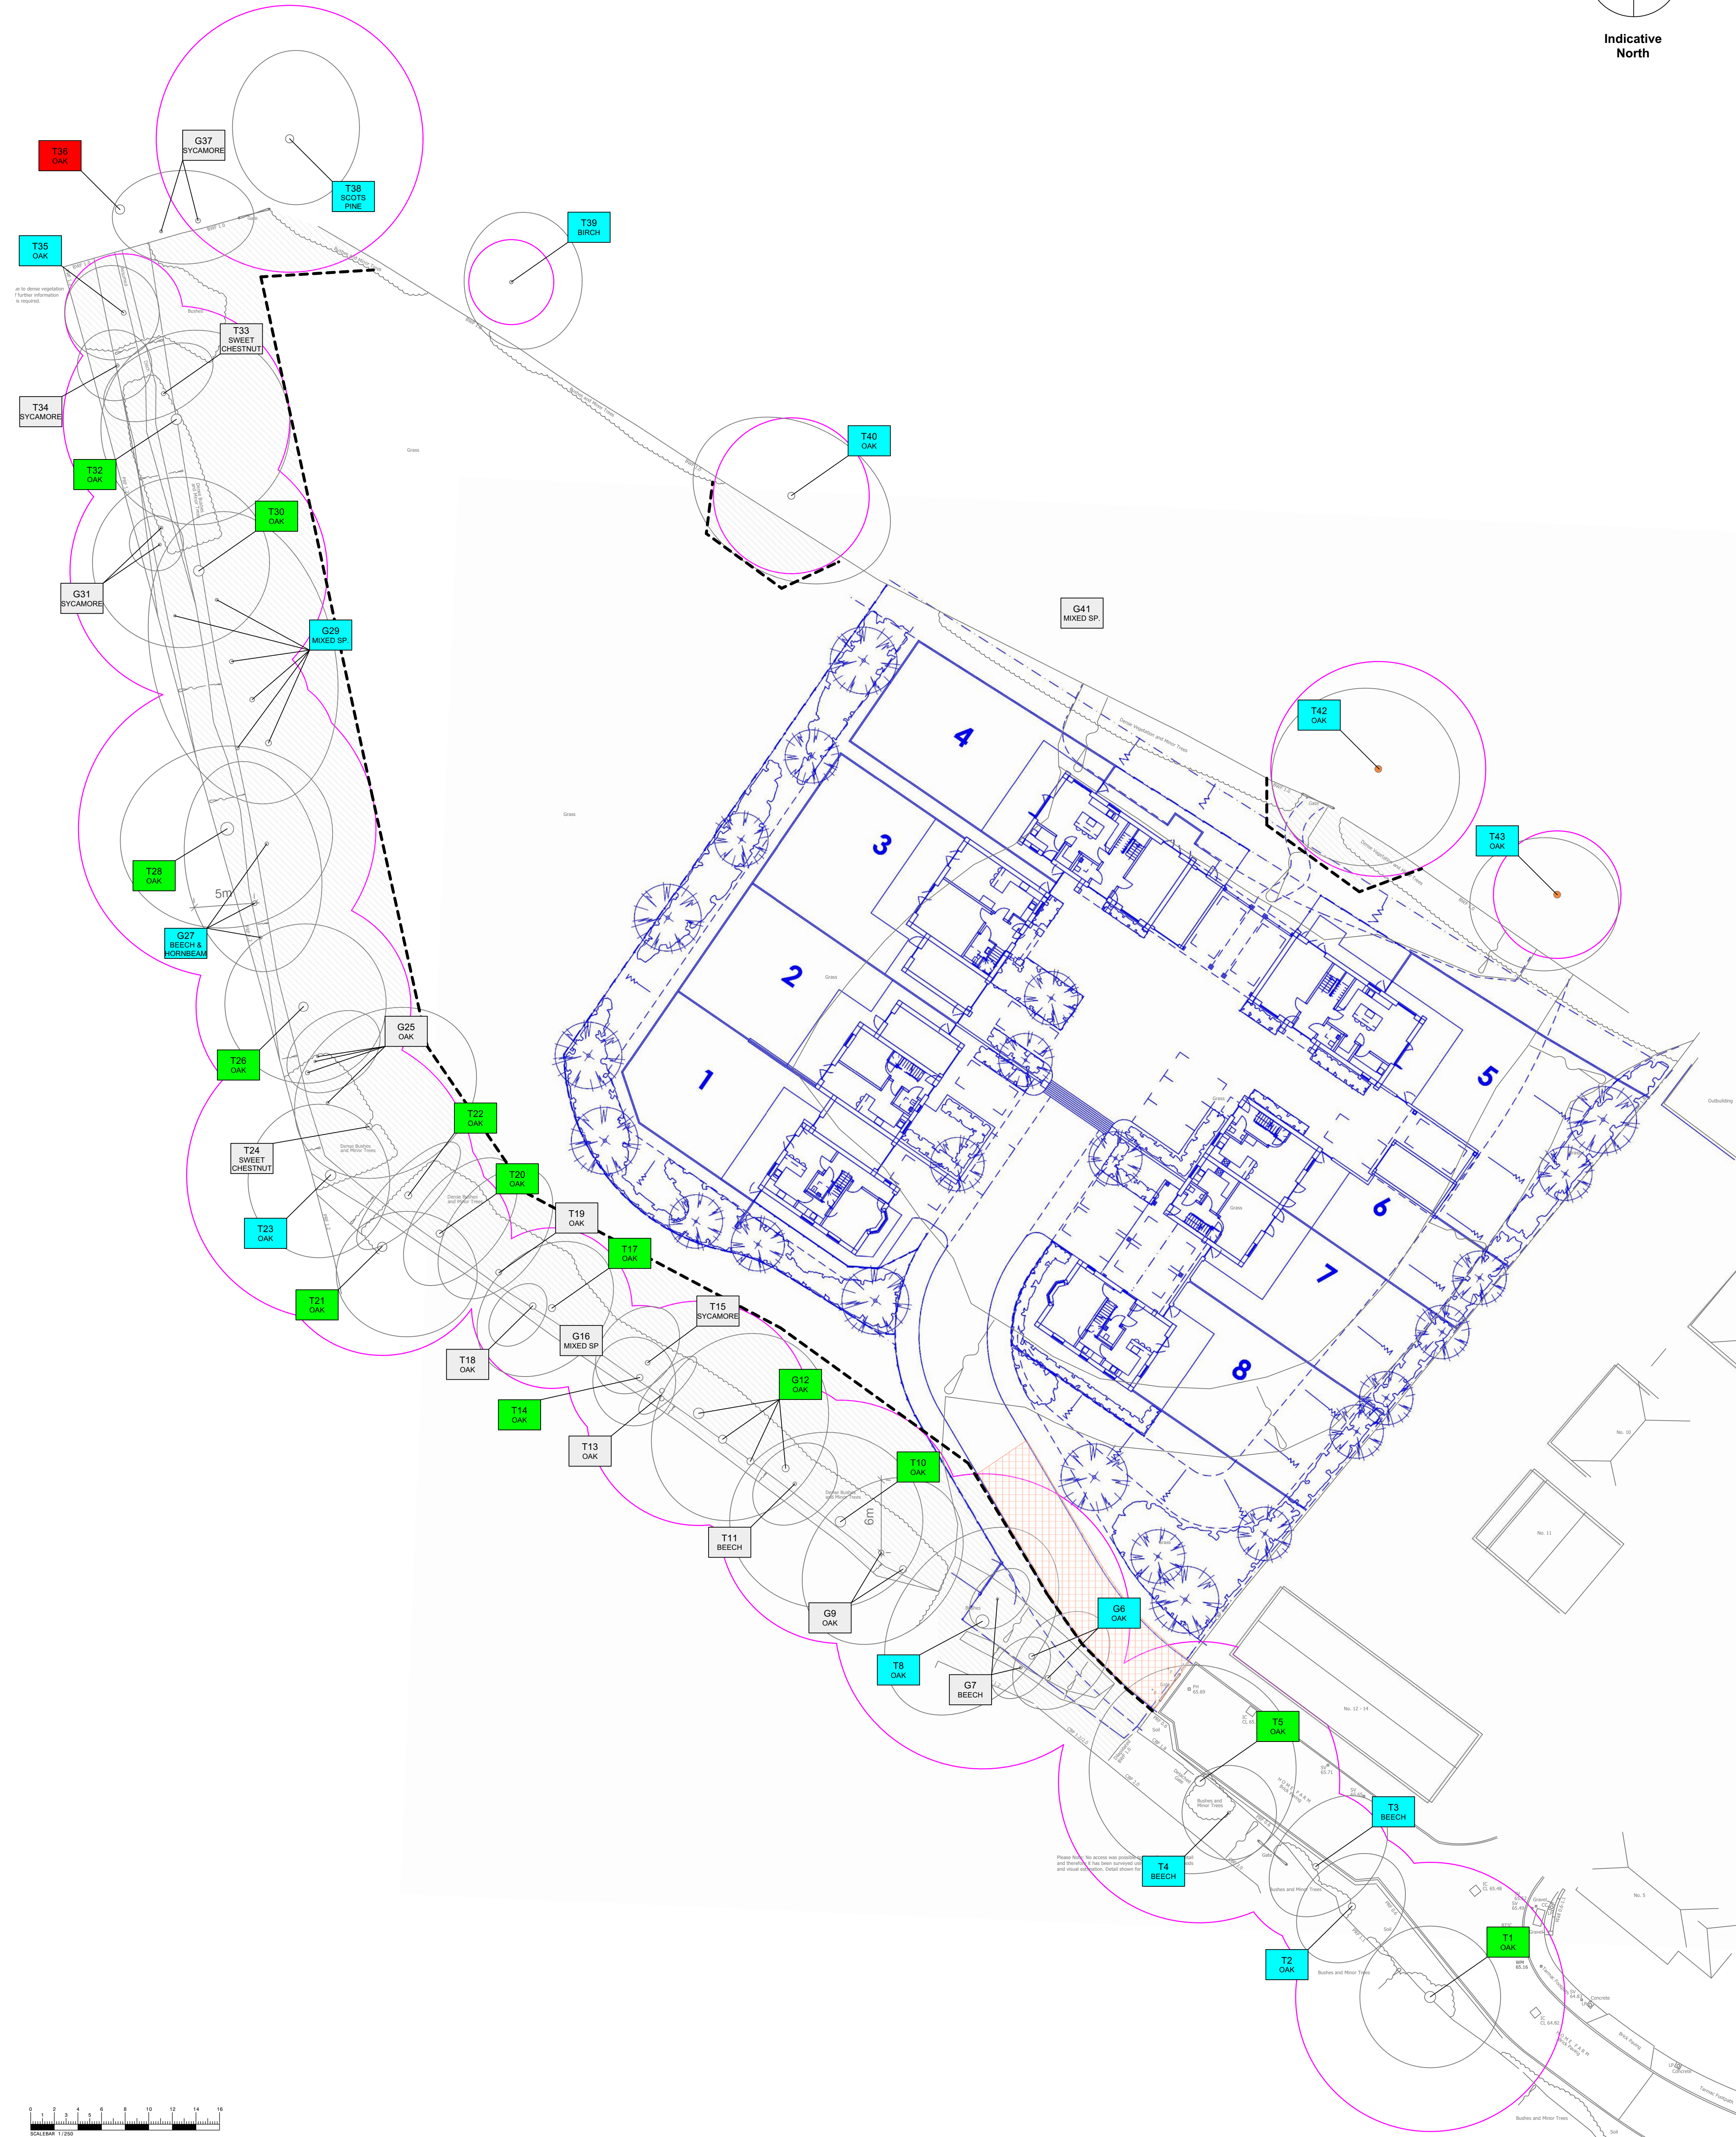
## Appendix 1: Tree Protection Plan

ECO 4 - TREE PROTECTION AT HOME FARM, ST JOHNS ROAD, HEDGE END

COMPOSITE PLAN: LAND SURVEY OUTLINED IN GREY,  
PROPOSED DEVELOPMENT SHOWN IN BLUE

Tree protection barriers  
with construction exclusion zone

Minimum extent of 'Low  
invasive type' surfacing

**Root Protection Areas (RPAs):** Below  
ground tree constraints for important  
trees based on BS 5837 guidance

- 1.4 **The Tree Protection Plan:** This is included in Appendix 1 and is a composite drawing derived from the information provided. It shows the existing landscape features (from the land survey) in grey superimposed over the proposed layout shown in blue. This allows the relationship between the two to be clearly seen and an appropriate analysis of the implications of the proposed site changes to be undertaken. The Tree Protection Plan has also been annotated to show protection measures for any retained trees which could realistically be affected by the proposed development. It shows any activities in Root Protection Areas (RPAs) and if any trees are to be removed, they are shown with a red dashed crown outline.

5.1.1 **Tree Protection Plan (TPP):** The plan in Appendix 1 is illustrative, but is based on the layout drawings and topographical survey provided. Therefore, all scaled measurements should be checked against the original design documents. The attached plan and all other information in this report should only be used for dealing with the tree protection issues and all other uses are prohibited, unless authorised by ecourban ltd. All the existing trees will have been numbered, with any higher categories (A and B) highlighted in green and blue rectangles and any low categories (C and U) highlighted in grey and red respectively. The plan also shows the locations of the proposed protective measures, including areas where special care may be required. The TPP is an important document and a copy of it should be kept on site for reference whilst the development is under construction.

5.1.2 **Protective barriers:** The approximate location of the barriers is illustrated on the plan in Appendix 1 and information on barrier design based on BS 5837:2012 guidance is included in Appendix 3. The protective barriers will be erected before any materials or machinery are brought onto the site and before any clearance or construction activities occur. Once the protective barriers have been positioned, these will stay in situ for the duration of the construction, unless previously agreed with the project arboricultural consultant or council's tree officer. There will be no access into the protected areas and the storage of excavated debris and building materials will be prohibited in RPAs, unless authorised by the project arboricultural consultant, after discussion with the council's tree officer. No fires or fuel storage will be allowed within or near to protected areas under any circumstances.

5.2.2 **Installation of new surfacing:** Trees/groups T5, G6 and T8 may be affected by the installation of the new access drive. I have shown the minimum extent of 'low invasive' type surfacing required to successfully retain the trees on the plan included in Appendix 1 and the extent of this is based on their BS derived RPAs. The cellular system will act as ground protection for the

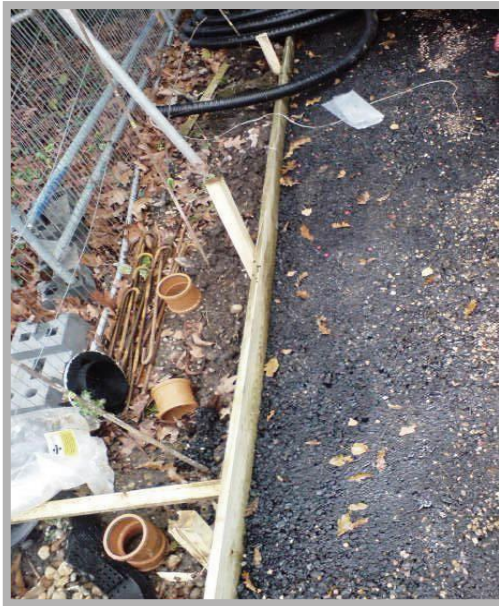
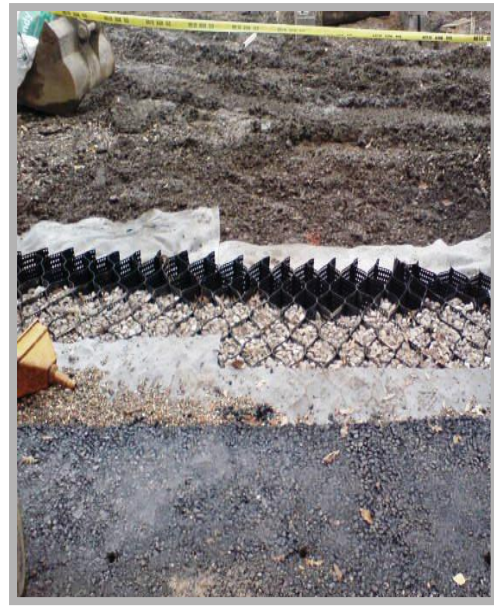
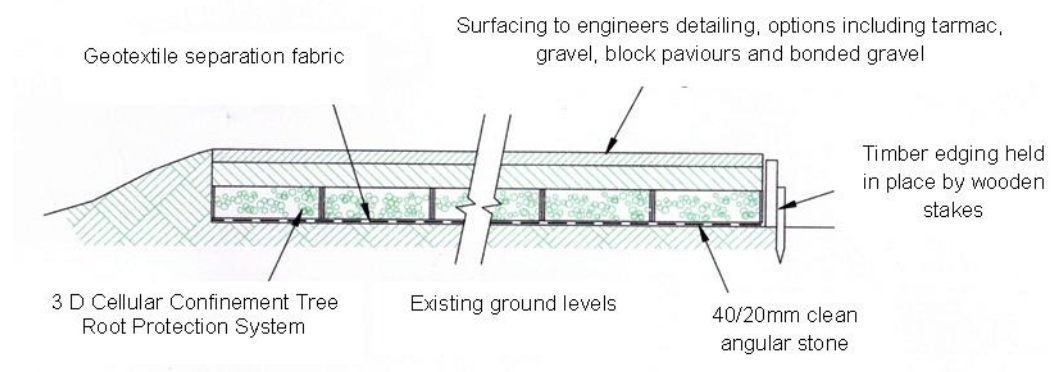
| Ref: No dig surfacing | Drawing No. NDS 1 |

Illustration adapted from original drawings provided by Geosynthetics Ltd.

*Appropriate sub-base options for new hard surfacing include three-dimensional cellular confinement systems. Alternatively, piles, pads or elevated beams can be used to support surfaces to bridge over the RPA or, following exploratory investigations to determine location, to provide support within the RPA while allowing the retention of roots greater than 25 mm in diameter.*

parts of the RPAs that are outside the protective barriers and so will need to be installed before any other construction activity occurs on site. The use of a cellular confinement system is suggested in BS 5837:2012 as one appropriate way to achieve hard surfacing over tree roots and the following guidance is based on this principle. However, before implementation the following specifications and guidance will need to be reviewed by an engineering specialist, to ensure that the final construction is appropriate from an engineering viewpoint and suitable for the purpose intended.

- **Sub base and final wearing courses:** Once a level surface has been formed, the cellular system will be installed on top of the existing soil, with no compaction of its structure. The cell infill material will be crushed aggregate (typically 20-40mm, clean angular stone), with no fines, as per the manufacturer's specification. A temporary wearing course of tarmac and/or aggregate, separated by a geotextile membrane is likely to be the most appropriate way of providing a suitable ground protection/working surface during the clearance and construction phase of the project. At the final stages of the construction, the temporary wearing course will be removed (under arboricultural supervision), and the final surfacing will be installed. Suitable final wearing courses include resin bound gravel, paving slabs, washed gravel or block pavements set on a sand base, although other surfacing may be appropriate after consultation with the project arboriculturist.

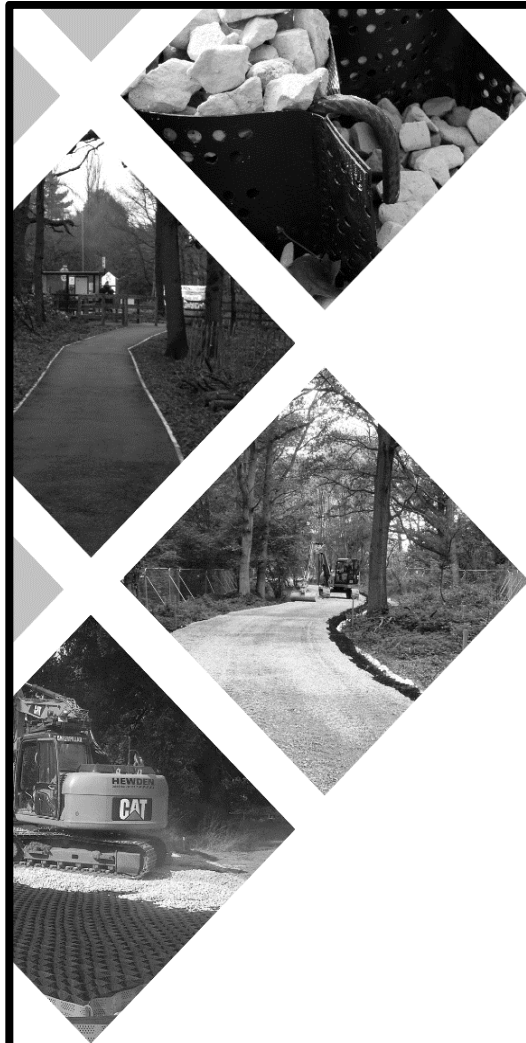
## What is Cellweb®TRP?

*Cellweb®TRP is a cellular confinement system specifically designed for tree root protection. The system creates a stable, load-bearing surface for traffic or footfall whilst eliminating damage to roots through compaction and desiccation.*
